Technical Service Bulletin

Topic	HVAC refrigerant leakage suspected or reports of a damp/musty smell within the cabin - Diagnosis guidelines
Market area	Australia E04 Bentley rest Asia and Australia (6E04),China 723 Volkswagen (Anhui) Automotive CO (6723),China 796 VW Import Comp. Ltd (Vico), Beijing (6796),Germany E02 Bentley rest Europe (6E02),Japan E03 Bentley Japan (6E03),Korea, (South) E08 Bentley South Korea (6E08),United Arab Emirates E06 Bentley Middle East and Africa (6E06),United Kingdom E01 Bentley UK (6E01),United States E05 Bentley USA and rest America (6E05)
Brand	Bentley
Transaction No.	2069806/7
Level	EH
Status	Released for publishing
Release date	Sep 8, 2025

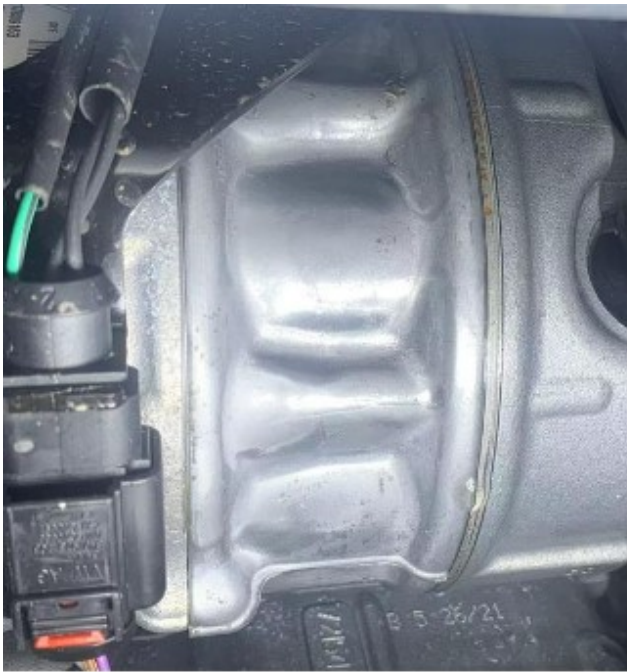
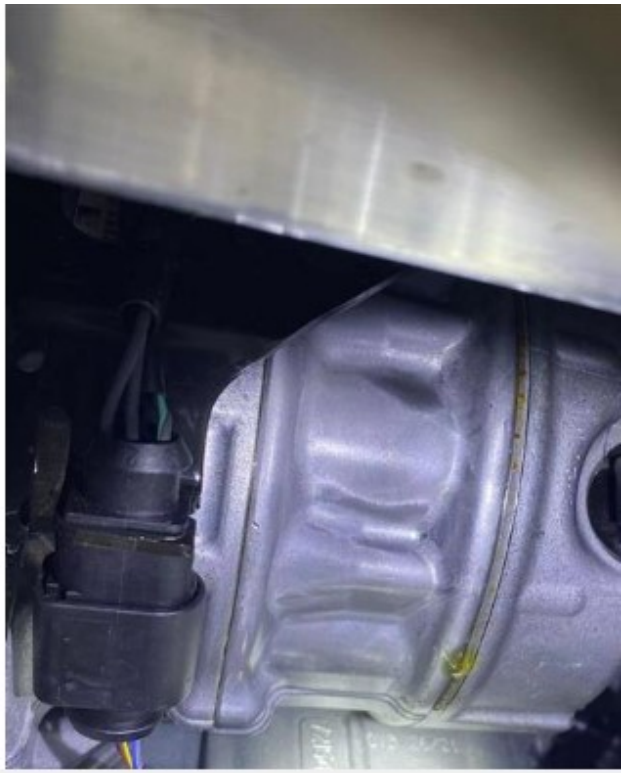
Figure 1

- HVAC is not cooling or the HVAC is not effective due to leakage of the refrigerant
- Refrigerant recovered from the system shows a low volume or no refrigerant at all
- Leakage is suspected from the compressor as no other leakage source was found

please refer to the examples shown below (Figures 1,2 and 3) of leaks found on the HVAC compressor

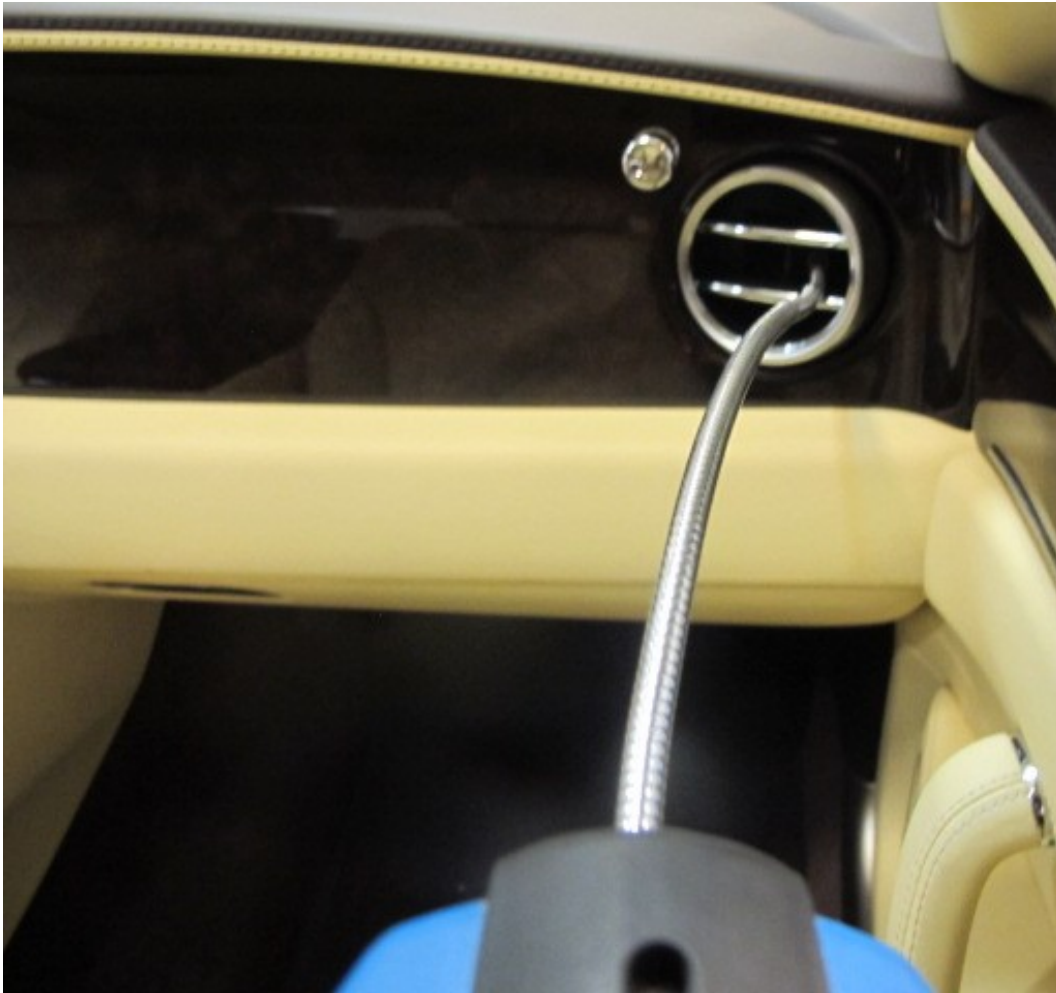
Figure 4

In the event the HVAC sniffer tool traces a HVAC leak from any of the outlets (Figure 4)

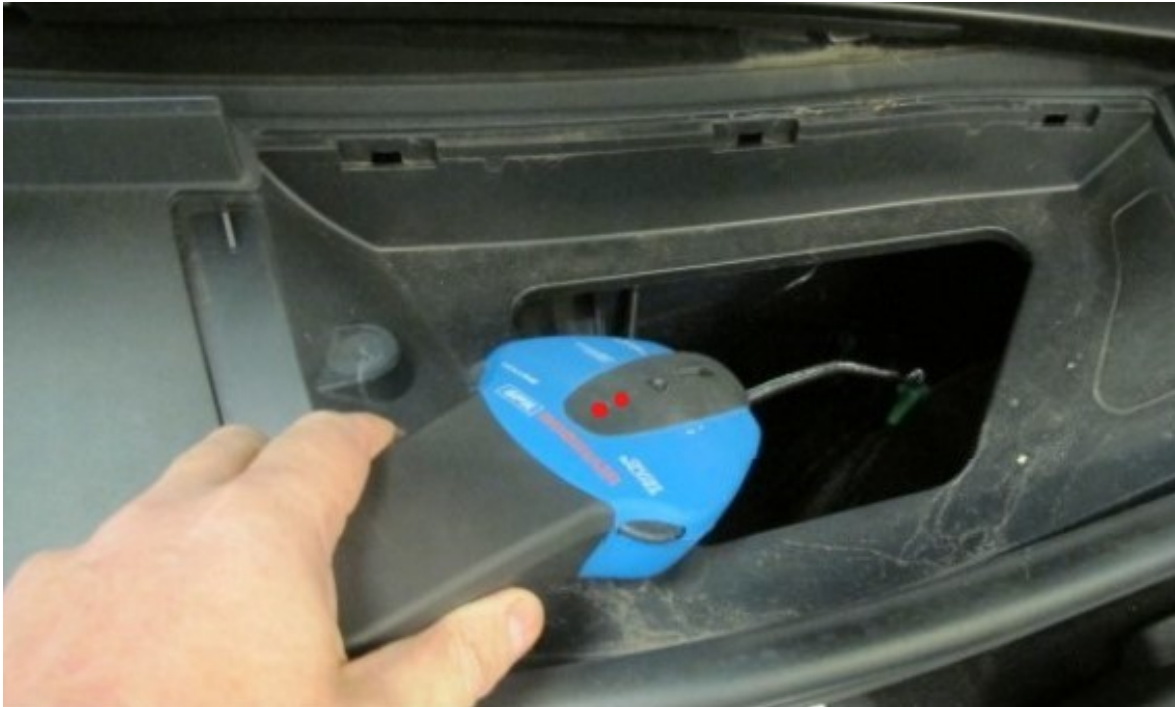
Figure 5

The operative **MUST** first ensure that a leak is not evident within the plenum chamber or around the centre console (Figures 5 and 6) as refrigerant could be leaking into the plenum chamber/cabin, and recirculated back into the cabin which could lead to misdiagnosis and/or incorrect part replacement.
