Topic	Steering Wheel – Specification Verification Bentayga Series 25MY (SC25/40)
Market area	Bentley: worldwide (2WBE),China 796 VW Import Comp. Ltd (Vico), Beijing (6796)
Brand	Bentley
Transaction No.	2079381/1
Campaign number	ED68
Note	
Type	
US code

25MY Bentayga Series

Technical background

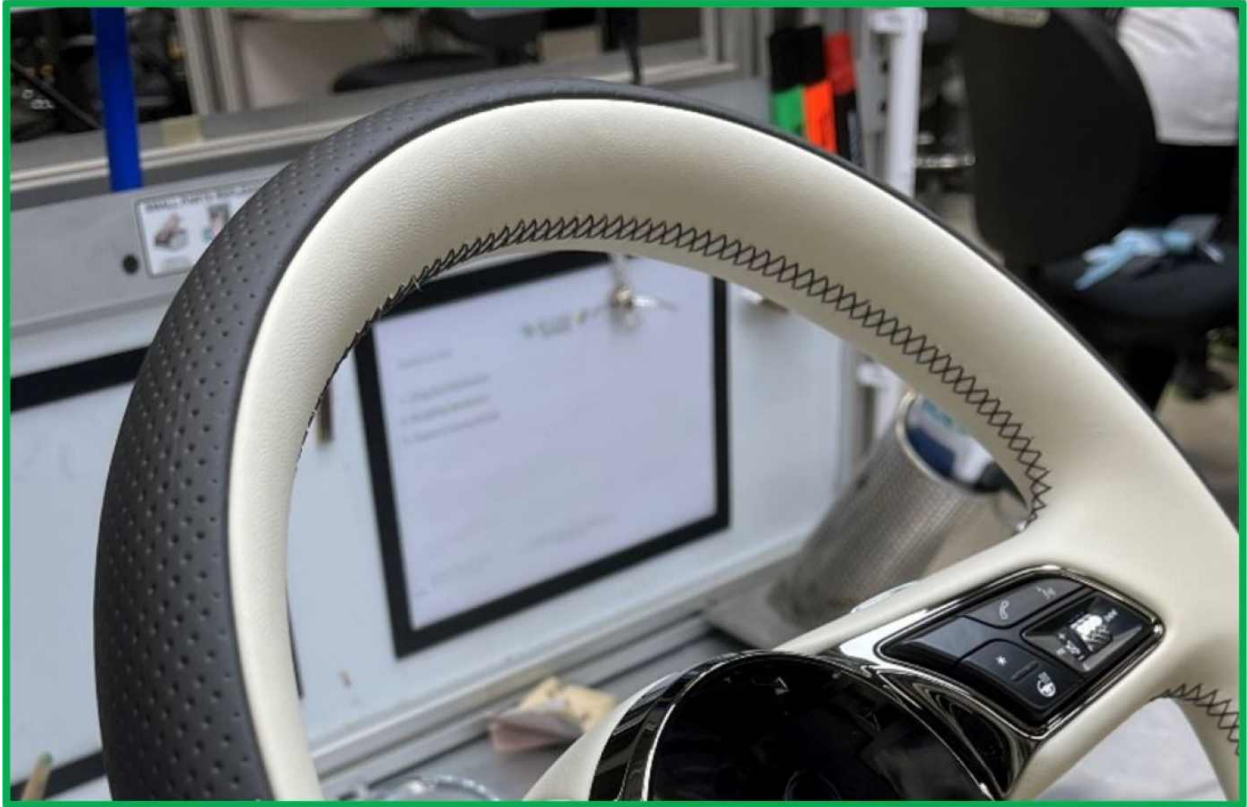
Figure 1 *OK condition of steering wheel fitted*

2. Perform a check of the steering wheel. If the specification is correct, as per figure 1 with indentation present on the outer leather. Refer to the identification section to confirm campaign completion.

The steering wheel colour is not related to the build specification, only the indentation present on the outer leather should be checked.

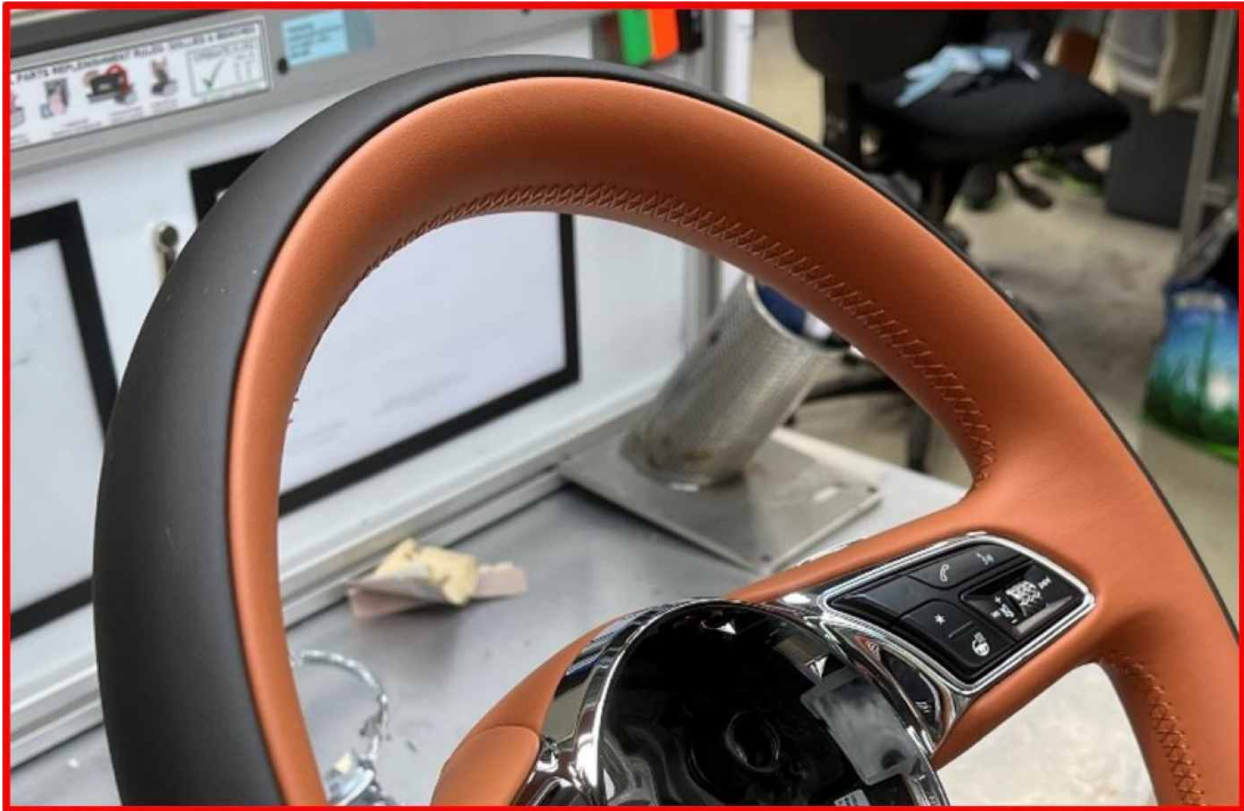
Figure 2 NOK condition of steering wheel fitted

3. If the steering wheel does not match the specified part, as per figure 2. Without the indentation present on the outer leather. Replace it with the correct specification part listed in the genuine parts section.

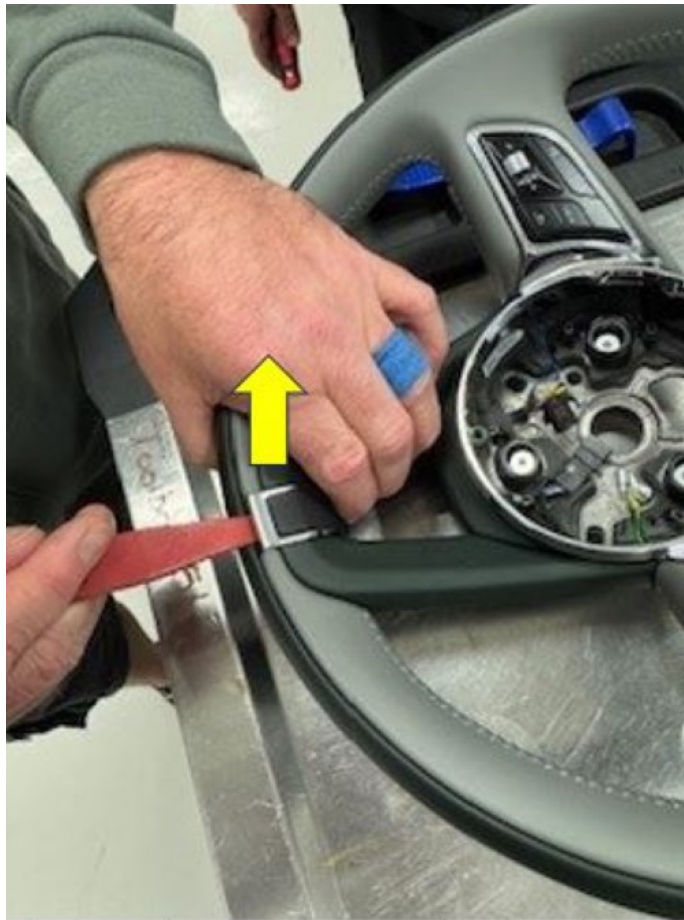
Figure 4 – *Lower trim chrome bezel trim insert*

7. Using Removal wedge -3409- remove the Lower chrome bezel trim insert, use flat tool to pry in an upwards direction as shown in figure 4.

Reinstallation Note: Ensure the leather is properly tucked and aligned before pressing the component back into place

- Multifunction switches -A- and -B- shown and the chrome bezel in figure 3.
- Gearshift paddles.
- Lower chrome bezel trim insert shown in figure 4.

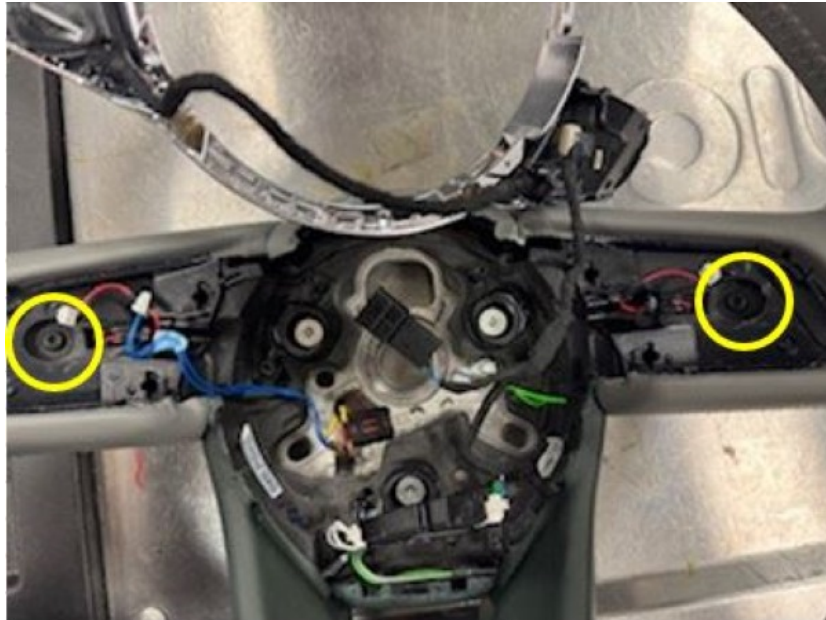
Figure 5 – Gearshift paddle fixing location

8. Remove the fixings circled shown in figure 5, then remove the gearshift paddles from the steering wheel.

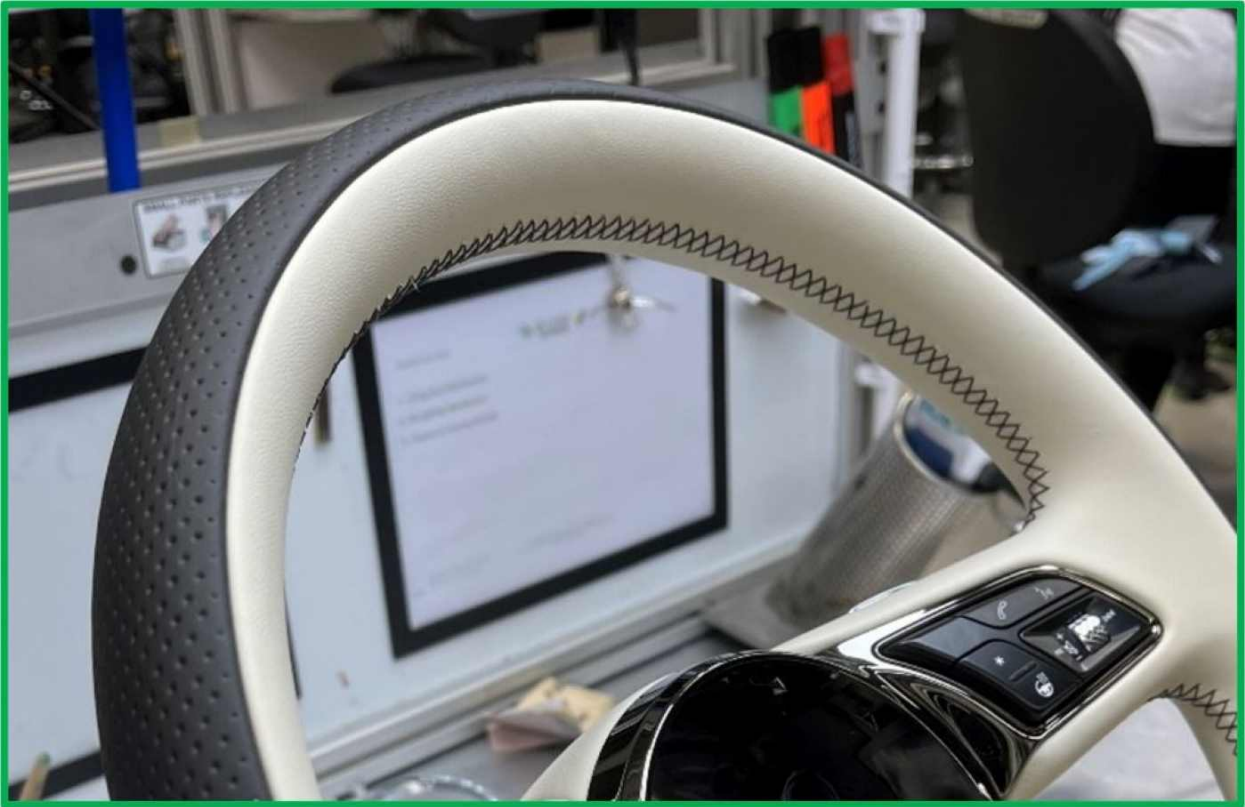
Fitment of the correct specification steering wheel as per Figure 6 confirms campaign completion.

Figure 6 *OK condition of steering wheel fitted*
