Technical Service Bulletin

Topic	Service info: Paint Damage/Anomalies All Models
Market area	Bentley: worldwide (2WBE),China 796 VW Import Comp. Ltd (Vico), Beijing (6796)
Brand	Bentley
Transaction No.	2078038/2
Level	EH
Status	Released for publishing
Release date	Sep 23, 2025

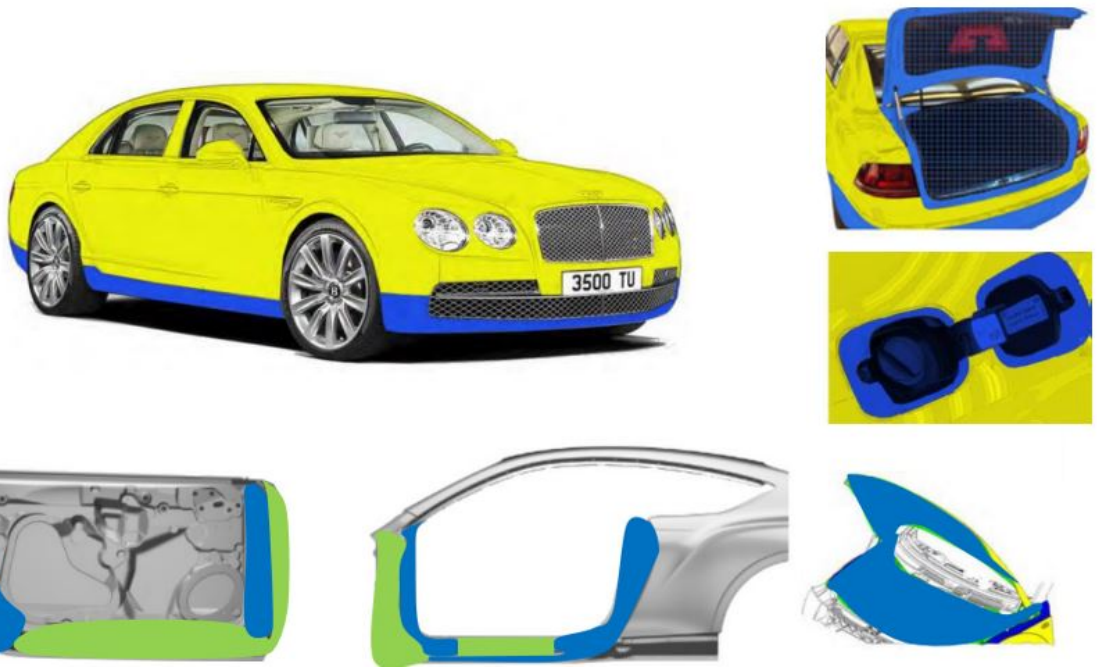
Continental GT/GTC/Flying Spur

Zones to be considered:

1

Zone 1

2

Zone 2

3

Zone 3

- Inspection of the vehicle surfaces must be carried out WITHOUT artificial lighting.
- Attach both photographs and include a brief description of the location of the anomaly including if it is Zone 1, 2 or 3 (see diagrams below for zone criteria).

If a defect cannot be seen from a distance of 80 cm then the defect should not be identified as requiring rework.
