9YA, 9YB- A/C Blows Warm or Fan Remains Active After Shutdown for LIN bus 2 Electrical Fault

Models	Model Year	Model Type	VIN Range	Vehicle-Specific Equipment
Cayenne	As of 2019 up to 2023	9YA, 9YB	All	Ionizer (2V4)

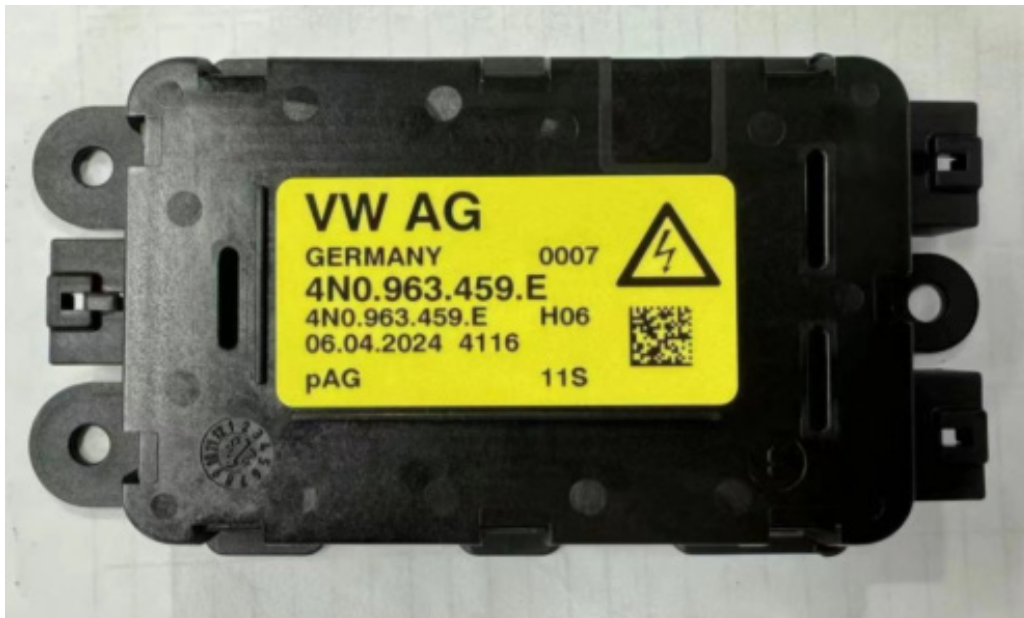
Check the yellow label on the replacement part before installation. Parts with the latest countermeasure will end in label index E and contain version 11S on the yellow label as shown in Figure 1. Only install replacement parts with labels that match these designations.

Figure 1: Replacement ionizer part label

Replace ionizer with part number PAD963459A or later before further diagnosis of the A/C system for this issue.
