**Washer Fluid Leaking at Front Left Cover Hinge/Hose for Front Windshield Washer System Leaking: Observe the Specified Procedure (58/25)**

Model Line: **911 (991)**

Model Year: **As of 2012 up to 2019**

Concerns: **Windshield washer system hose**

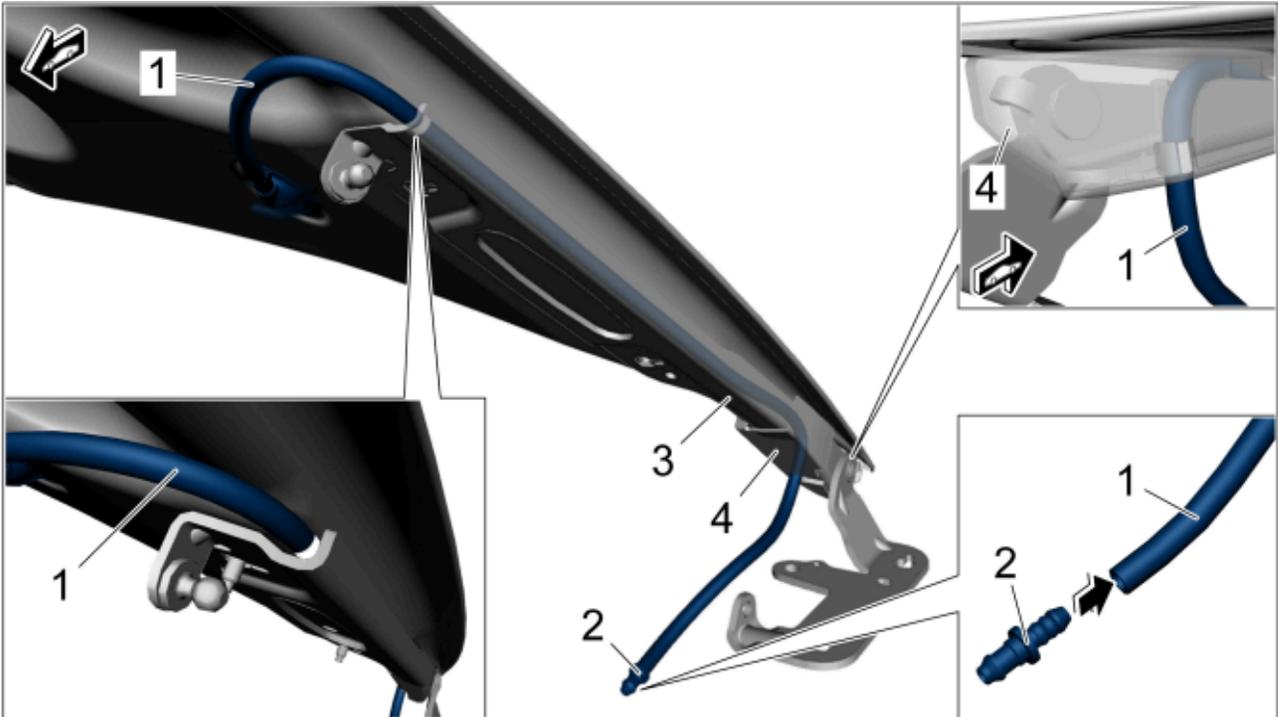
The leak can be narrowed down to a damaged hose for the front windshield washer system in the area of the cover hinge.

- 1 – Front windshield washer system hose
- 2 – Connection piece
- 3 – Front left cover hinge
- 4 – Hose holder

- 3 Replace the previous hose for the front windshield washer system with a **new** hose for the front windshield washer system ⇒ *Front windshield washer system hose routing -1-*.  
Connect an **additional** new connection piece ⇒ *Front windshield washer system hose routing -2-* to the new hose on the front windshield washer system ⇒ *Front windshield washer system hose routing -1-*.

Make sure that the hose is laid in the same way as the original hose installation. ⇒ *Front windshield washer system hose routing*
