HYUNDAI

Technical Service Bulletin

GROUP CAMPAIGN	NUMBER 25-01-071H
DATE OCTOBER 2025	MODEL(S) SANTA CRUZ (NXT)

SUBJECT: TCU SOFTWARE UPDATE FOR 8DCT HIGH PRESSURE ELECTRIC OIL PUMP (SERVICE CAMPAIGN TEJA)

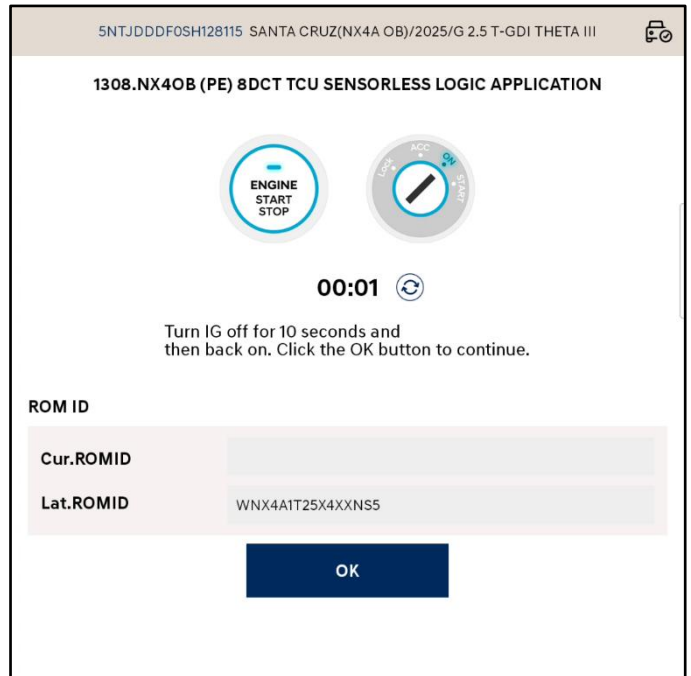
3. After the ECU update process shows 100% complete, follow the prompts on the screen to cycle the ignition **OFF** for at least **10 seconds** to reset the control unit (certain models may take up to **30 seconds**).

Use the **Refresh** button to reset the timer.

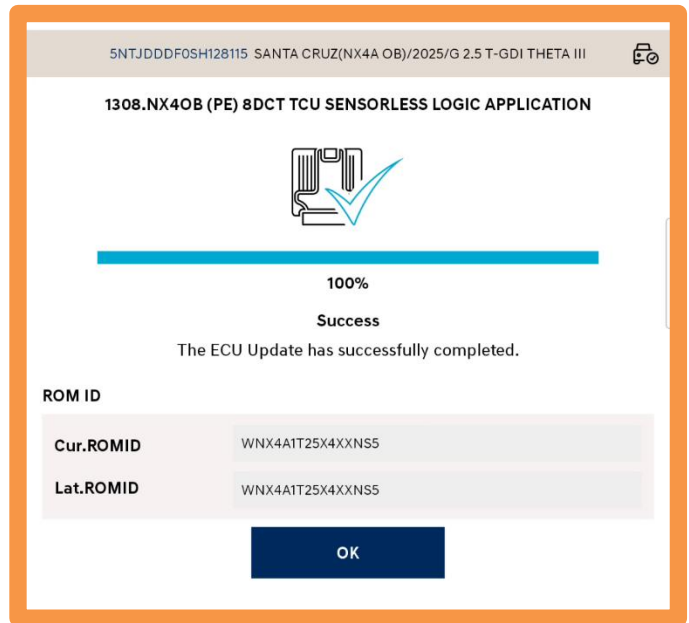
Take a screenshot of the ECU Update “Success” screen using your tablet and upload to STUI.
