GENERAL MOTORS
DCS7343
URGENT - DISTRIBUTE IMMEDIATELY

Subject: N252517790 - Customer Satisfaction Program
Reaction Carrier Cracks

Models: 2025-2026 Chevrolet Colorado
2025 Chevrolet Express
2025 Chevrolet Silverado 1500
2025-2026 GMC Canyon
2025 GMC Savana
2025 GMC Sierra 1500

Condition	Certain vehicles listed above, equipped with 8L80 or 8L90 Transmissions, may have a condition in which the reaction carrier cracks.
Correction	Dealers are to replace the reaction carrier.

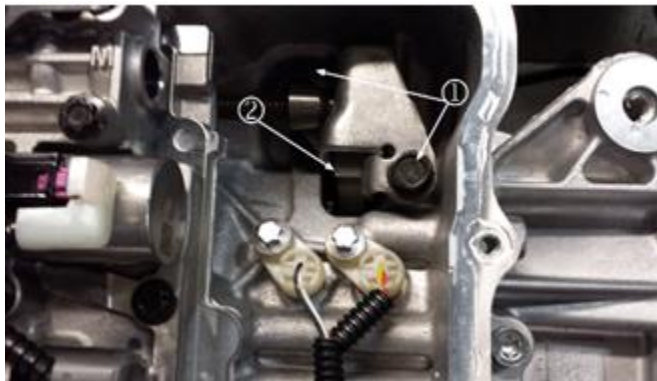
4119602

4. Remove and discard the two Park Pawl Actuator Bracket Bolts (1).
5. Move the park pawl (2) away from the output carrier assembly gear.

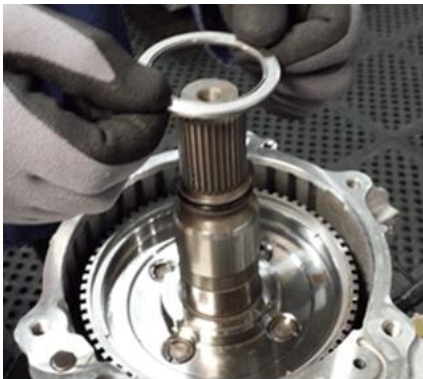
4121151

10. Remove the Output Shaft Bearing and note the orientation.

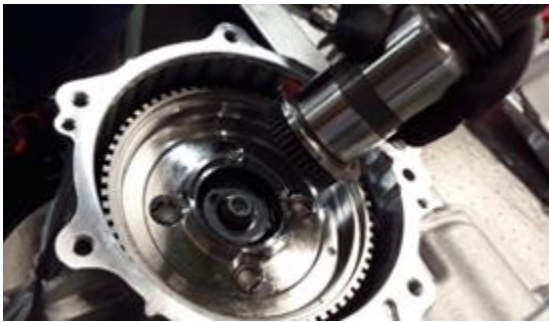
4119614

11. Remove the Output Shaft.

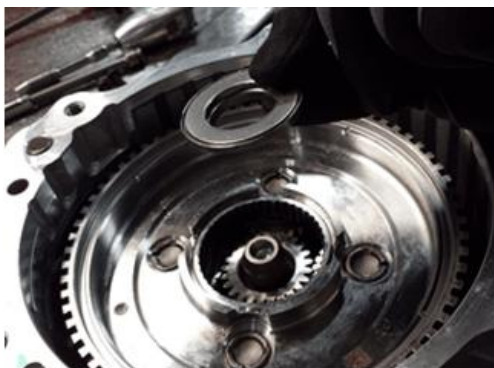
4121181

12. Remove the Output Sun Gear Thrust Bearing.

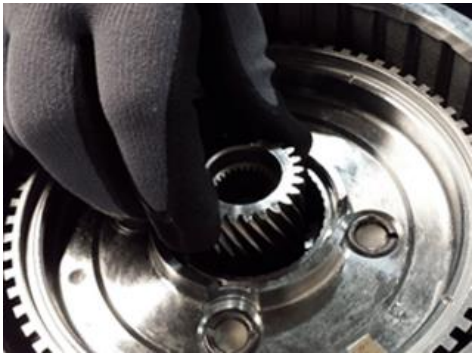
13. Remove the Output Sun Gear.

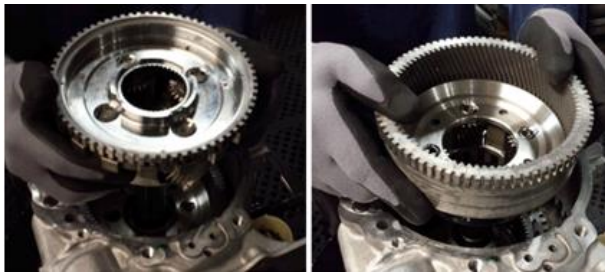
14. Remove the Output Carrier Assembly and the Reaction Carrier Assembly.

15. Install a new Reaction Carrier. Refer to *Reaction Carrier Overhaul* in SI.

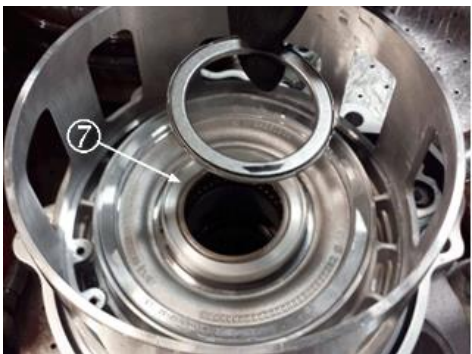
17. Install the Output Shaft Bearing into the case extension assembly. It may be helpful to apply a small amount of Transgel between the Output Shaft Bearing and the Case Extension bearing pocket (7).

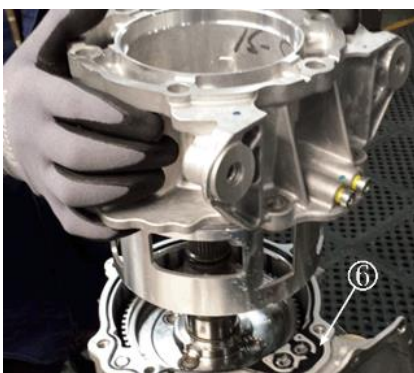
18. Install the Case Extension Seal (6). Ensure the transmission is completely vertical and carefully install the Case Extension assembly. Verify the Output Shaft Bearing has remained in place.
