Technical Service Bulletin

GROUP	NUMBER
CAMPAIGN	25-01-052H
DATE	MODEL(S)
OCTOBER 2025	SANTA CRUZ (NXT) SANTA FE (MX5A)

SUBJECT: 2.5T-GDI ENGINE REPLACEMENT FOR COOLANT LEAK
(SERVICE CAMPAIGN 9C3)

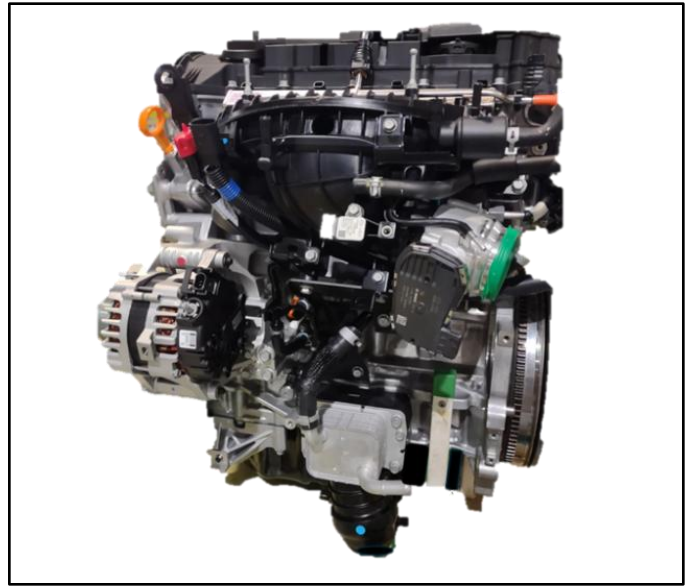
1. Remove the engine sub-assembly from the affected vehicle.

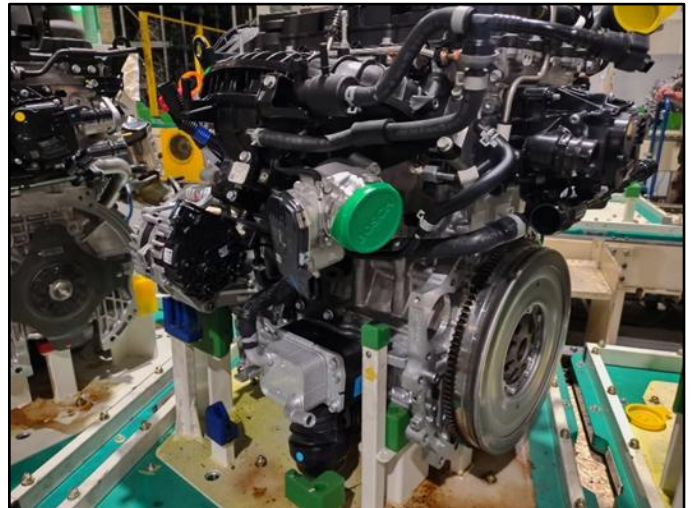
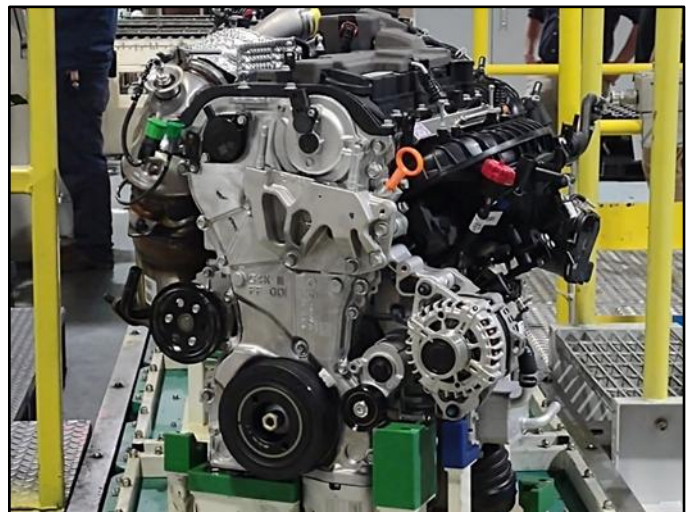
2. The new engine sub-assembly will contain many components already pre-installed onto the engine. Do **NOT** remove the components listed below from the original engine sub-assembly.

- Intake Manifold
- Throttle Body
- Dual Mass Flywheel
- Alternator Assembly
- Throttle Body
- High Pressure Fuel Components
- Ignition Coils and Spark Plugs
- Exhaust Manifold
- Turbocharger Assembly
- Water Pump Assembly
- Crankshaft Pulley
- Idler / Tensioner Assembly
- ITM Assembly

Transfer all remaining components from the original engine sub-assembly to the **new** one.

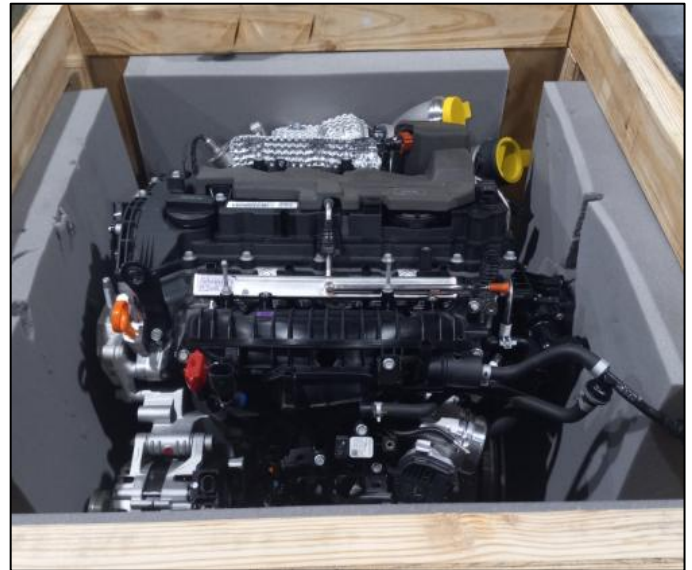
- Place the **original** engine sub-assembly in the same crate that the new engine sub-assembly arrived in.

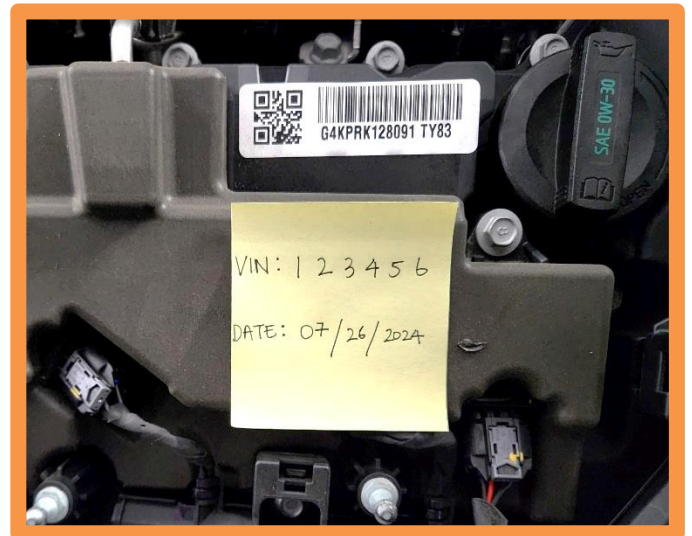
Using the STUI camera function, take a photo of the new engine serial number.

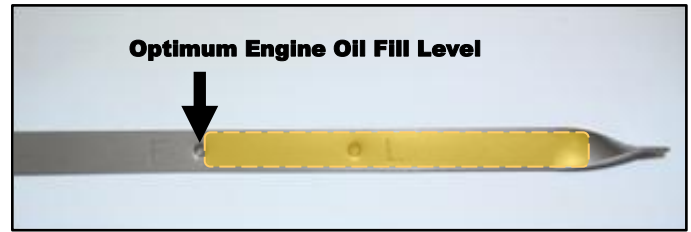
- Verify the engine oil level is at the “Full” mark as shown.

The new engine sub-assembly will come pre-filled with engine oil.

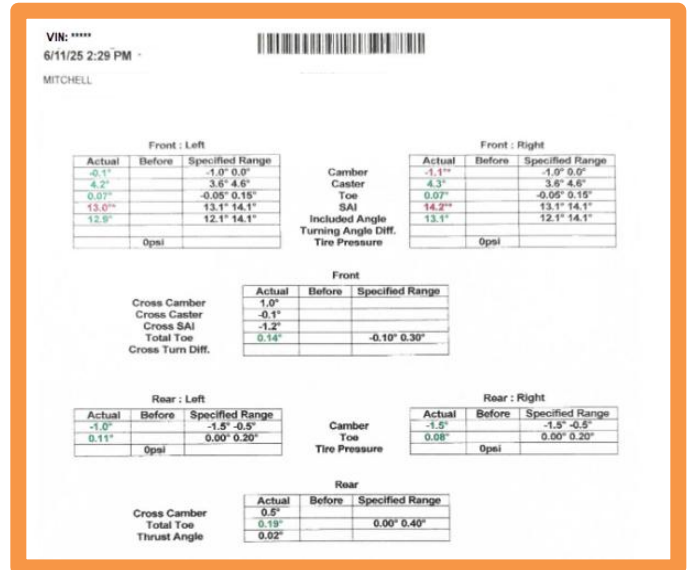
Using the STUI camera function, take a photo of the completed alignment sheet clearly showing the vehicle's VIN and date of alignment .

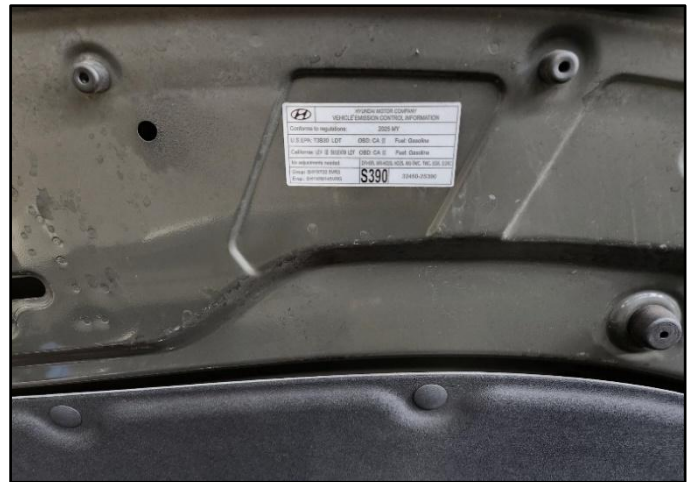
1. Fill in the Dealer Code and Date on the Campaign Sticker, and apply adjacent to the existing Emission Label, on the underside of the hood, as shown.
