<b>HYUNDAI</b> <b>Technical Service Bulletin</b>	GROUP <b>CAMPAIGN</b>	NUMBER <b>25-01-050H-1</b>
	DATE <b>OCTOBER 2025</b>	MODEL(S) <b>IONIQ 9 (ME1A EV)</b>
<b>SUBJECT:</b> WALK-IN SWITCH INSPECTION & REPLACEMENT (SERVICE CAMPAIGN TEC)

**Description:** Certain IONIQ 9 (ME1A EV) vehicles may have walk-in switches that are not fully secured. This bulletin provides instructions to inspect and, if necessary, replace the walk-in switch.

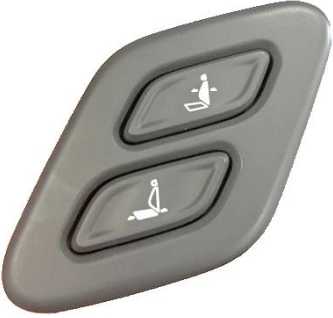
Model	Part Name	Part Number	Figure	Remarks
IONIQ 9 (ME1A EV)	Switch Assembly – Walk in, RH	88085-DO000YGN

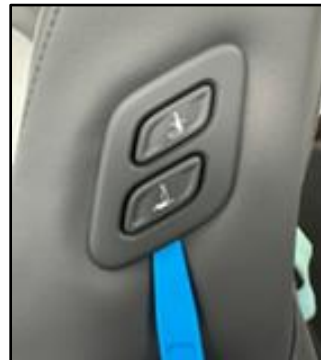
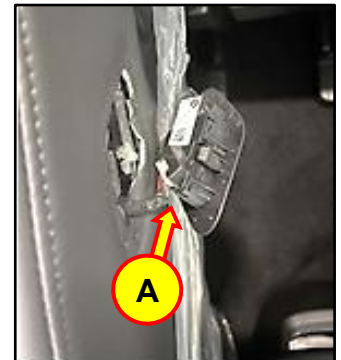
1. Use a plastic trim removal tool to pry off the walk-in switch assembly from the bottom and disconnect the connector (A).

Use a plastic trim removal tool to prevent damage to parts.

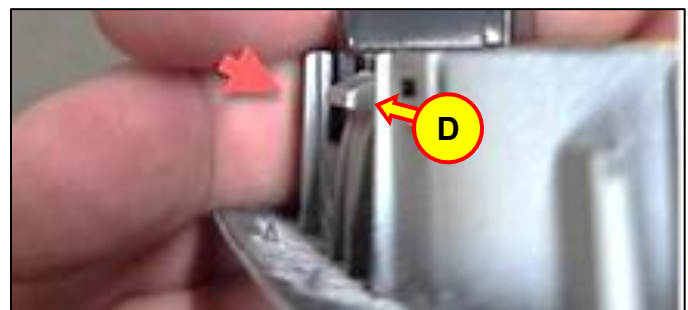
2. Inspect both locking tabs for cracks (B), damaged/missing tabs (C), or deformation (D):
  - **PASS:** If any tabs are **NOT** cracked, missing pieces, damaged, or deformed, reinstall the walk-in switch. Proceed to the [Walk-in Switch Assembly Installation](#) procedure.
  - **FAIL:** If the switch is cracked, damaged, missing pieces, and/or has any deformed tabs, proceed to the [Walk-in Switch Assembly Installation](#) procedure to install a new walk-in switch assembly.

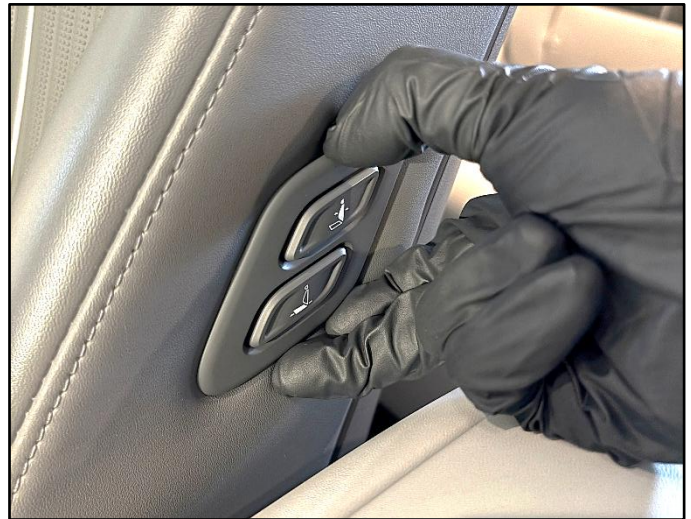
1. Install the walk-in switch assembly and firmly press until both locking tabs are engaged.
2. Pull on the walk-in switch assembly to confirm the switch is securely installed.

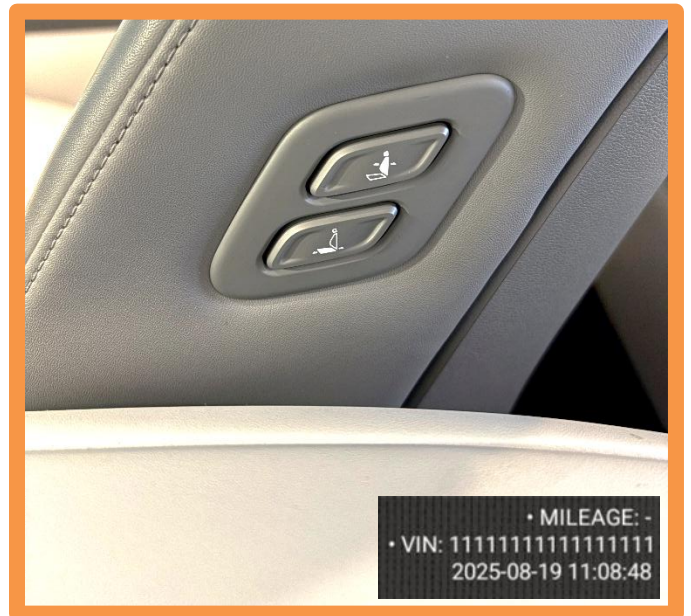
Using the STUI camera function, take a photo of the installed walk-in switch after pulling on it to confirm it is secure.

**NOTE:** If the STUI camera function is **NOT** used, write the last 6 digits of the VIN and date of repair on a piece of paper to include in the photo.
