Maserati

Low Pressure Fuel Pump Diagnosis

DATE: OCTOBER 23, 2025

Affected Models: All Models (All MY) equipped with ICE.

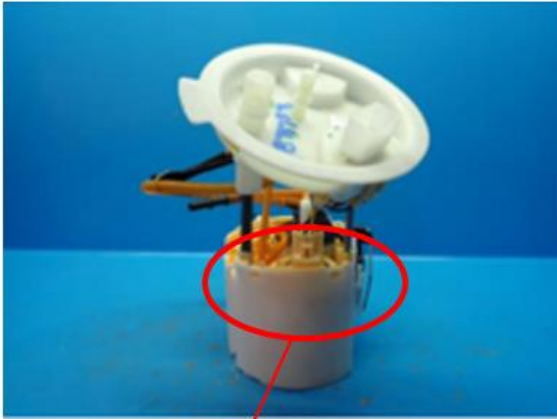
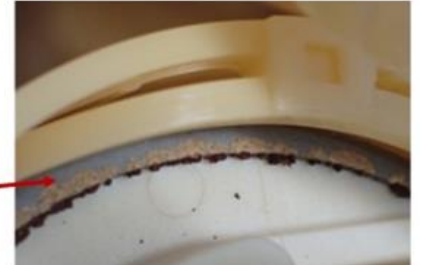
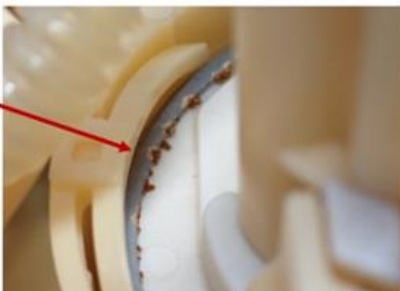
- Remove the fuel pump following the procedure in the Technical Documentation
- Inspect the pump for signs of corrosion (refer to below image)

- If corrosion is found:
 - Take clear photos of the affected pump
 - Open a **Blue On Line case for Technical Support** and attach the photos
 - Replace the fuel pump
 - **Note:** Fuel pump replacement due to corrosion is **not covered under warranty** (considered external influence)
- If no corrosion is found:
 - Open a **Blue On Line case for Technical Support**
 - Attach inspection photos so that TSO may assist with root cause analysis
