# Service Bulletin

Bulletin No.: PIC6625

**Subject: Interior View Camera - Currently Not Turned On**

Brand:	Model:	Model Year:		VIN:		Engine:	Transmission:
		from	to	from	to		
Cadillac	CELESTIQ	2025		All	All	All	All

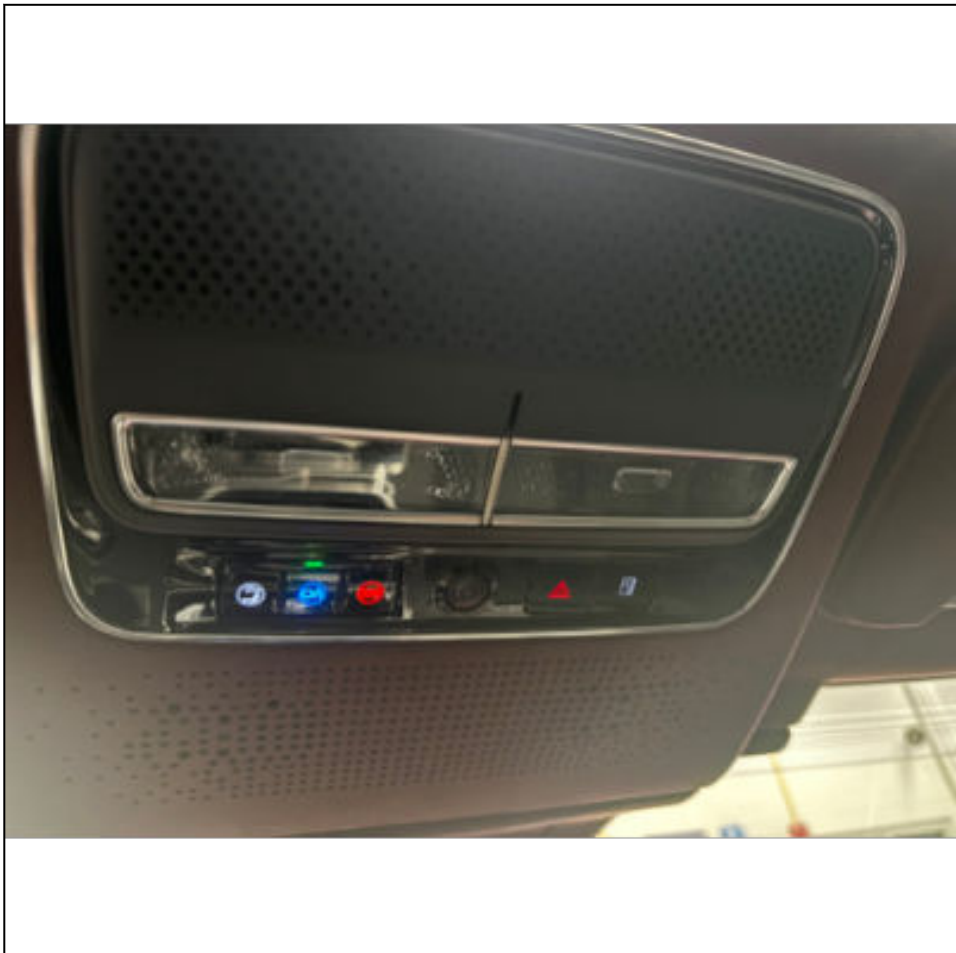
<b>Involved Region or Country</b>	North America
<b>Condition</b>	<p>Some clients may comment about the B350B Interior View Camera (located in the roof console) being inoperative.</p>

In the meantime, please advise the customer they may continue to drive the vehicle.

The current concern may be a potential customer dissatisfier, but it is not a Safety Issue and does not create a substantial loss of use or value.

The PI will be updated or replaced with a TSB should the feature be enabled for MY25 vehicles in the future, The bulletin will be issued to direct any required hardware updates, camera reconnection, and associated software updates.

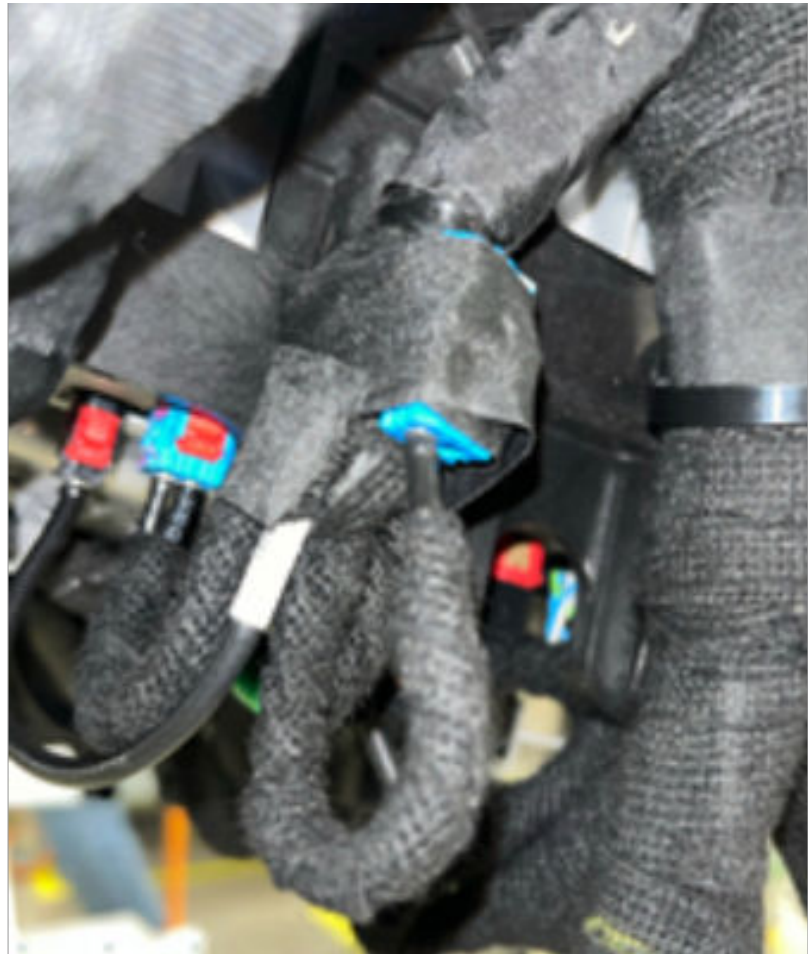
7011541

<p style="text-align: right;">7010707</p> <p>Some technicians may find the shielded coax cable going to the B350B Interior View Camera disconnected from the backside of the A11 Radio. Some technicians may further find the cable has been intentionally taped off.</p>

<b>Cause</b>	The Interior View Camera feature is not currently enabled and therefore intentionally disconnected for safety and security.
--------------	---
