Preview Solution CBR-2512-1

## Volvo Chassis - Air-Valve Cover Popping Off Seat - VN (4)

Published 7 October 2025

Volvo Chassis - VN (4)

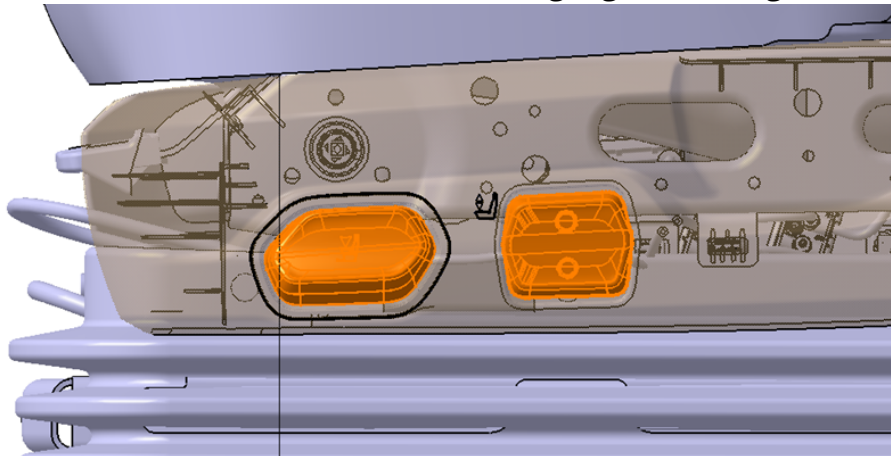
1. Drain the air tanks.
2. Remove the two air-valve covers. (Highlighted orange below)

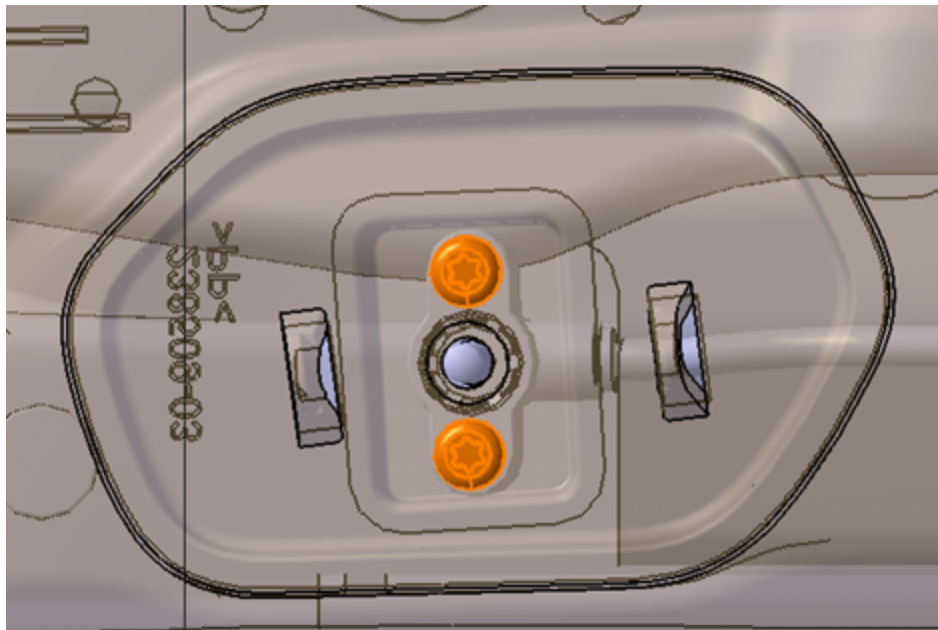
3. Remove the two screws that hold the forward dump valve to the side cover. (Highlighted orange below)

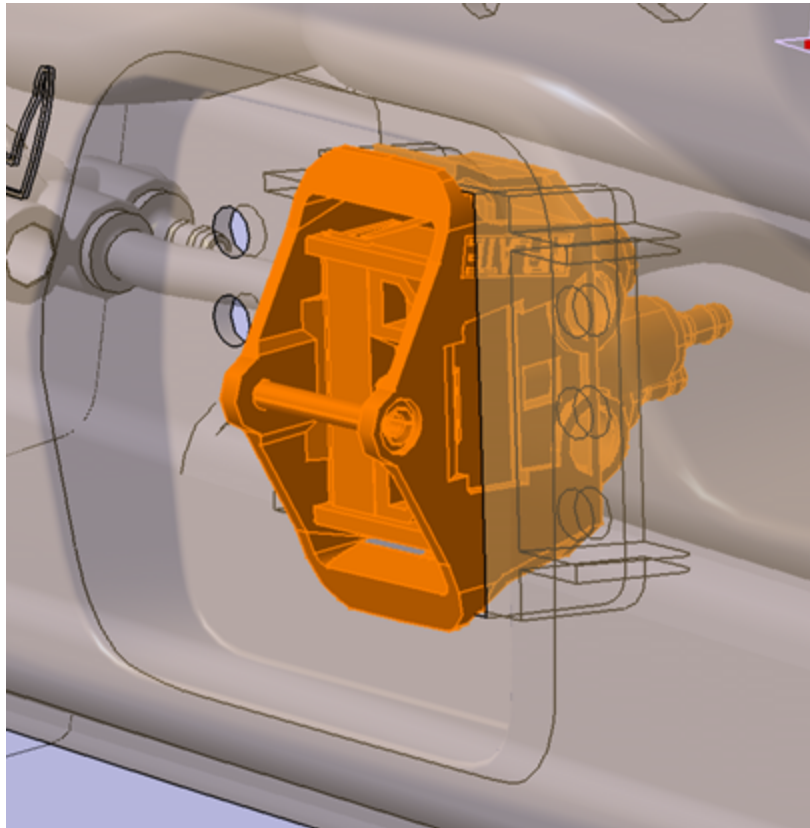
4. Snap the rear dump valve cover out of the seat side cover and detach the airline.

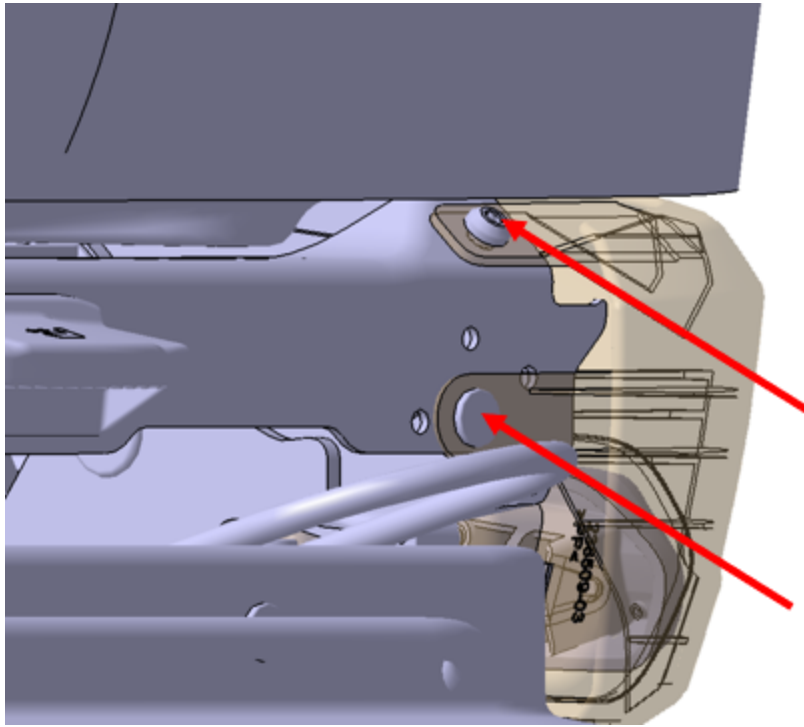
5. Retain all parts and hardware for reuse.  
6. Remove the push-pin and Torx screw that holds the front of the cover to the seat.

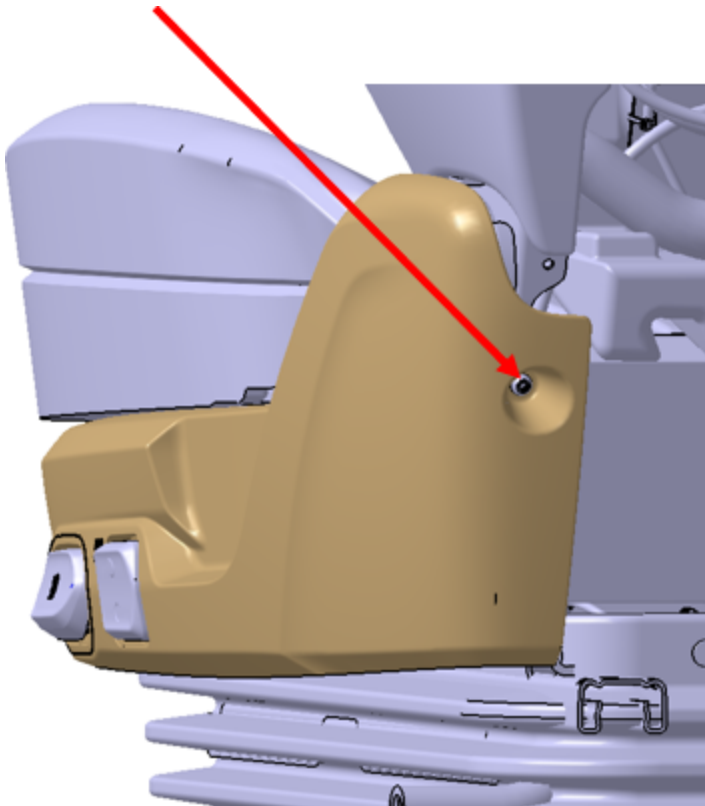
7. Remove the Torx screws that are at the rear of the cover.

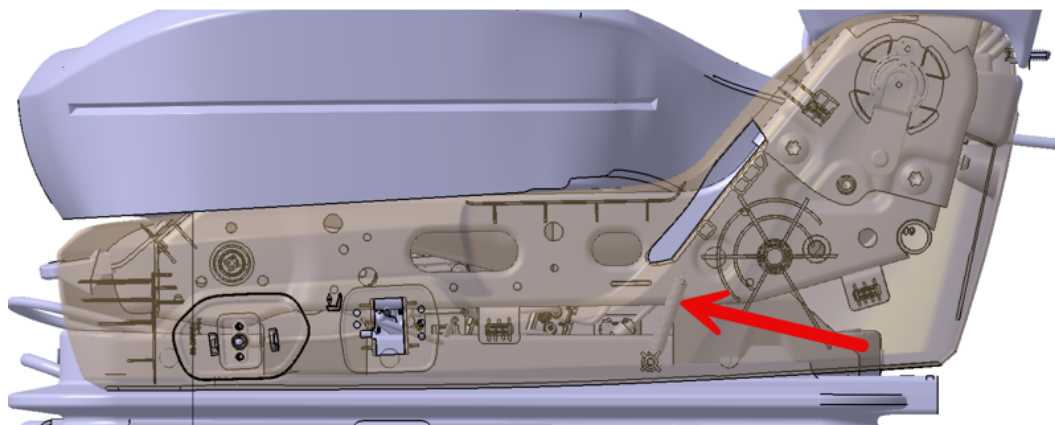
9. Unhook the spring from the cover.
