Technical Service Bulletin

GROUP	NUMBER
CAMPAIGN	25-01-078G
DATE	MODEL(S)
OCTOBER 2025	GV70 (JK1, JK1A)

SUBJECT: FRONT BRAKE SQUEAL NOISE PAD REPLACEMENT
(LIMITED COVERAGE CAMPAIGN L01G)

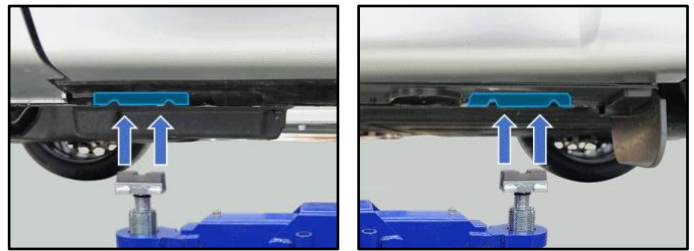
1. Visually check if the lift blocks are properly seated on the vehicle support points and raise the vehicle.

When raising a vehicle from anywhere other than the support points may damage vehicle components.

Refer to the shop manual.

- **General Information > Lift and Support Points > General Information**

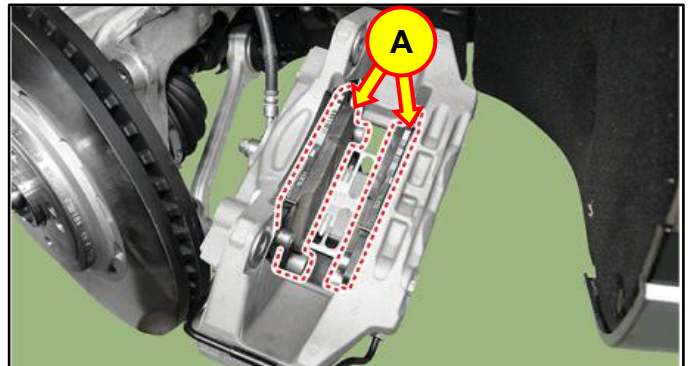
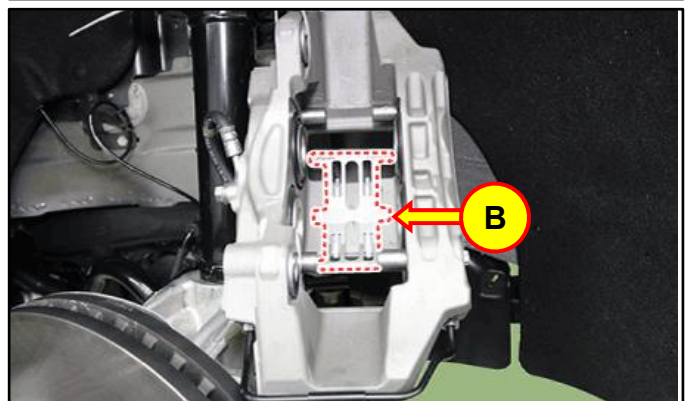
2. Remove both front brake pads (A) and radial spring (B) from both sides of the vehicle by referring to the shop manual:

- **Brake System > Brake System > Brake Pad > Removal**

3. Install the new radial spring and brake pads by referring to the shop manual:
 - **Brake System > Brake System > Brake Pad > Installation**

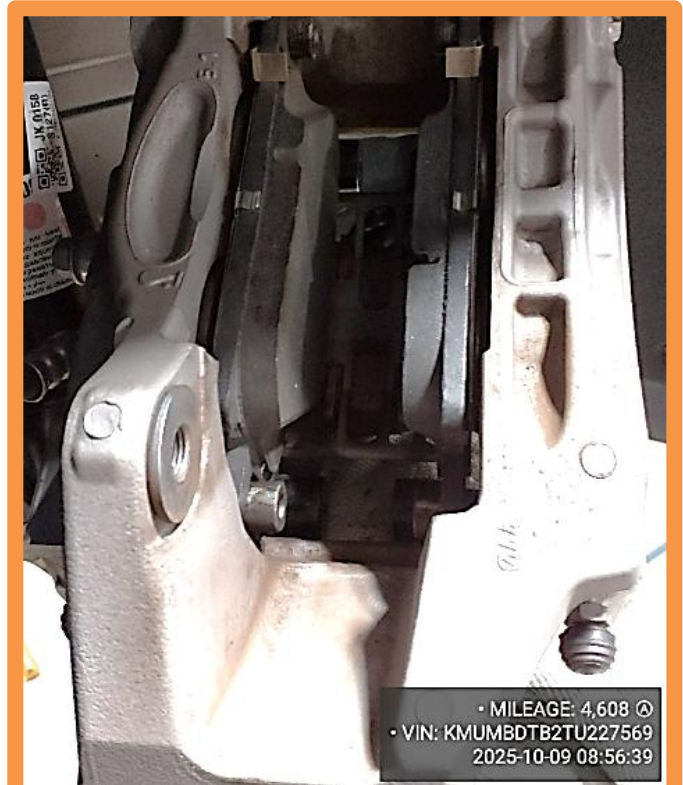
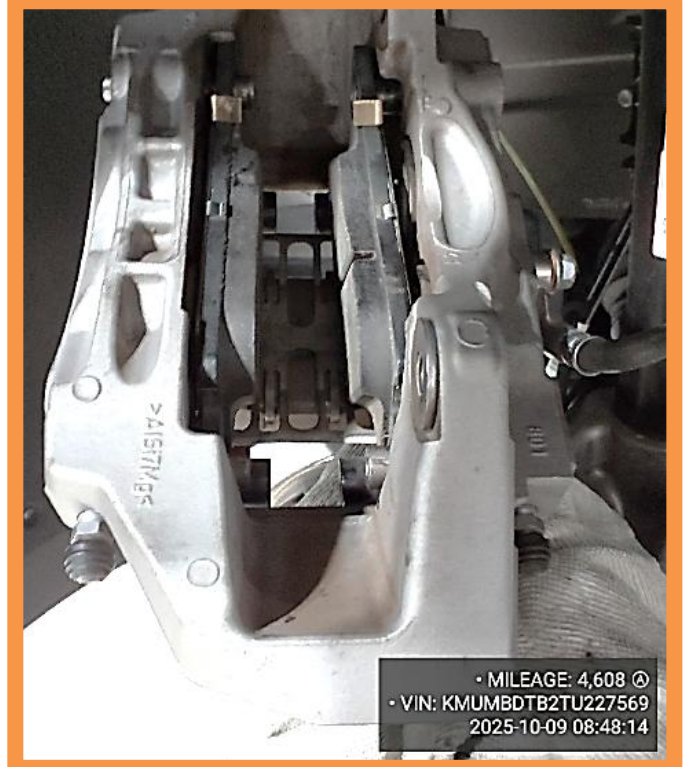
Using the STUI Camera function, take photos of the new brake pads installed on both sides of the vehicle.

Upload the photo to STUI.

NOTE: If the STUI camera function is **NOT** used, write the last 6 digits of the VIN and the date of repair on a piece of paper to include in the photo.
