| Doc No. | IATSB004327 | |
| Title | Handbrake Bezel Ring – Remove and Install | |
| Affected Vehicle(s) | Station Wagon<br>QuarterMaster | PF00001 - |

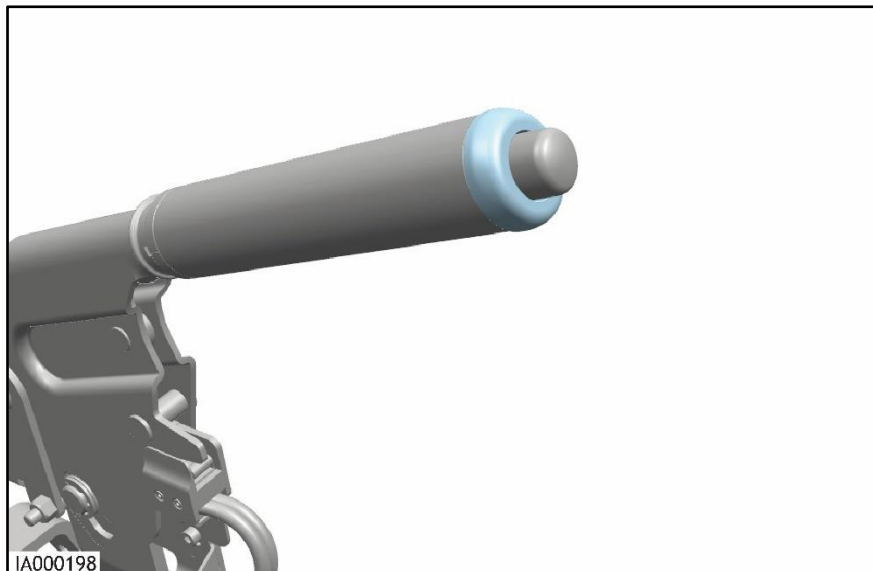
Take care not to damage surrounding components.

Using a suitable tool, remove the Handbrake Bezel Ring.

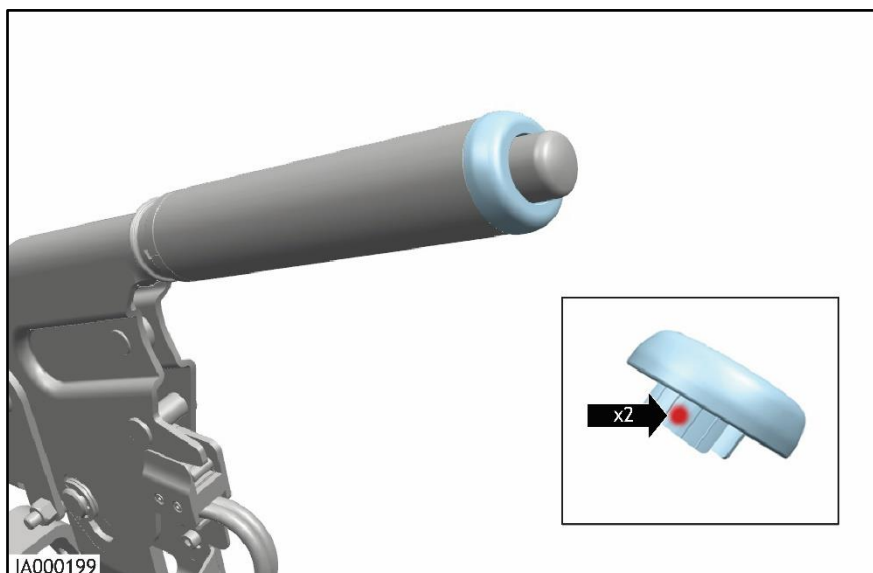
- Place suitable glue on the 2 tabs on the new Handbrake Bezel Ring.
- Install the new Handbrake Bezel Ring.

Parts: GRA-6B00-051660 – Handbrake Bezel Ring – Grey. Quantity: 1

GRA-6B00-051650 – Handbrake Bezel Ring – Green. Quantity: 1

Local Supply - Super Glue All Plastics 2 GM – Loctite. Quantity: 1
