# Technical Service Bulletin

<b>Topic</b>	Brake noise identification
<b>Market area</b>	Australia E04 Bentley rest Asia and Australia (6E04), China 723 Volkswagen (Anhui) Automotive CO (6723), China 796 VW Import Comp. Ltd (Vico), Beijing (6796), Germany E02 Bentley rest Europe (6E02), Japan E03 Bentley Japan (6E03), Korea, (South) E08 Bentley South Korea (6E08), United Arab Emirates E06 Bentley Middle East and Africa (6E06), United Kingdom E01 Bentley UK (6E01), United States E05 Bentley USA and rest America (6E05)
<b>Brand</b>	Bentley
<b>Transaction No.</b>	2052785/10
<b>Level</b>	EH
<b>Status</b>	Released for publishing
<b>Release date</b>	Sep 23, 2025

Noise/squeal complaint from the braking system

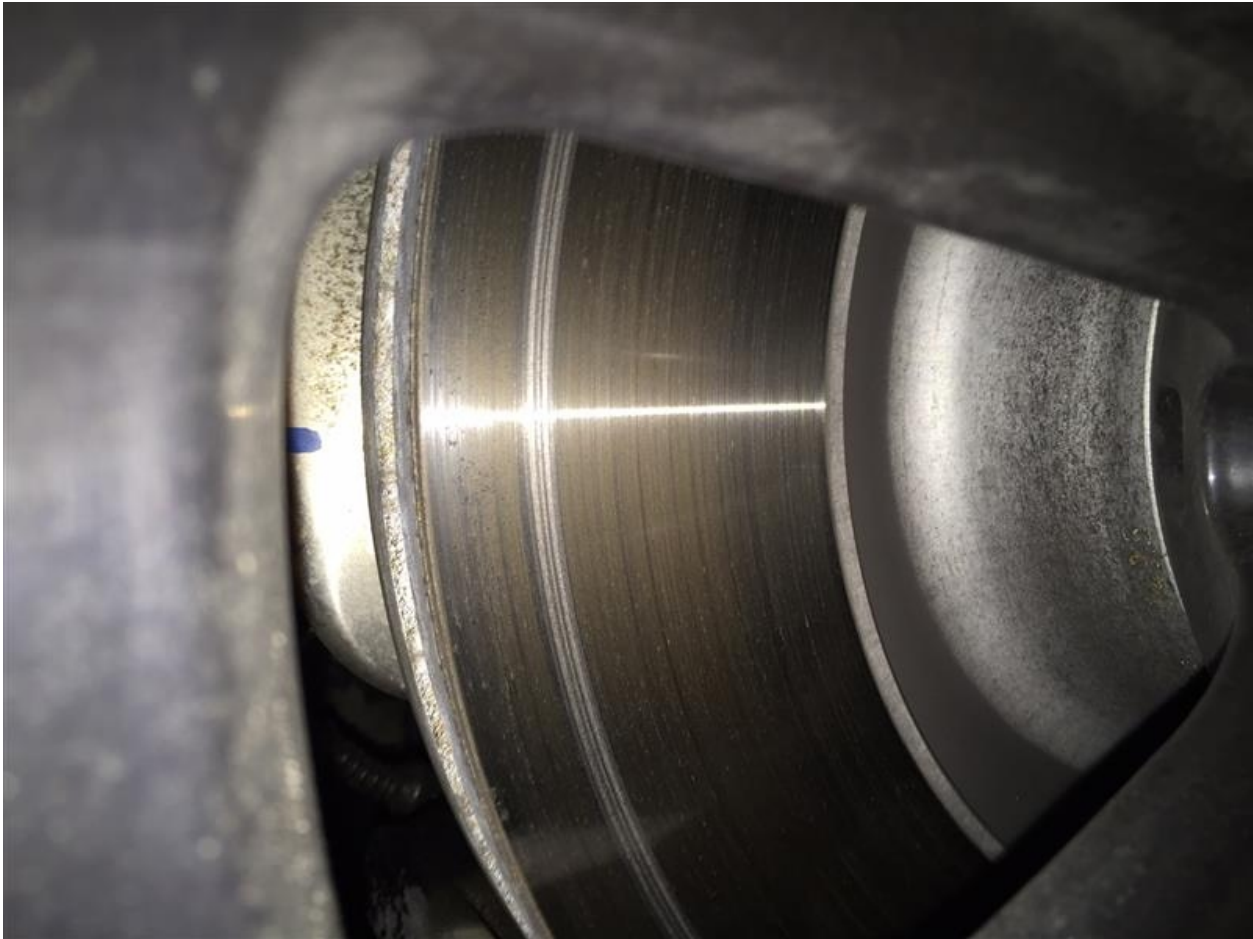
Figure 2

- Discs have a groove in them (Figure 2)

1) Check the overall condition of the brakes to determine if the brake noise can be attributed to one of the causes listed in the *Technical Background* section of this TPI. If the noise is not a result of one these causes, proceed with point 2

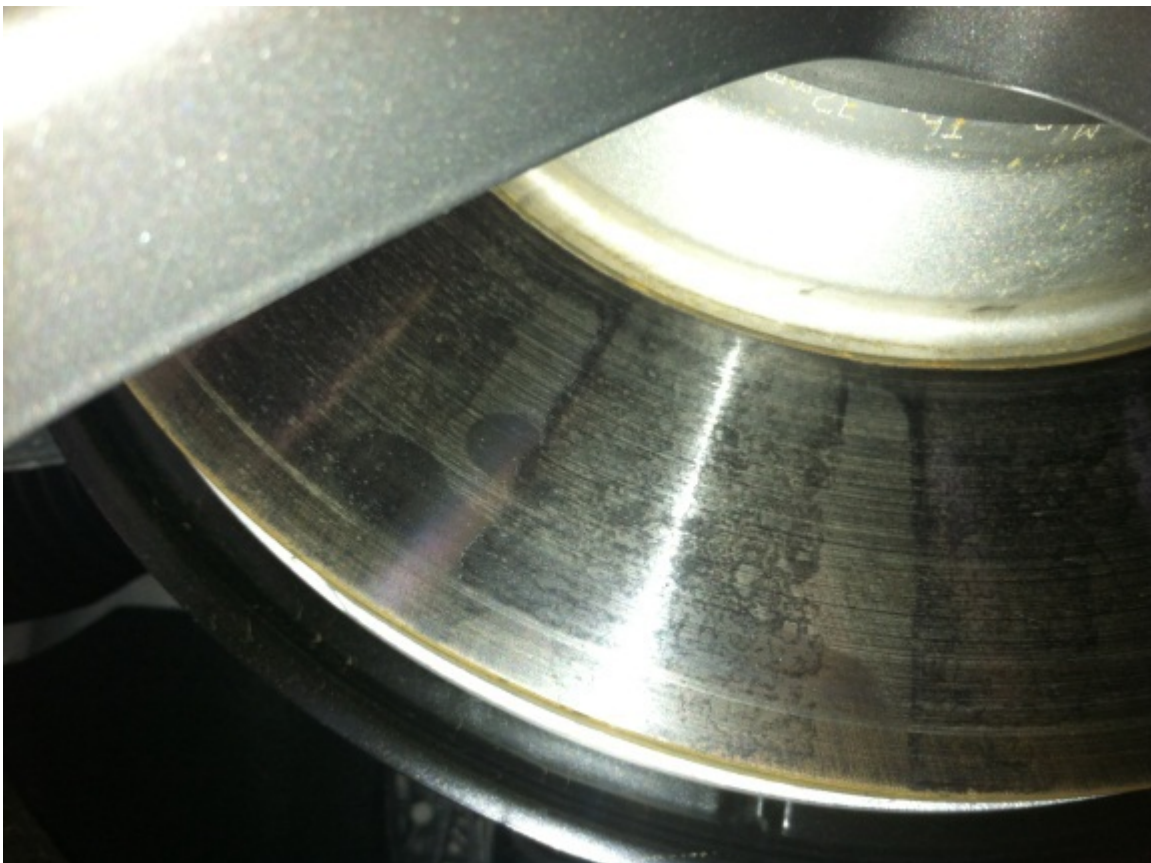
Figure 3

- There is chemical contamination on the braking surface of the disc due to a wheel or tyre cleaner being sprayed directly onto the disc (Figure 3)

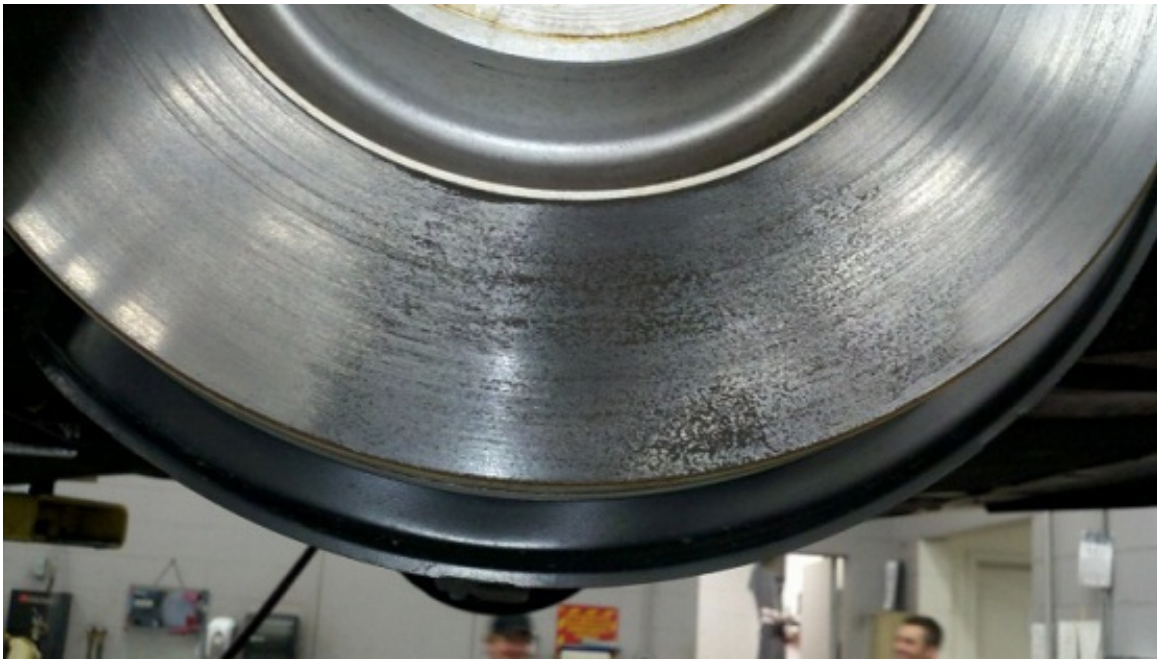
Figure 4

- There are 'pad marks' on the brake disc as a result of the brake pad material transferring to the discs. This can occur when a vehicle has been stood for long periods of time in a wet or snowy environment (Figure 4)

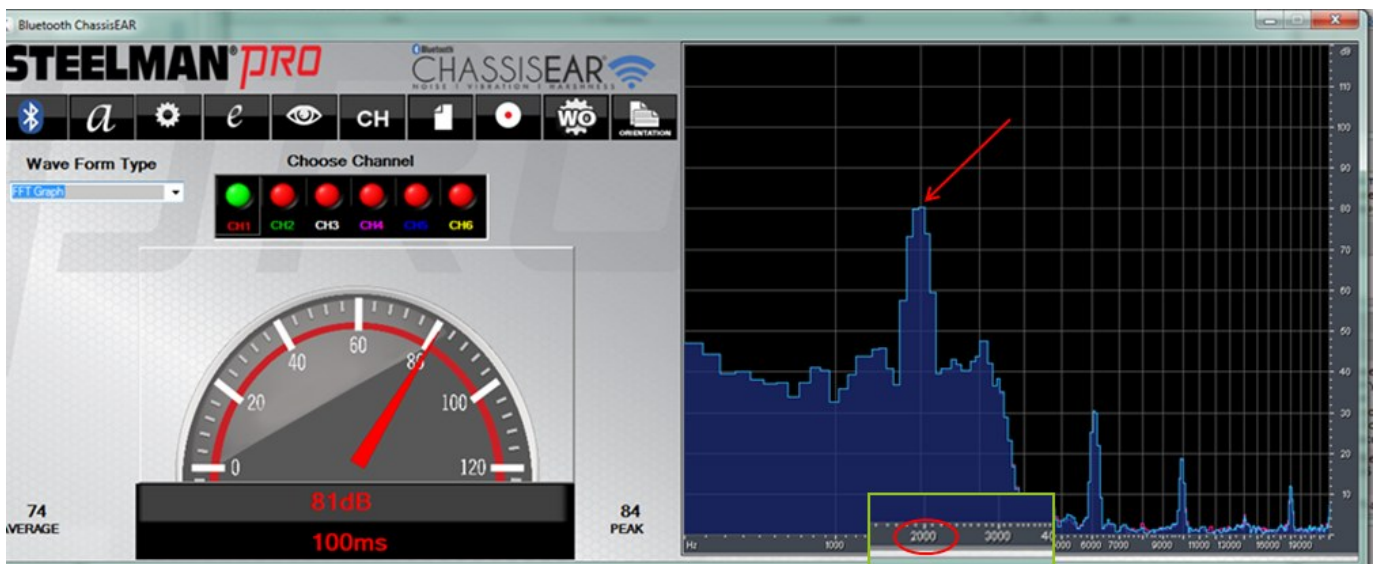
Refer to 'File recording' in the WT 10437 user instructions

Select 'FFT Graph' as **Wave Form Type** and read the peak achieved during the recording as highlighted in the example above (in this case brake squeal peak frequency is 2000Hz)

Using the microphone provided in the kit, record the noise from outside of the vehicle
