**Model:** RS 457

**Subject:** Replacement of timing chain tensioner - Technical update

**Campaign Code:** 2025\_RS457\_TENSIONER

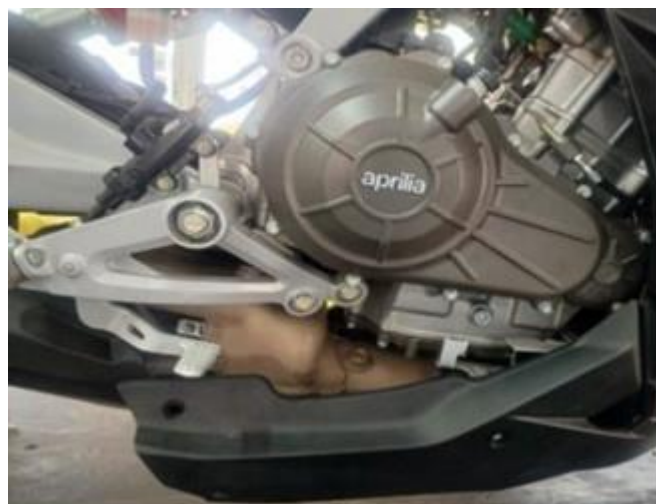
Loosen the lower heat shield.

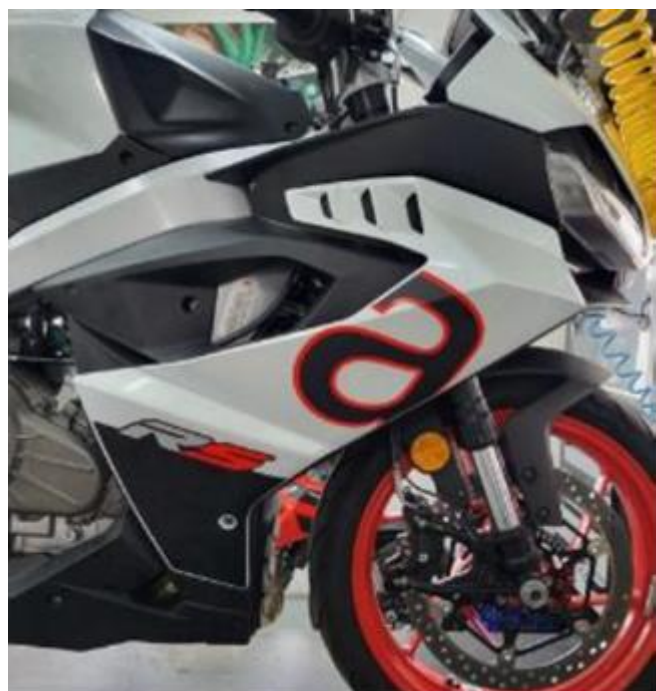
Remove the right side engine fairing.

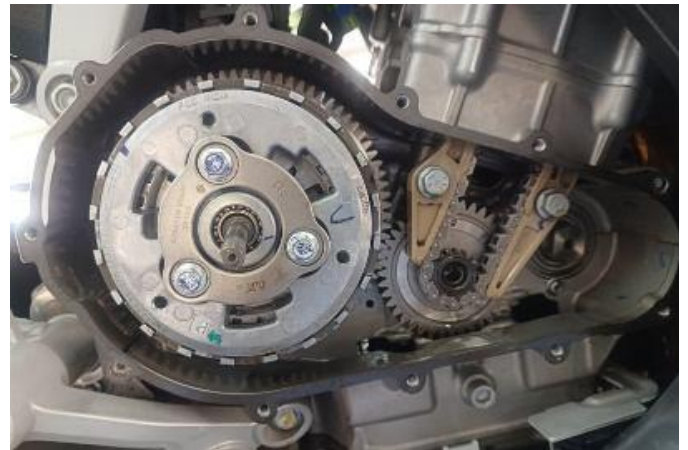
Disconnect the clutch cable and remove the clutch cover.

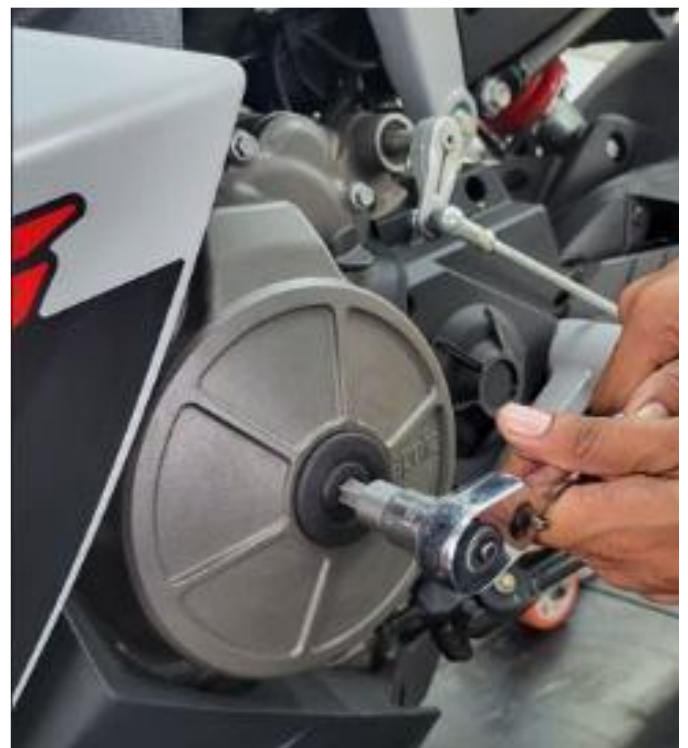
Remove the small cover on the flywheel cover.

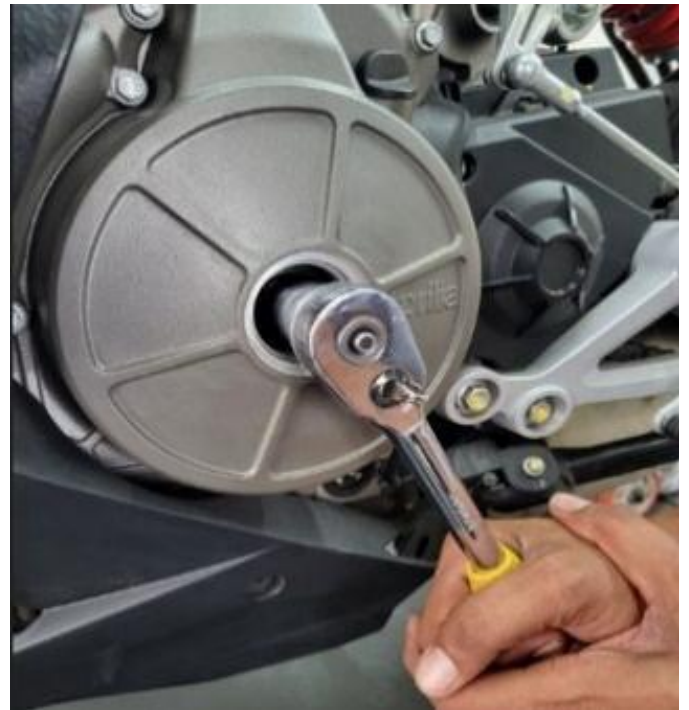
Rotate the crankshaft to find the Upper Dead Centre.

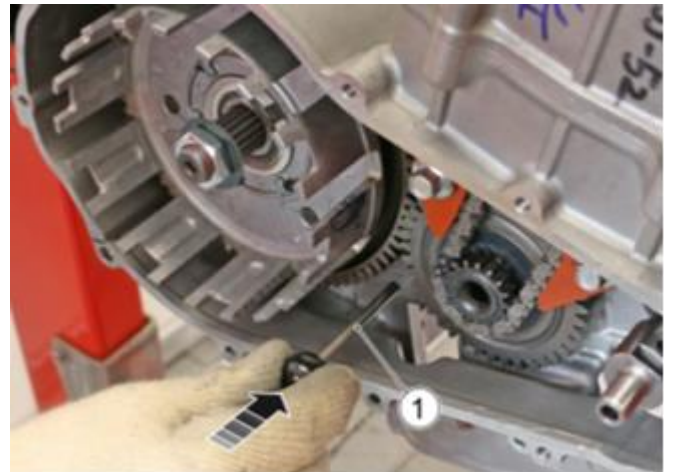
Insert the timing pin 020851Y (1) intercepting the hole in the crankshaft.

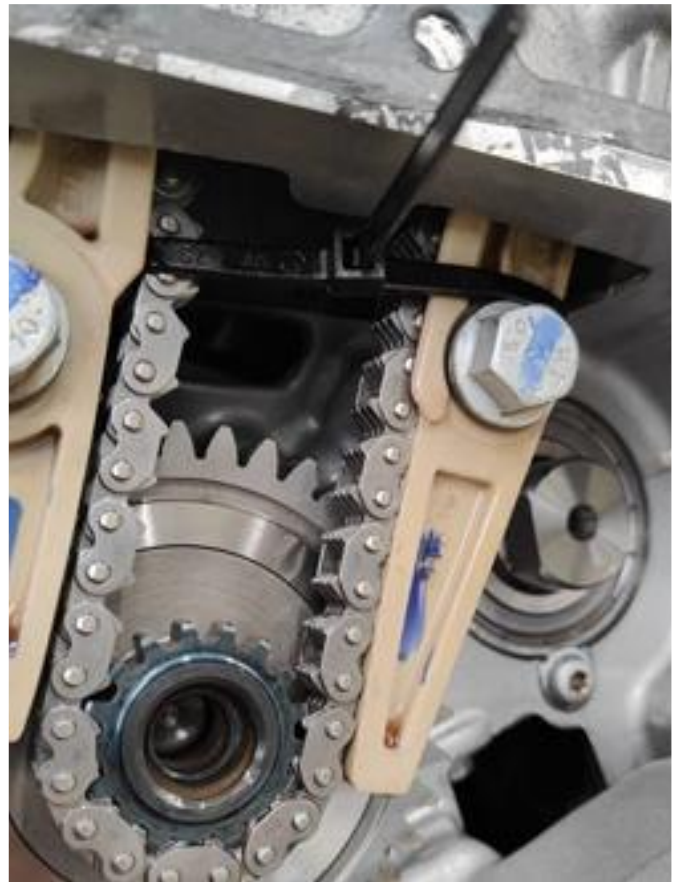
Check that the chain is free and place a clamp on the chain as shown in the figure to secure it.

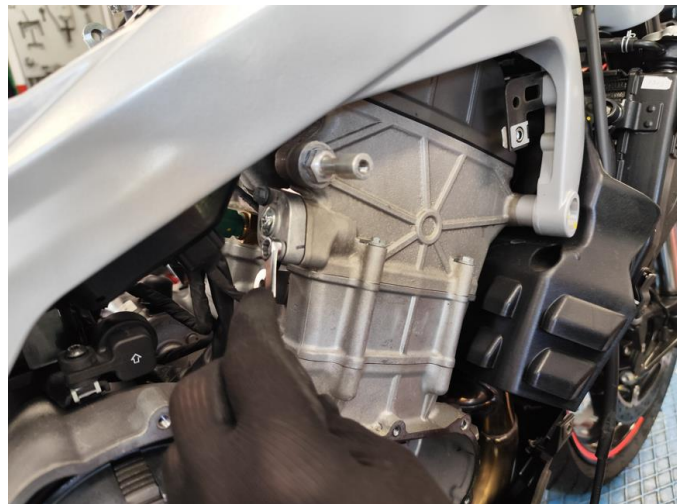
Remove the old chain tensioner.

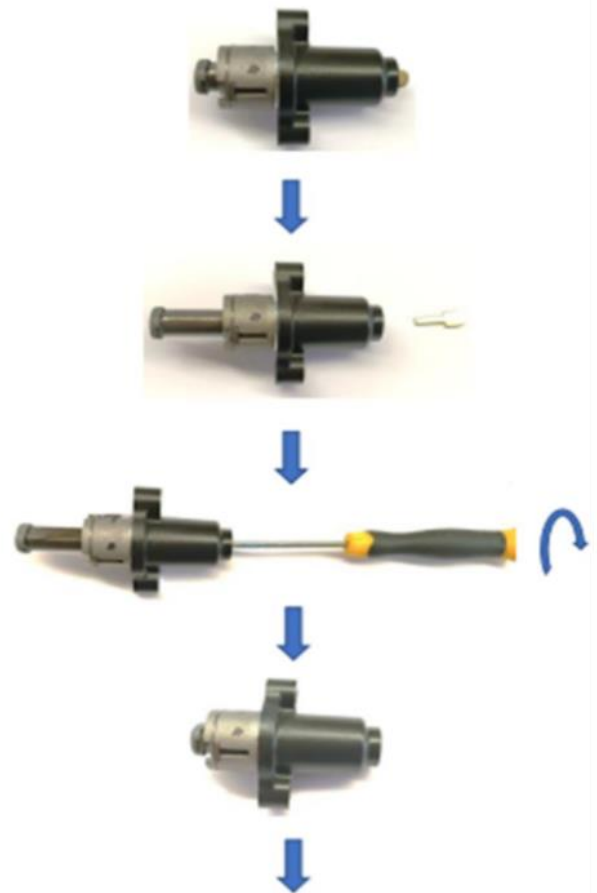
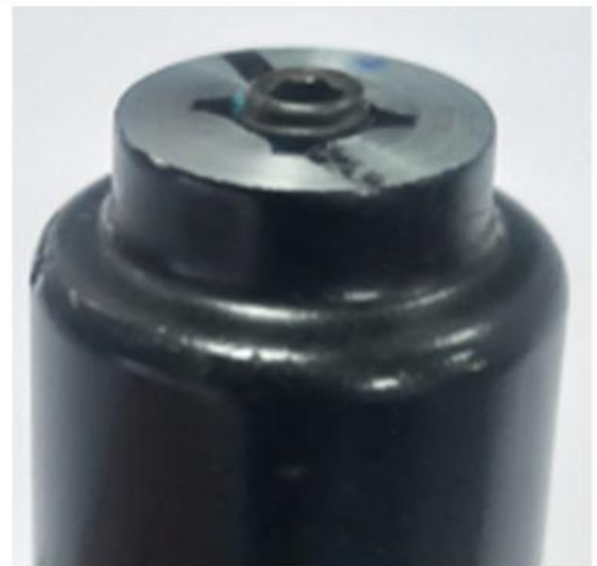
Prepare the new chain tensioner code 1A029415, removing the pin that holds it in place.

Then re-arm the chain tensioner with a flat screwdriver, tightening clockwise, until it is locked without the use of the pin.

Using a 3 mm Allen key, screw the grub screw onto the head of the chain tensioner.

Keep the distance of the grub screw approximately 0 - 0.5 mm from the surface of the chain tensioner body (see figure).

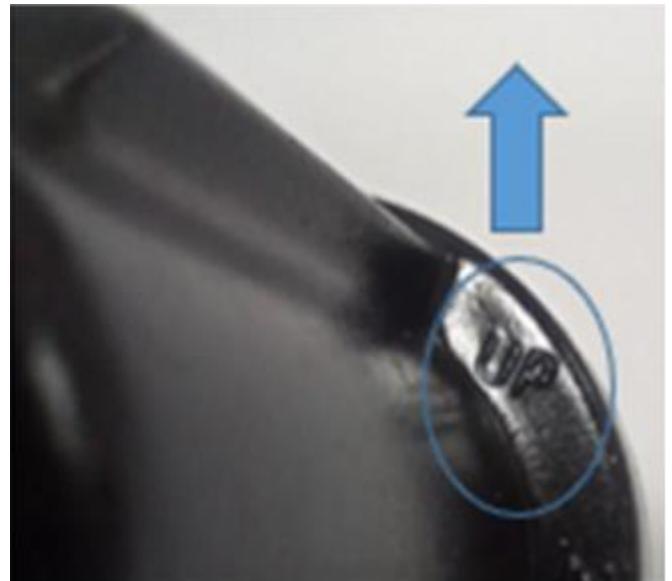
Insert the new chain tensioner, use a new gasket code 1A024276.

Maintain the direction of the chain tensioner as indicated on the chain tensioner. The ribbing must face upwards.

Hand-tighten both fixing screws and ensure that there is no gap between the chain tensioner and the mounting surface.

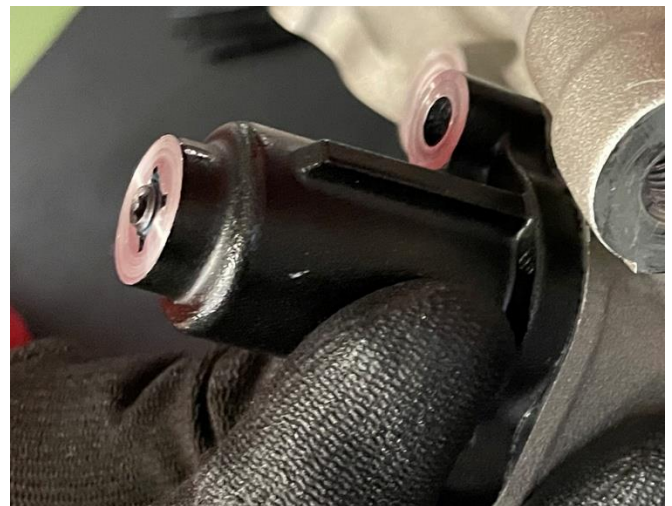
Take care during insertion so that the chain tensioner does not disengage.

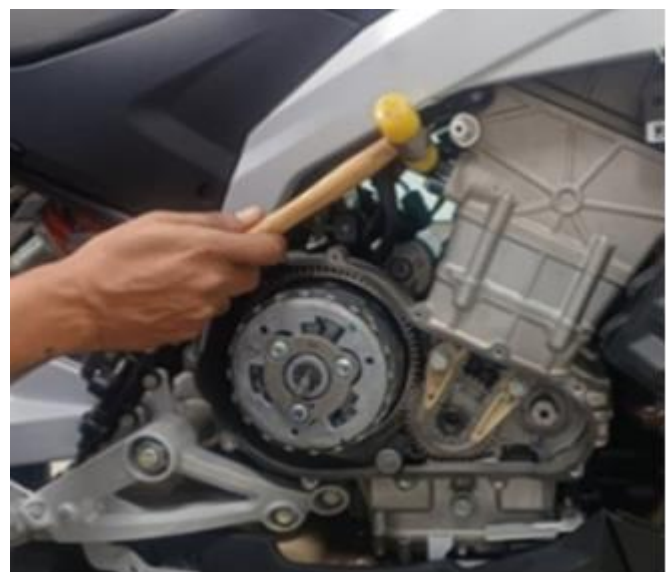
With a rubber mallet, tap the side of the chain tensioner to cause it to disengage (you will hear a click, confirming this).

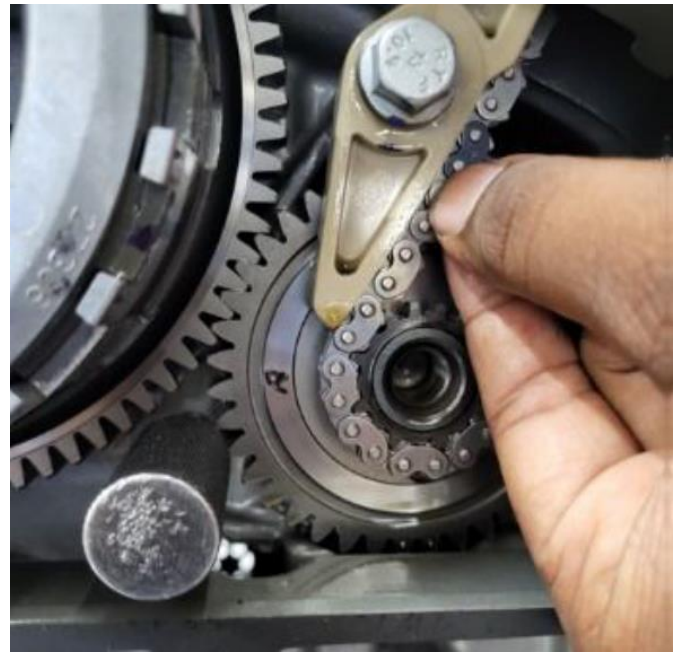
Having **removed the clamp**, ensure that the chain is tensioned after the new chain tensioner is released.

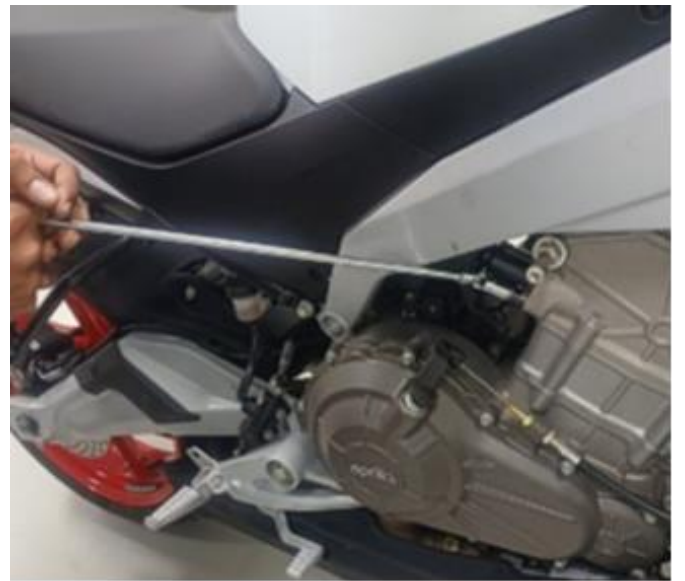
Tighten the 2 screws of the new chain tensioner to a torque of 10 Nm  $\pm$ 10%.
