October 28, 2025

Rear Trim Panel Will Not Secure Properly

Year	Model	Trim Level	VIN Range
2023-25	CR-V Hybrid	ALL	ALL

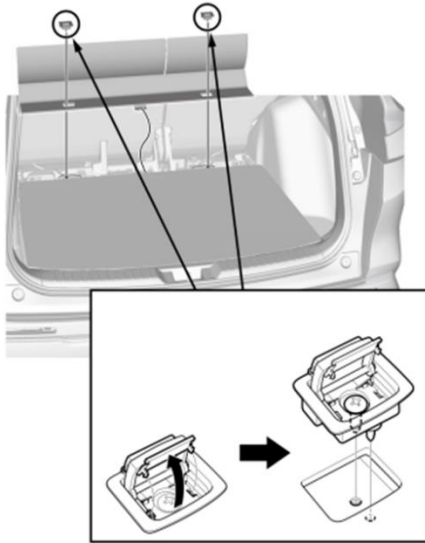
1. Remove the front cargo floor flap assembly.

NOTE: *Interior Trim Area* ([CLICK HERE](#)).

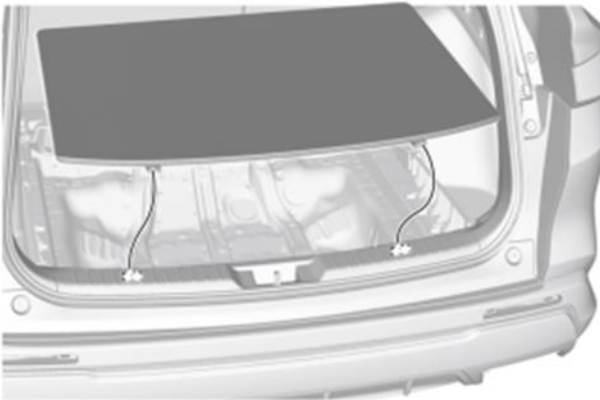
2. Remove the rear cargo floor lid.

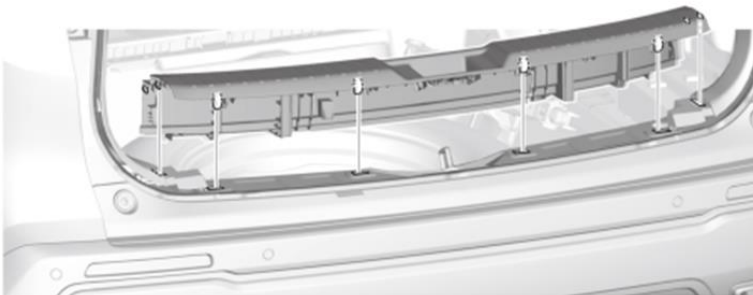
3. Remove the rear trim panel.

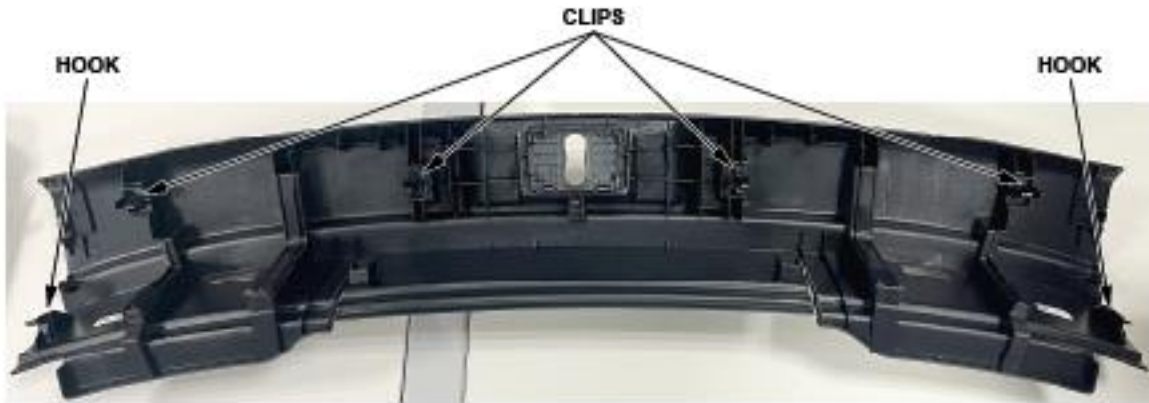
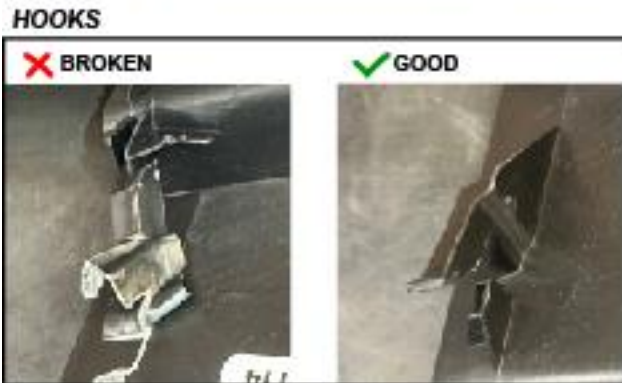
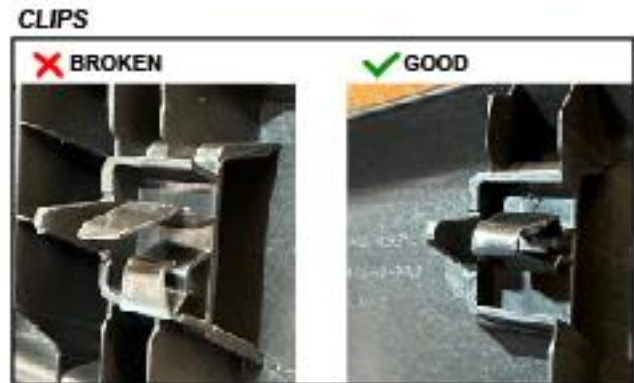
4. Inspect the mounting clips, and hooks for damage/broken at the 6 locations.

- If any of the mounting clips, or hooks are damaged the rear trim panel must be replaced.
- If there is no damage found on any of the mounting clips or hooks the trim panel can be reused.

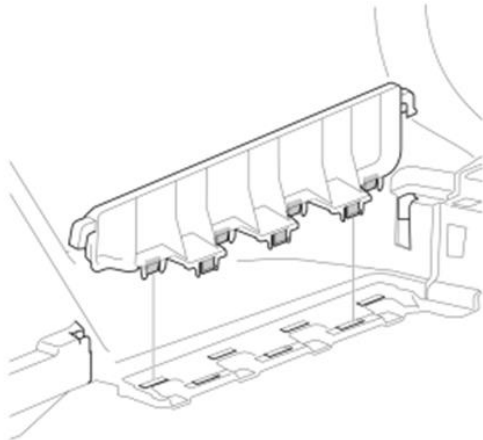
5. Remove both the left and right-side partitions.

NOTE: Right side image shown. Left side is similar.

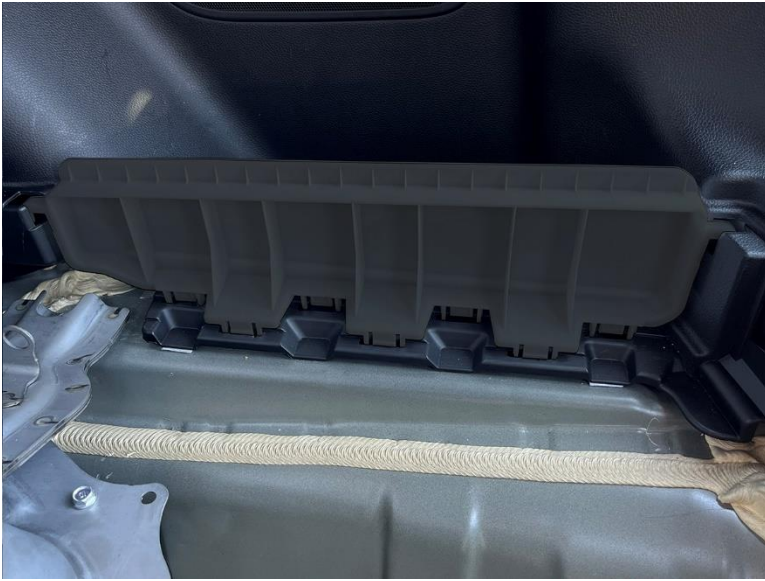
6. Install new left and right partitions.
