## Check engine light with fault code P3005CA in MRD1 (CDI)

| Topic number | LI49.20-N-078466 |
| Function group | 49.20 - Exhaust gas aftertreatment |
| Validity | Sprinter 907 OM654 |

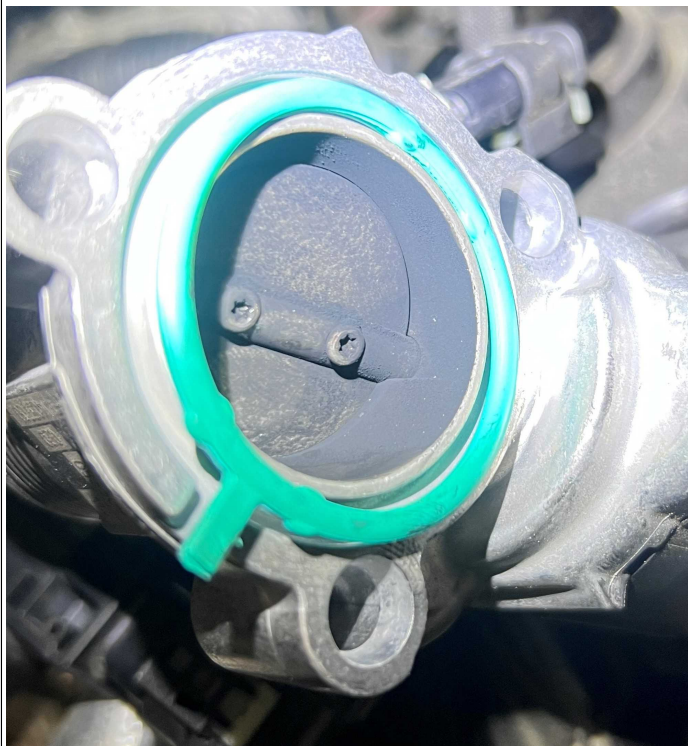
LP EGR.jpg

Low-Pressure EGR Valve

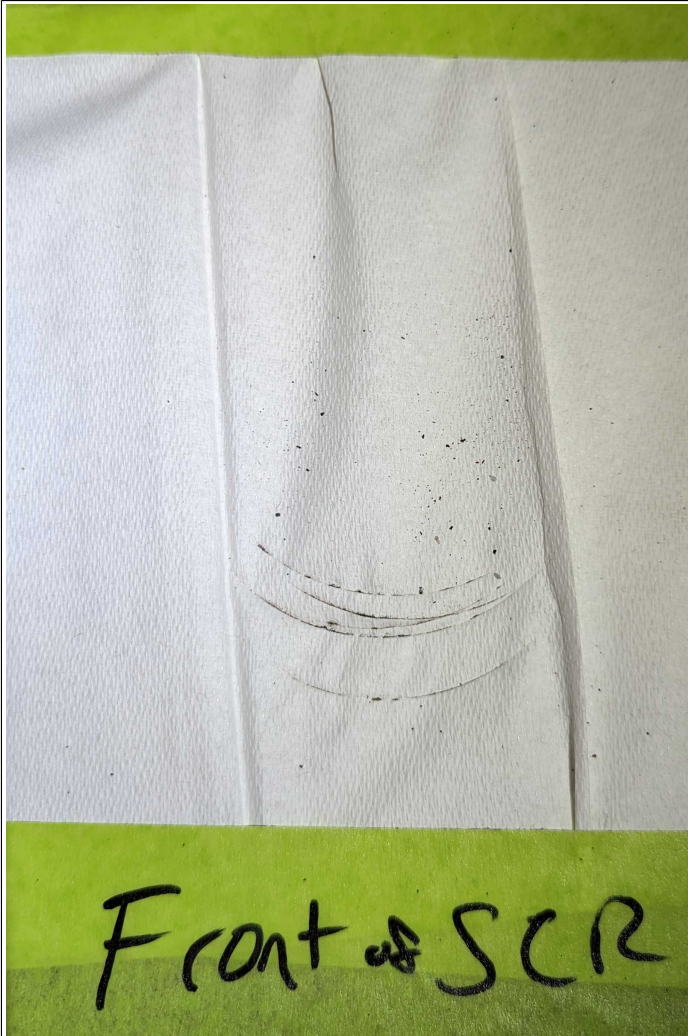
[SCR Front.jpg](#)

White Cloth SCR Front Side

- If soot was found during step 1 or if this vehicle had the Diesel Particulate Filter (DPF) replaced prior due to failure and the fault returned, please complete the below steps:
- Remove the 'SCR Catalytic Converter, underbody', place a white cloth/rag on the floor, and lightly tap the 'SCR Catalytic Converter, underbody' onto the floor to see if any soot comes out. Repeat this inspection on both ends of the SCR catalytic converter. If soot is found on the rag, please replace the 'N74 (Soot Particulate Sensor Control Unit)' and 'SCR Catalytic Converter, underbody' with the needed components.

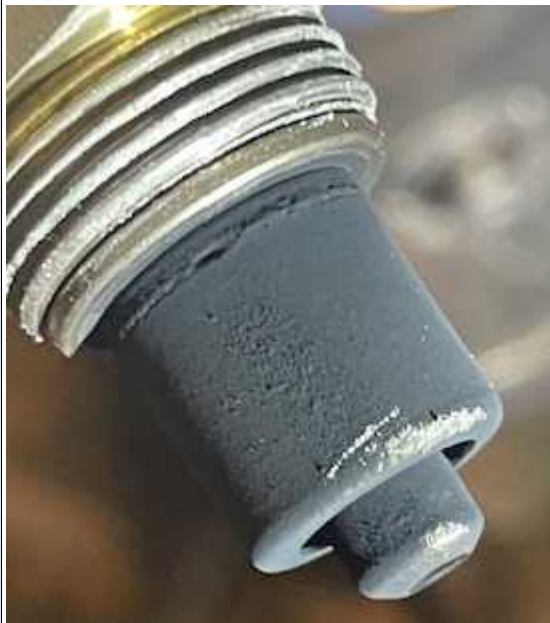
[Soot Sensor.jpg](#)

Soot Sensor Covered in Soot

2. The N74 (Soot Particulate Sensor Control Unit) identifies soot or debris located downstream of the 'SCR Catalytic Converter, underbody'.
