**TECHNICAL SERVICE BULLETIN, VIN:  
SB-78 GT1 Battery Heat and Spyder Memory Power**

## Technical Service Bulletin SB-78 Repair Instructions

**Purpose:** Installation of Spyder State of Charge/Temp Sensor Harness on 2025 GT1 motorhomes. This will allow the Spyder control panel to display correct battery voltage and clear "charge batteries" message when batteries are at 100%.

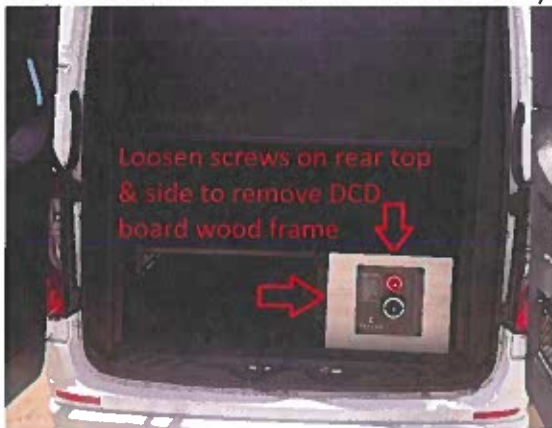
Figure 1

1. Open the rear doors of the van and turn off the main red and black power switches, shown in figure 1.
2. Remove DCD board wood frame to access rear of the board, shown in figure 1. (This will allow access to the rear of the board and the house batteries.)

5. Install the DCD board wood frame back to its original location, as shown in figure 1.
6. Check battery voltage with multimeter and confirm battery voltage on the Spyder control panel is the same. If batteries are fully charged, "! CHARGE BATTERIES !" message on the Spyder control panel should no longer be displayed. **NOTE:** The batteries may have to cycle a few times before the true state resets. See figure 4.

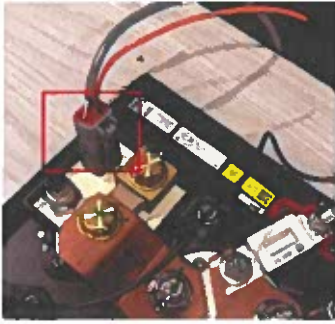
Figure 2

3. Plug the harness into the connector on the rear of the DCD board, shown in figure 2.

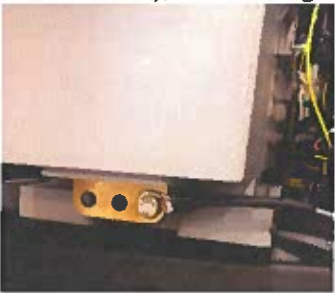
Figure 3

4. Use the 5/16" bolt and nut to connect the other side of the harness to the negative terminal on the first house battery, shown in figure 3. (The first battery will be the one farthest to the right)
