**Document ID:** IK1201507

**Title:** S13 Leaks at the Coolant Return Pipe Hose Clamps

**Applies To:** All S13 Engines

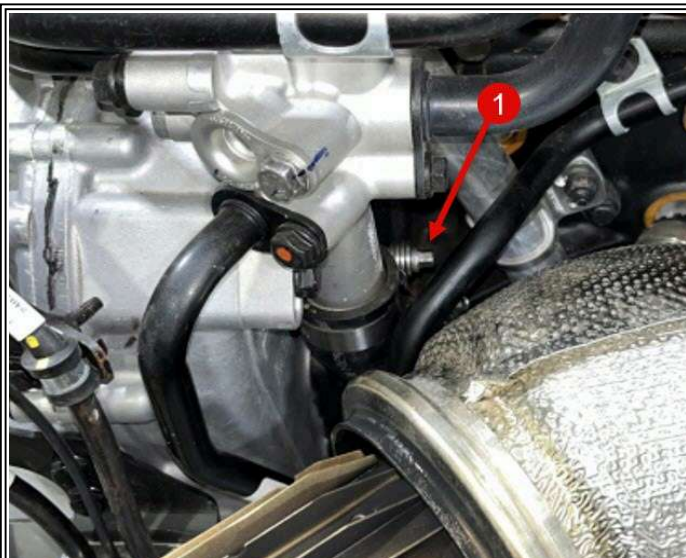
**Figure #3: Constant Torque Clamp**

6. Before installing the new hose, position two new 3523809C1 constant torque clamps (**Figure #3 & 4**) over the coolant return pipe with the hex inboard towards the cylinder block and facing forward.

Item 1: Clamp positioned inboard facing forward

- 7. Install a new 104696N1 rubber hose over the coolant return pipe and coolant distribution housing.
- 8. Position the two clamps over the hose and torque the clamps to 70-80 In. lb. ( 8.0 to 9.0 Nm)
- 9. Install and tighten the clamps for the steel return pipe to the cylinder block if previously removed.
- 10. If removed in step 2, reinstall the turbo downpipe using new gaskets (**Figure #2 Item 1 and 2**). Tighten clamps to 12 ft-lbs. (15 Nm).
- 11. Fill the cooling system per the service manual instructions linked [HERE](#).
