SS 3076-FTL2022 P4 Main Mirror Arm Covers Loose - Falling Off

All New Cascadia models.

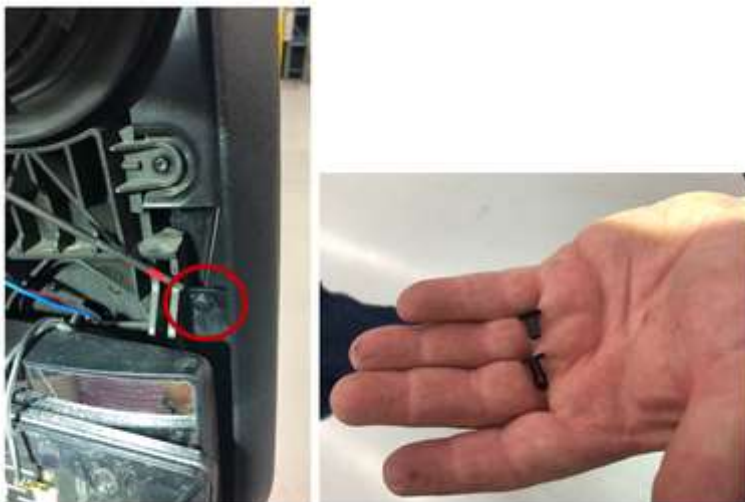
Lower arm covers designs have clips that hold the cover on but over time the clips can fail and allow the covers to become loose or fall off. Clip shown below falls off and cause the Lower Cover to fall off.

Figure 1: Arm Cover Clip installed-removed

This Service Solution has been removed as the information is now available in the 5th Gen Cascadia Workshop manual, Group 60: 4-12 and 4-13 Removal and Installation of the Mirror Bracket Cover.
