Technical Service Bulletin

Subject: WATER FOUND IN TRUNK AFTER HEAVY RAIN OR CAR WASH	Bulletin No.: 09-034/25
	Last Issued : 10/30/2025

2019-2026 Mazda3 4-Door (Japan built) vehicles with VINs lower than JM1 BP**** ** 852004 (Produced before Sept. 4, 2025)

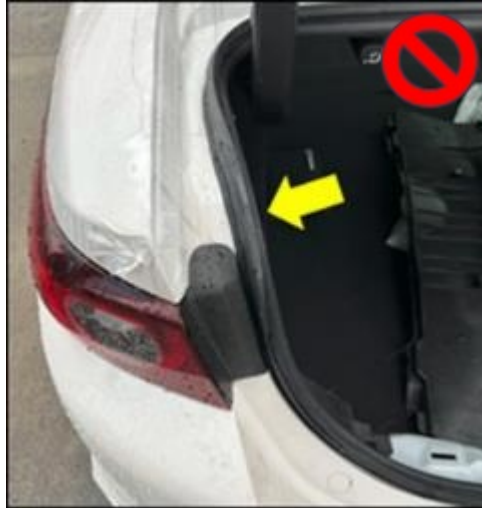
Some customers may notice water in the trunk after a car wash or heavy rain. This may be caused by insufficient sealing performance of the trunk lid weatherstrip. Due to improper installation of weatherstrips, the lip of the weatherstrip may lean toward the inside of the trunk, resulting in insufficient sealing performance. To eliminate this concern, the length of the trunk lid weatherstrip has been extended 14 mm {0.5 in.}.

2. Is the lip of the trunk lid weatherstrip tilted inward as shown in the image below?

Weatherstrip area tilted inward

3. Replace the trunk lid weatherstrip with a new one according to the following procedures.

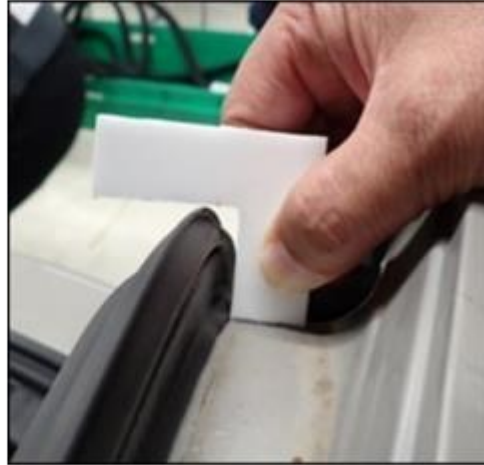
a. Create an L-shaped gauge (shown below) to measure the height of the weatherstrip using thick paper or similar material.

L-shaped gauge: 24mm {0.95 in.}

NOTE: Other L-shaped gauge dimensions are not specified; create as needed.

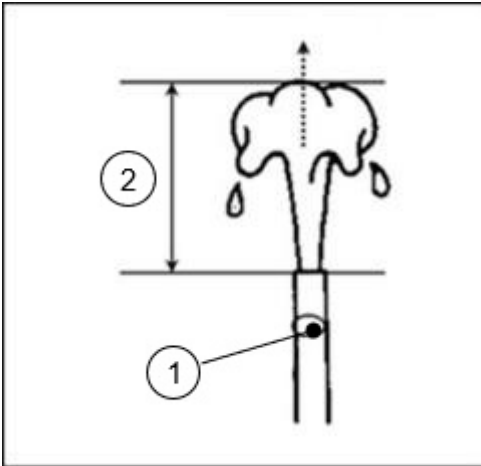
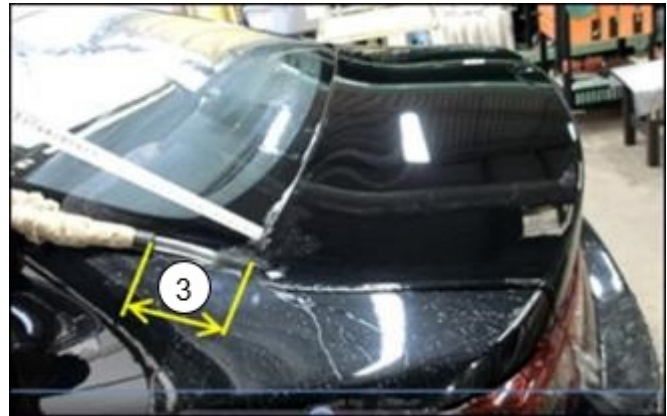
a. Spray water for 20-30 seconds on each side from a distance of 100 mm {4 in.} in front of both sides of the front edge of the trunk lid as shown below, ensuring that all the water enters the parting gap.

► Water spraying conditions

- Water Flow Rate: The table below or 25.5 liters / min.

1	Hose Inner Diameter	14 - 16 mm {0.55 - 0.63 in.}
2	Water Head when facing vertically upward	270 - 330 mm {10.6 - 13.0 in.} (height of 950 - 1050 mm {37.4 - 41.3 in.} above the ground)

- Water Spraying Distance (3): 90 - 110 mm {3.5 - 4.3 in. }

5. Check for water intrusion in the trunk according to the following procedures. If water intrusion is detected, remove the trunk lid weatherstrip and reinstall it properly.
