## Surround View Camera Intermittent Operation

### Vehicles Affected

**Bulletin #: 2407.5**

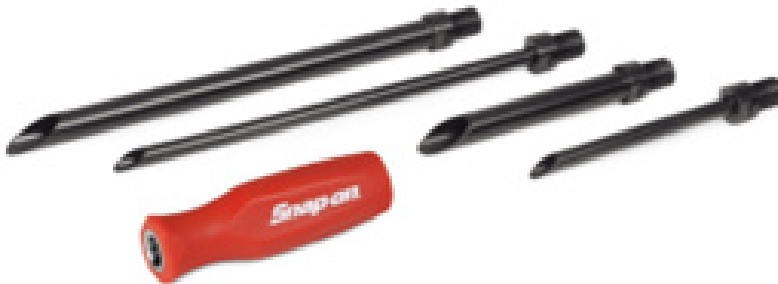
**Figure 3**  
**Snap-On - WINS1000R**

Recommended using **VAS 6720 & Wire Insertion Tool Set** (e.g. Snap-On - WINS1000R).

**IMPORTANT:** Ensure no material is removed from any grommet when piercing and do **NOT** drill any holes. Avoid damaging wires by pointing insertion tool **AWAY** from wires while penetrating.

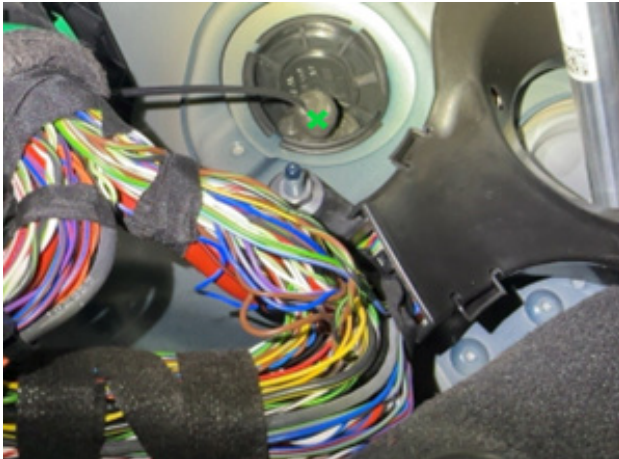
**Figure 4**  
**Cabin Side - Clutch Master Cylinder Grommet**

- Pictures above are of driver side camera overlay to zFAS control unit from A-pillar connector. Grommet of use is for the missing clutch master cylinder.
- If the vehicle is a manual, refer to the pictures below to be used for driver side camera overlay. Passenger footwell grommet is to also be used for rear and passenger camera overlays. When overlaying wires, ensure wires are secured to existing harnesses and area of piercing is properly sealed.
- Recommended points of piercing are designated by green X's.
