Technical Service Bulletin

Topic	Seat Fans Inoperative All Models 17-25MY
Market area	Bentley: worldwide (2WBE),China 796 VW Import Comp. Ltd (Vico), Beijing (6796)
Brand	Bentley
Transaction No.	2077529/3
Level	EH
Status	Released for publishing
Release date	Sep 24, 2025

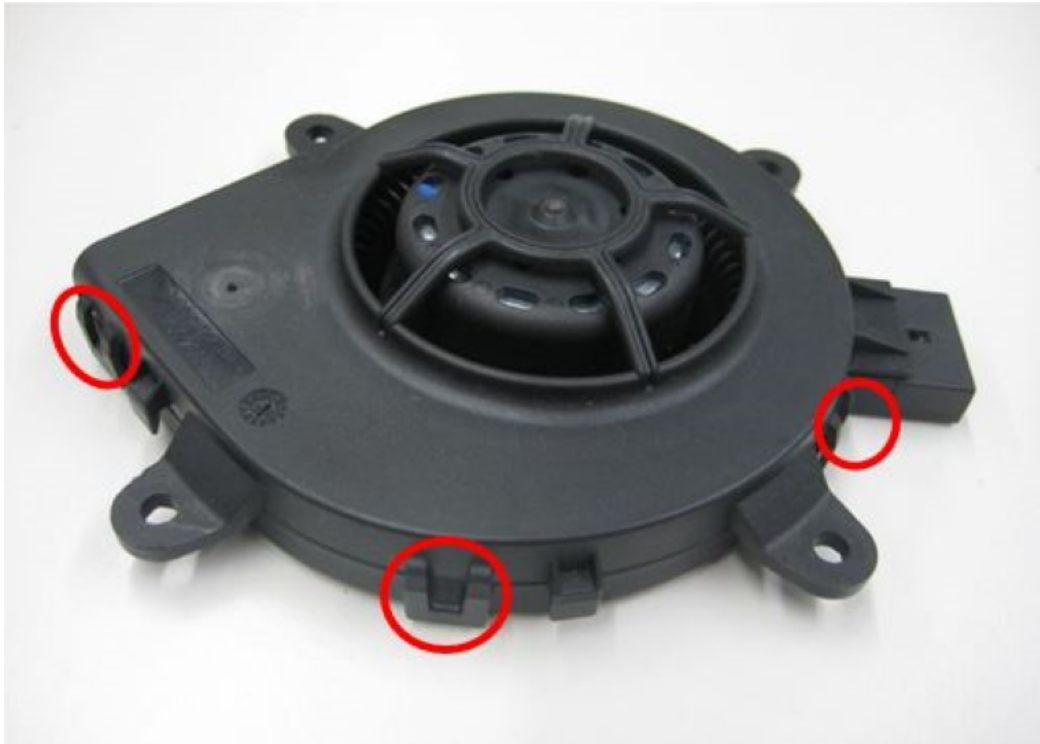
Figure 1

3. Disconnect the ventilation fan from the seat and check for any breakage of the clips on the casing.

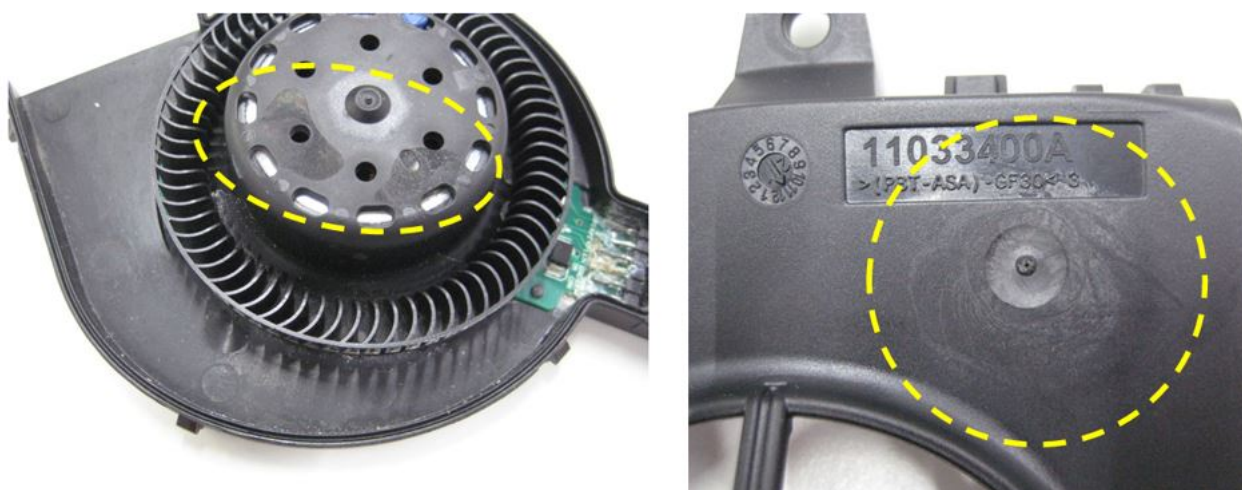
Figure 2

4. Remove the upper casing of the seat ventilation system for visual inspection of the internal components.

Plastic clips circled in red may become brittle over time. Use proper tools and techniques if disassembling the fan assembly to avoid breakage.

5. Check for any liquid ingress marks on the seat ventilation fan casing as seen on example circled in yellow in figure 2.

If there are any signs of liquid ingress, corrosion, or disconnection is observed. Document the findings with photos and attach them to a DISS ticket, as warranty claims for replaced parts may not be accepted.

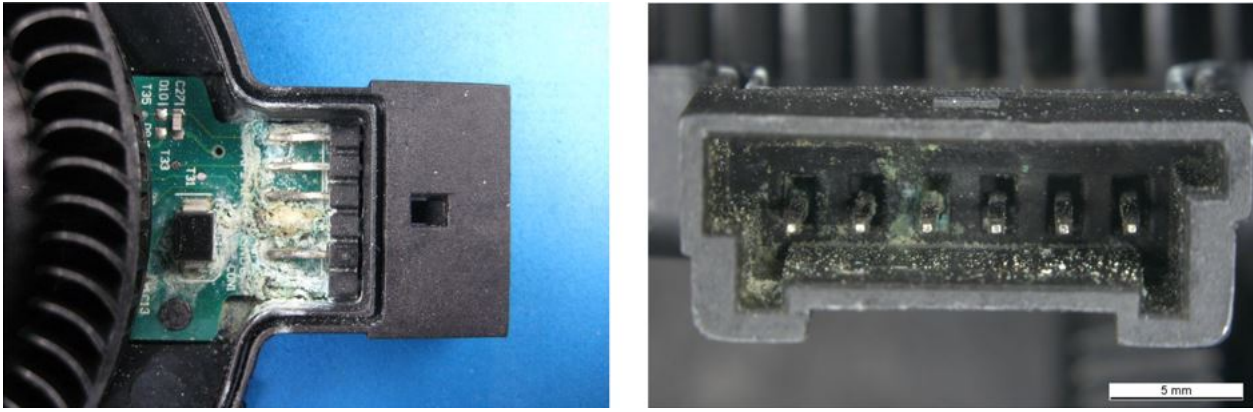
Figure 3

6. Inspect the electrical connector pins for signs of corrosion or discoloration as seen on example in figure 3.

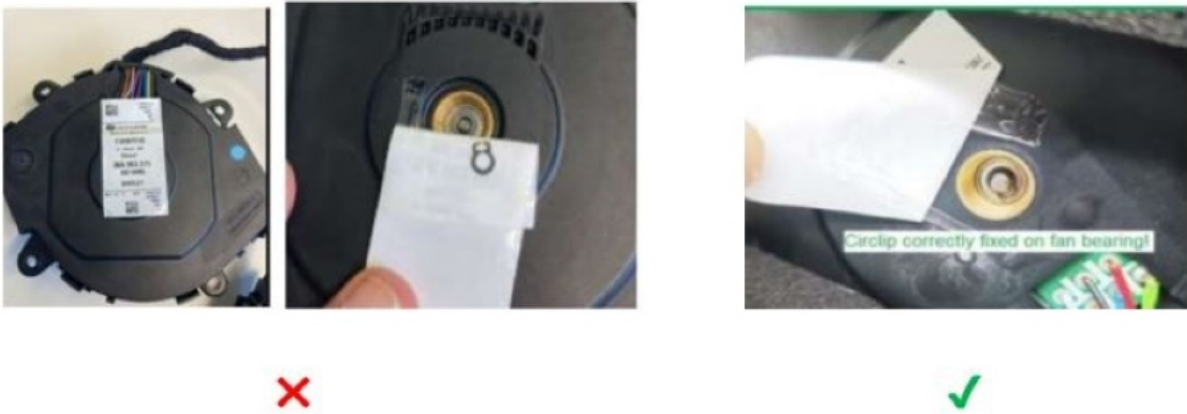
Figure 4

Inspect the underside of the seat ventilation for the defective and the new part being installed to ensure the holding clip (behind the label) is in place before it is installed into a vehicle, see figure 4 below.
