Rattling Noises From the B-Pillar Area: Observe Documentation Specifications (SY 85/25)

Model Line: **Macan (XAB)**

Model Year: **As of 2024**

Concerns: **B-pillar**

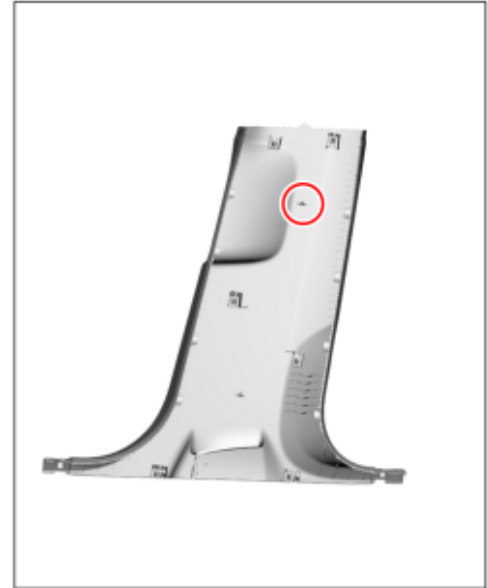
Enclosure: Material contact point of B-pillar trim panel (lower part) on the left

Material contact point on the left B-pillar trim panel (lower part). Material contact point between B-pillar and B-pillar trim panel covered with felt. For exact fault location, see enclosure.
