WSG4 - Replacing Luggage Compartment Cover (Workshop Campaign)

Model Line: **Macan (XAB)**

Model Year: **As of 2023 up to 2026**

Concerns: **Luggage compartment cover**

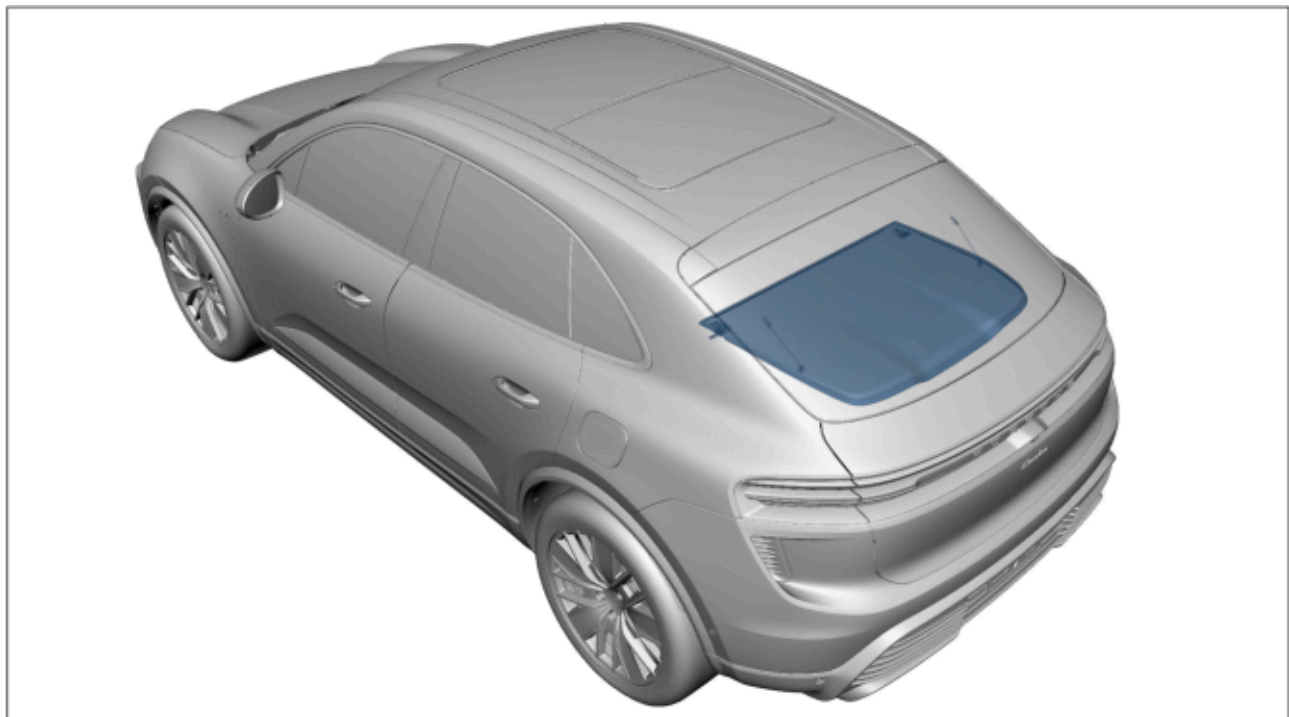
Installation position

Installation Position:
