**Complaint - Oil Leakages on Double Clutch Transmission (Porsche Doppelkupplung (PDK)): Observe Specified Procedure (88/20)**

Model Line: **911 (992)**

Concerns: **Double clutch transmission (PDK)**

Cause: Oil leakages on double clutch transmission.

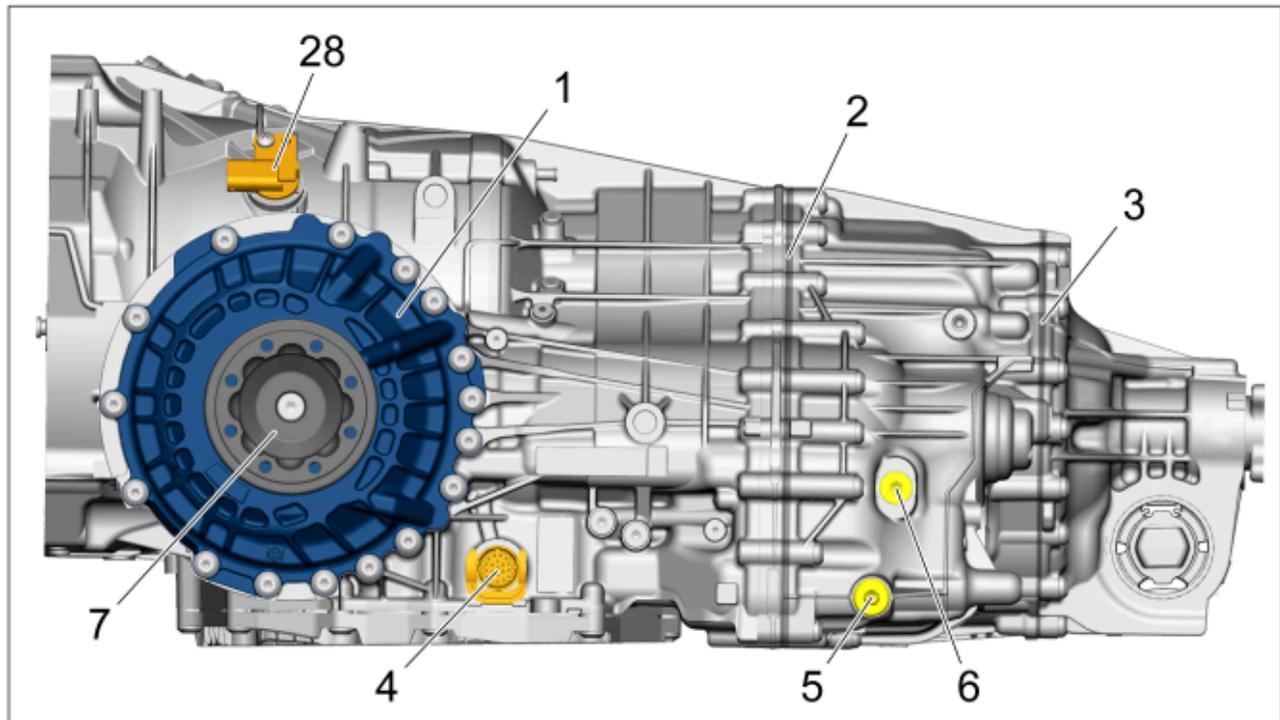
Please note that a transmission of the 911 GTS / 911 Turbo is shown here. For vehicles without the M-no. **OK1**, component no. **28** is not present.

| Item | Leak area | Possible cause(s) | Repair measure |
| ⇒ Right side of transmission -1- | Differential gear cover<br>1A - 1C | Sealing ring damaged (A) | Replace sealing ring, see ⇒ Workshop Manual '391555 Replacing flanged-shaft sealing ring'. |
| ⇒ Right side of transmission -2- | Rear transmission housing seal<br>2A - 2B | Screw loose (A) | Replace double clutch transmission, see ⇒ Workshop Manual '373419 Removing and installing double clutch transmission'. |

| ⇒ Right side of transmission<br>-3- | Front transmission housing seal<br>3A - 3B | Screw loose (A) | Replace double clutch transmission, see ⇒ <i>Workshop Manual '373419 Removing and installing double clutch transmission'</i> . |
| ⇒ Right side of transmission<br>-4- | Central connector on the left<br>4A - 4B | Sealing ring damaged (A) | Replace wire harness, see ⇒ <i>Workshop Manual '387719 Removing and installing transmission control unit'</i> . Tighten screws to 3 Nm (2 ftlb.). |
| ⇒ Right side of transmission<br>-5- | Screw plug | Sealing ring damaged | Replace screw and tighten to 27 Nm (20 ftlb.). Re-use spring and sleeve during installation. |
| ⇒ Right side of transmission<br>-6- | Oil filler screw | Sealing ring damaged | Replace screw and tighten to 27 Nm (20 ftlb.). |
| ⇒ Right side of transmission<br>-7- | Right halfshaft flange<br>7A - 7C | Sealing ring damaged (A) | Replace sealing ring, see ⇒ <i>Workshop Manual '392255 Workshop Manual "392255 Replacing sealing ring for right halfshaft flange - double clutch transmission"'</i> . |
| ⇒ Right side of transmission<br>-28- | Transmission housing / NTC sensor | Sealing ring damaged | Replace sensor |

| Item | Leak area | Possible cause(s) | Repair measure |
|---|---|---|--|
| | | Screw loose (B) | Replace screws, see ⇒ Workshop Manual '391555 Replacing flanged-shaft sealing ring'. |
| | | O-ring damaged (C) | Replace O-ring, see ⇒ Workshop Manual '391555 Replacing flanged-shaft sealing ring'. |
| | | Seal damaged (B) | |

| | | Seal damaged (B) | |
| | | Connector leaking (B) | |
| | | Right halfshaft flange damaged (B) | Replace halfshaft flange, see ⇒ <i>Workshop Manual '392519 Workshop Manual "392519 Removing and installing right halfshaft flange - double clutch transmission"'</i> . |
| | | Screw loose, leaking (C) | Replace screw, see ⇒ <i>Workshop Manual '392519 Workshop Manual "392519 Removing and installing right halfshaft flange - double clutch transmission"'</i> . |

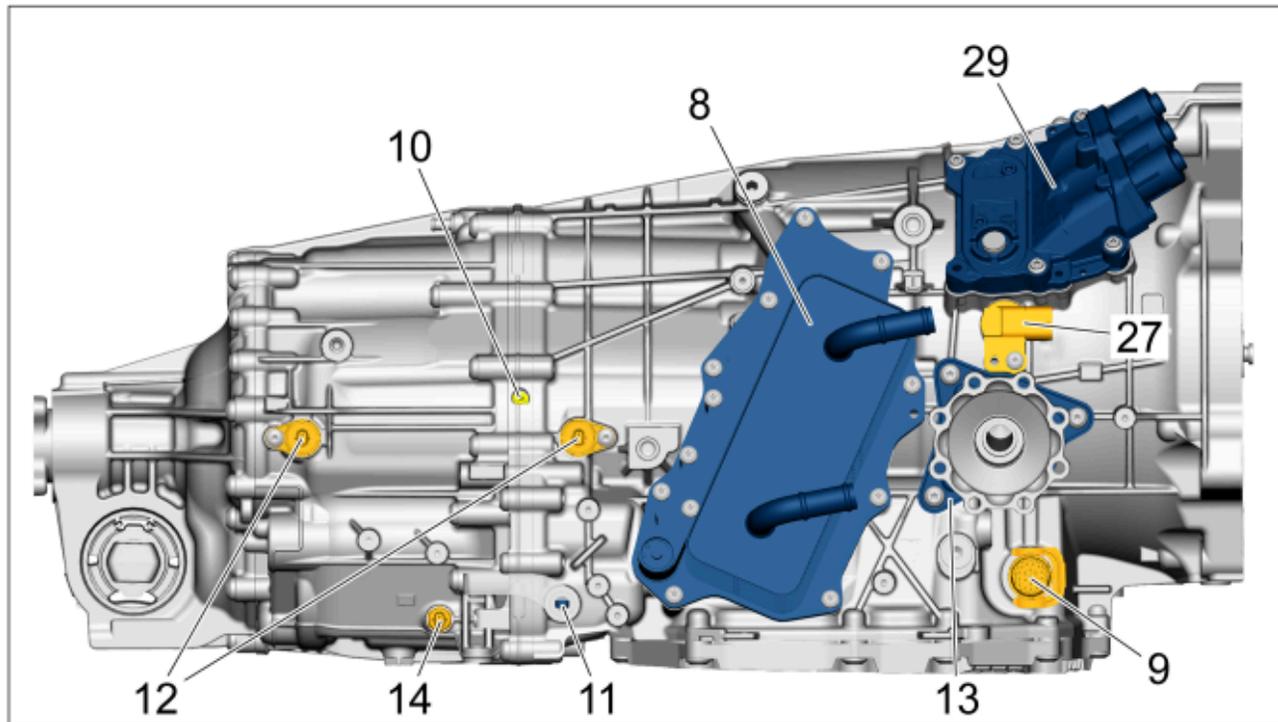
Please note that a transmission of the 911 GTS / 911 Turbo is shown here. For vehicles without the M-no. **OK1**, component nos. **27** and **29** is not present.

| Item | Oil leakage | Possible cause(s) | Repair measure |
| ⇒ Left side of transmission (with ATF cooler) -8- | ATF cooler<br>8A - 8C<br><br>If there are oil leakages in the ATF cooler area, see also ⇒ Left side of transmission (with ATF cooler) -15 and 16-. | Screw loose (A) | Replace screw, see ⇒ Workshop Manual '377219 Removing and installing transmission oil cooler'. |
| ⇒ Left side of transmission (with ATF cooler) -9- | Central connector on the right<br>9A - 9B | Sealing ring damaged (A) | Replace double clutch transmission, see ⇒ Workshop Manual '373419 Removing and installing double clutch transmission'. |
| ⇒ Left side of transmission (with ATF cooler) -10- | Bleeder screw | Shaft sealing ring damaged | Replace double clutch transmission, see ⇒ Workshop Manual '373419 Removing and installing double clutch transmission'. |

| ⇒ Left side of transmission (with ATF cooler) -11- | Selector shaft | Sealing ring damaged | Replace sealing ring, see ⇒ Workshop Manual '373355 Replacing selector shaft sealing ring'. |
| ⇒ Left side of transmission (with ATF cooler) -12- | Speed sensor<br>12A - 12B | Sealing ring damaged (A) | Replace sealing ring. |
| ⇒ Left side of transmission (with ATF cooler) -13- | Left halfshaft flange | Grease leak on bearing | Replace bearing, see ⇒ Workshop Manual '392555 Replacing left halfshaft flange bearing'. |
| ⇒ Left side of transmission (with ATF cooler) -14- | Temperature sensor<br>14A - 14B | Sealing ring damaged (A) | Replace temperature sensor, see ⇒ Workshop Manual '377419 Removing and installing transmission oil temperature sensor'. |
| ⇒ Left side of transmission (with ATF cooler) -27- | Rotor position sensor | Sealing ring damaged | Replace rotor position sensor |
| ⇒ Left side of transmission (with ATF cooler) -29- | Line connection box | Seal damaged | Replace seals on line connection box, see ⇒ Workshop Manual '373427A2 Removing and attaching double-clutch transmission' |

| Item | Oil leakage | Possible cause(s) | Repair measure |
|--|--|---|--|
| | | Seal damaged (B) | Replace seal, see ⇒ Workshop Manual '377219 Removing and installing transmission oil cooler'. |
| | | ATF cooler leaking (C) | Replace ATF cooler, see ⇒ Workshop Manual '377219 Removing and installing transmission oil cooler'. |
| | | Connector leaking (B) | |

| | | Screw loose (B) | Replace screw and tighten to 3.2 Nm (2.2 ftlb.) and a final tightening torque angle of 30°. |
| | | Connector leaking (B) | |

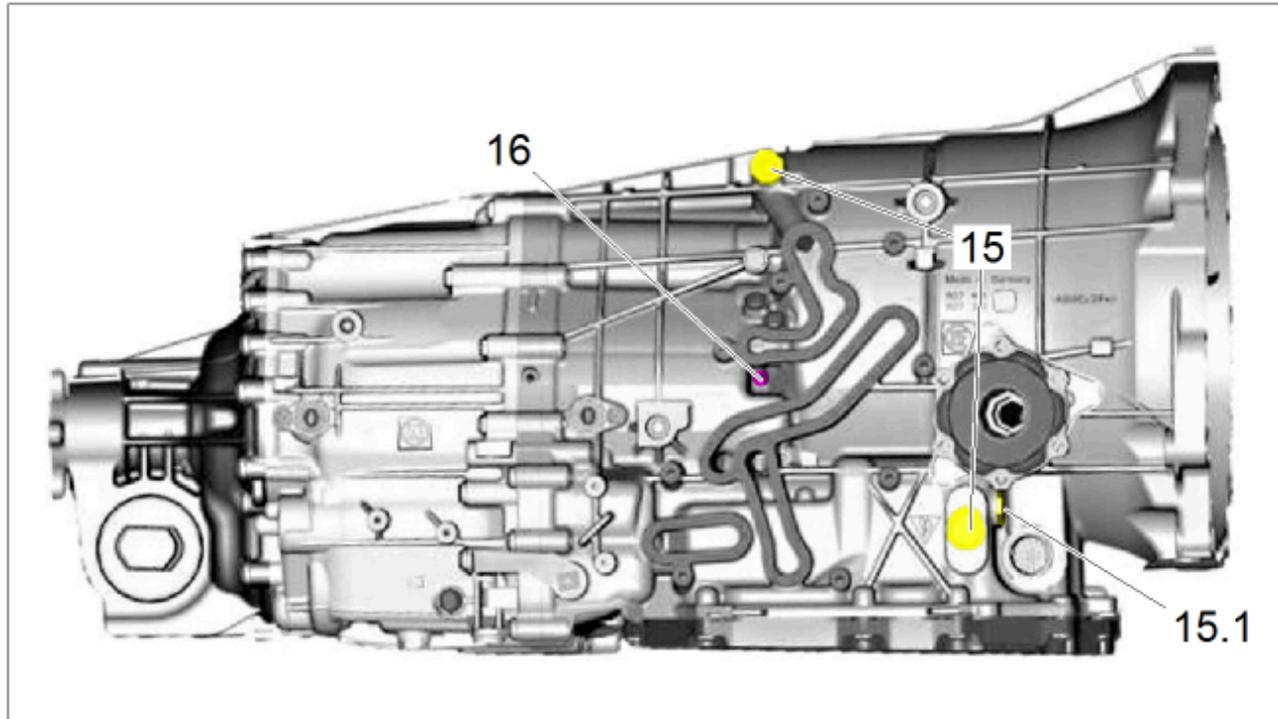
| Item | Oil leakage | Cause | Repair measure |
| ⇒ Left side of transmission (without ATF cooler) -15- | Screw plug<br>15A - 15B | Screw loose (A) | Replace screw and tighten to 27 Nm (20 ftlb.). |
| ⇒ Left side of transmission (without ATF cooler) -15- | Oil filler screw<br>15C - 15D | Screw loose (C) | Replace screw, see ⇒ Workshop Manual '370235 Checking and topping up ATF'. |
| ⇒ Left side of transmission (without ATF cooler) -15.1- | Screw plug<br>15.1A - 15.1B | Screw loose (A) | Replace screw and tighten to 27 Nm (20 ftlb.). |
| ⇒ Left side of transmission (without ATF cooler) -16- | Oil chamber partition<br>If there are oil leakages in this area, see also ⇒ Left side of transmission (without ATF cooler) -8 and 15 / 15.1-. | Shaft sealing ring damaged | Check the area using an endoscope.<br>Replace double clutch transmission if there are leaks, see ⇒ Workshop Manual '373419 Removing and installing double clutch transmission'. |

If there is a leak around item 16, observe the specified procedure.

- Clean oil leak bore area and coat it directly with leak-locating spray
- Correct the oil level
- Perform a test drive
- Visually inspect the leak area of the oil leak bore

If the fault can be reproduced, the double clutch transmission must be replaced. If not, continue fault finding.

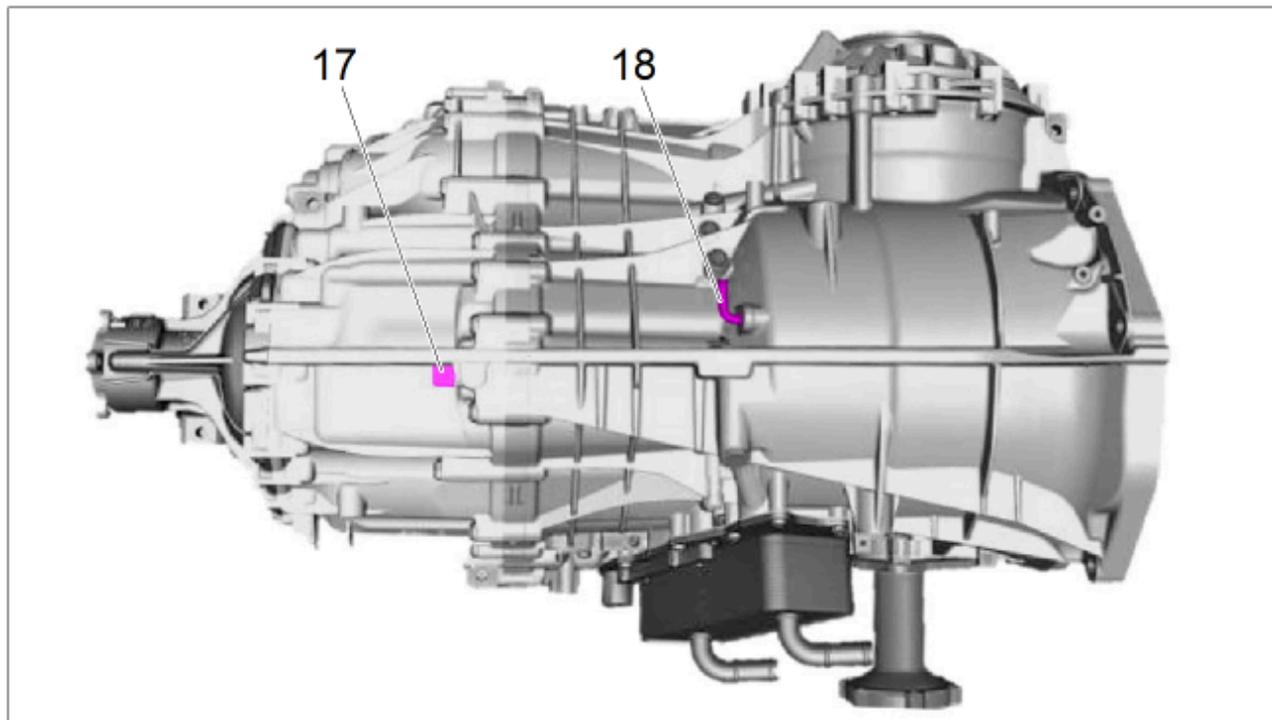
Upper side of transmission

| Item | Oil leakage | Cause | Repair measure |
| ⇒ Upper side of transmission<br>-17- | Hydraulic space breather<br>17A - 17B | Oil over-filling (A) | Check oil level of hydraulic chamber and final drive, see ⇒ <i>Technical Information '373419 follow-up actions'</i> .<br><br><b>Oil level in hydraulic chamber too high and final drive OK:</b> Correct the oil level.<br><br><b>Oil level in hydraulic chamber clearly too high and final drive too low:</b> Replace double clutch transmission, see ⇒ <i>Workshop Manual '373419 Removing and installing double clutch transmission'</i> . |

| Item | Oil leakage | Cause | Repair measure |
|---|---|---|--|
| | | Insufficient defoamer (B) | Replace ATF, see ⇒ <i>Workshop Manual '370255 Replacing ATF'</i> . |

**Oil level in final drive is clearly too high and ATF too low:** Replace double clutch transmission, see ⇒ *Workshop Manual '373419 Removing and installing double clutch transmission'*.

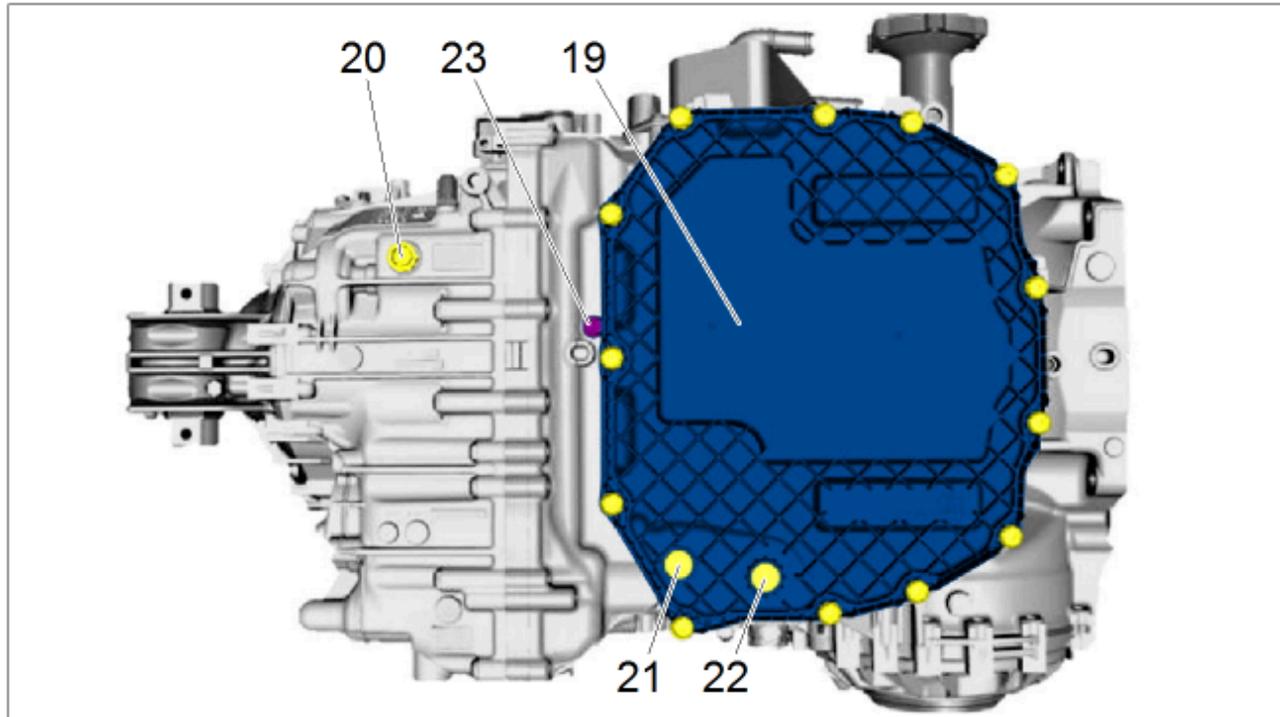
Lower side of transmission

| Item | Oil leakage | Cause | Repair measure |
| ⇒ Lower side of transmission<br>-19- | ATF pan<br>19A - 19C | Screw loose (A) | Replace ATF pan; see ⇒ <i>Workshop Manual '375519 Removing and installing ATF pan'</i> . |
| ⇒ Lower side of transmission<br>-20- | Screw plug<br>20A - 20B | Screw loose (A) | Replace screw, see ⇒ <i>Workshop Manual '399035 Checking and topping up oil for final drive (PDK gear-wheel oil)'</i> . |
| ⇒ Lower side of transmission<br>-21- | Screw plug<br>21A - 21B | Screw loose (A) | Replace screw, see ⇒ <i>Workshop Manual '370235 Checking and topping up ATF'</i> . |

| ⇒ Lower side of transmission<br>-22- | Oil drain plug<br>22A - 22B | Screw loose (A) | Replace screw, see ⇒ Workshop Manual '370255 Changing ATF'. |
| ⇒ Lower side of transmission<br>-23- | Oil chamber partition | Shaft sealing ring damaged | Replace double clutch transmission, see ⇒ Workshop Manual '373419 Removing and installing double clutch transmission'. |

| Item | Oil leakage | Cause | Repair measure |
|---|---|---|---|
| | | Seal damaged (B) | |
| | | Sealing ring damaged (B) | |

| | | Sealing ring damaged (B) | |

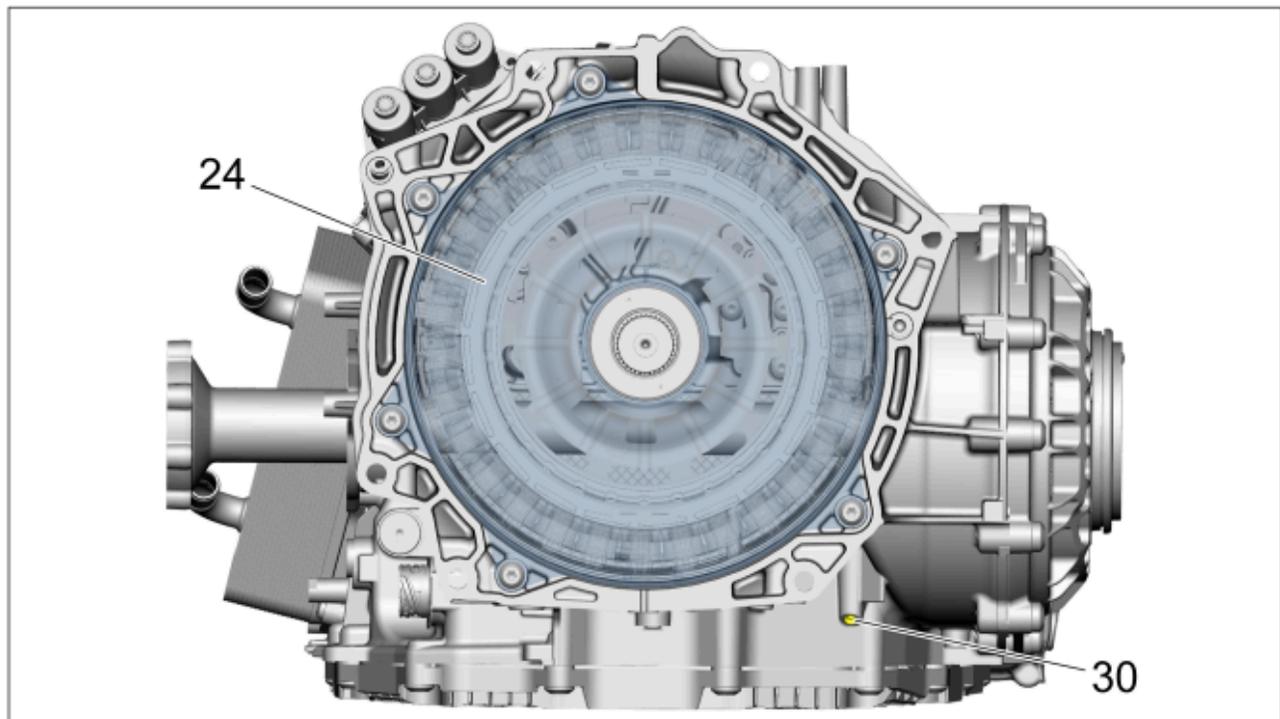
Rear side of transmission

Please note that a transmission of the 911 GTS / 911 Turbo is shown here. For vehicles without the M-no. **0K1**, component no. **30** is not present.

| Item | Oil leakage | Cause | Repair measure |
| ⇒ Rear side of transmission<br>-24- | Clutch bell-housing<br>24A - 24E | O-ring on clutch cover damaged (A) | Replace double clutch transmission, see ⇒ <i>Workshop Manual '373419 Removing and installing double clutch transmission'</i> . |

| ⇒ Rear side of transmission<br>-30- | Leakage oil bore | Shaft sealing ring for differential inner damaged | Replace transmission. ⇒ <i>Workshop Manual '373427A2 Removing and mounting Porsche Doppelkupplung (PDK)'</i> |

| Item | Oil leakage | Cause | Repair measure |
|---|---|---|--|
| | | Intermediate shaft sealing ring damaged (B) | Replace sealing ring, see ⇒ <i>Workshop Manual '386955 Replacing radial shaft seal'</i> . |
| | | Engine leaking (C) | Find oil leakages and fix them. |
| | | Apparent preservative grease leak (D) | No action required. |

| | | Flanged-shaft sealing ring damaged (E) | Replace sealing ring, see ⇒ <i>Workshop Manual '391555 Replacing flanged-shaft sealing ring'</i> . |

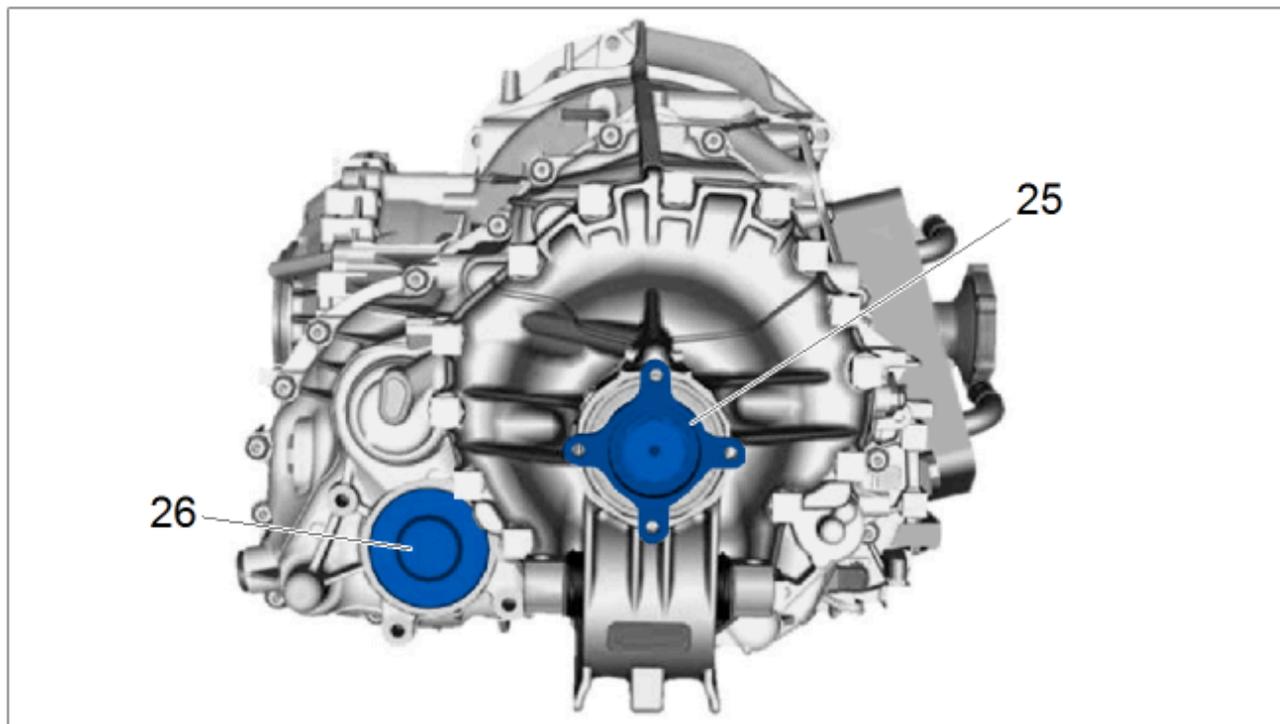
Front side of transmission

| Item | Oil leakage | Cause | Repair measure |
| ⇒ Front side of transmission<br>-25- | Output flange<br>25A - 25B | Sealing ring damaged (A) | Replace sealing ring and output flange, see ⇒ Workshop Manual '398255 Replacing cardan flange sealing ring'. |
| ⇒ Front side of transmission<br>-26- | Cover | Cover damaged | Replace cover, see ⇒ Workshop Manual '374955 Replacing cover'. |

| Item | Oil leakage | Cause | Repair measure |
|---|---|---|--|
| | | Output flange leaking (B) | |
