Technical Service Bulletin

Topic	Air spring fault finding guidelines - 25MY
Market area	Bentley: worldwide (2WBE)
Brand	Bentley
Transaction No.	2076718/2
Level	EH
Status	Released for publishing
Release date	Sep 24, 2025

25MY Continental GT/GTC & Flying Spur

The front and/or rear suspension appears to have dropped.

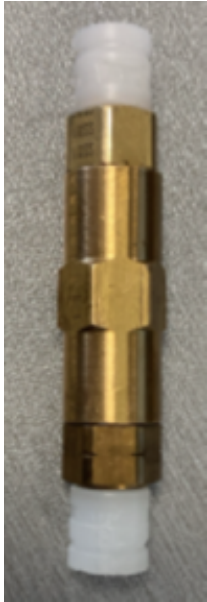
Figure 1

From the repair part (see parts information) shown in Figure 1, the VOSS connector can be removed with the stopper and collet as one item Figure 2.

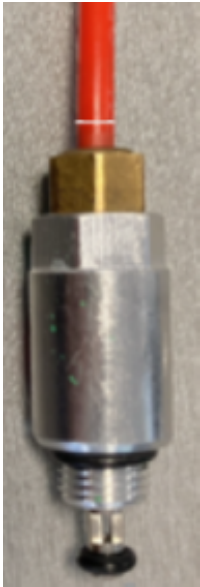
Figure 5 shows the air hose with the old collet removed, the hose cleaned up and installed in the new VOSS connector.

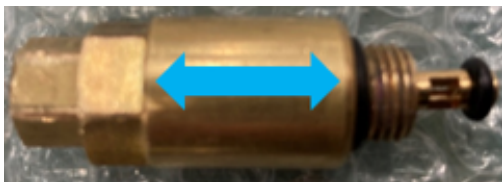
Figure 7

With the VOSS connector and hose fitted, the plunger is open and there is two way air flow (Figure 7).

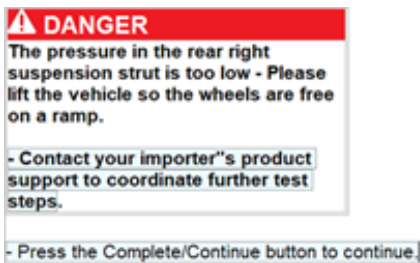
Figure 13

If there is a strut with less than 2 bar then the following message will be displayed to the retailer (Figure 13).

If ODIS displays the warning in figure 13, raise the vehicle immediately and raise a full technical DISS query.

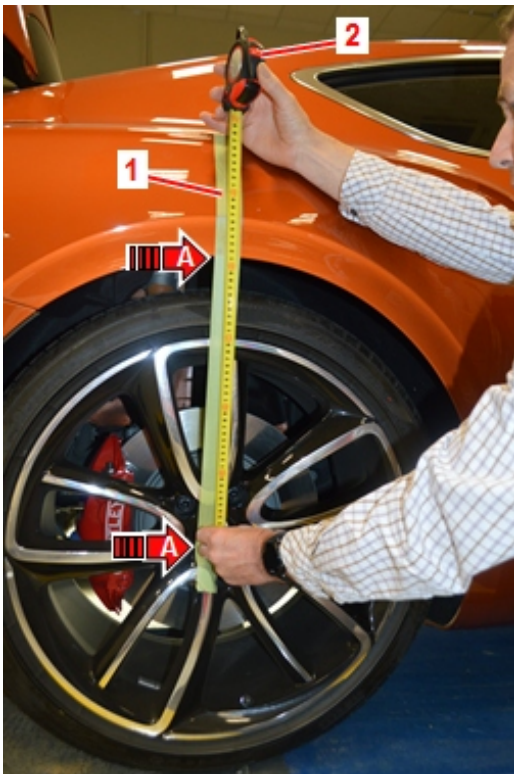
Figure 16

Apply strips of masking tape (1) from the centre of each wheel to the highest part of the wheel arch as shown, making sure the masking tape is applied ‘taut’

Using a tape measure (2), measure and take note of the ride heights (A-A) at all four corners of the vehicle. See Figure 16.

Leave the vehicle overnight and again measure the ride heights (**A-A**) at all four corners of the vehicle. Compare these values with those taken previously.

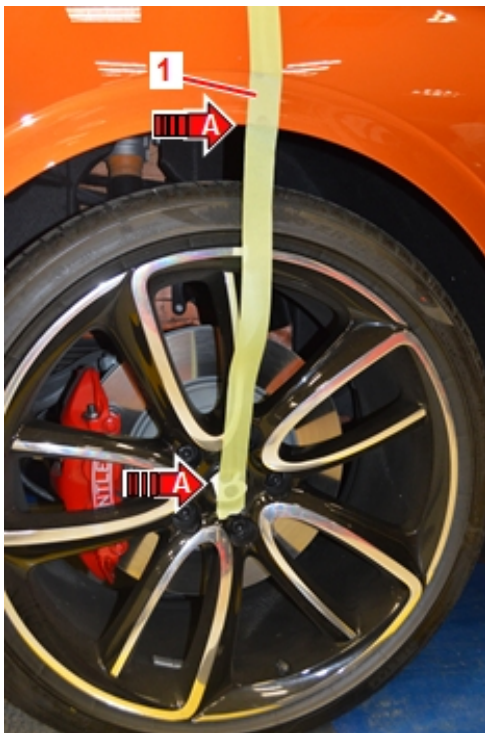
Figure 17

If there **IS** a difference in ride heights, and the strips of masking tape (**1**) have 'sagged' (shown in Figure 17), then refer to the following leak finding procedures below.

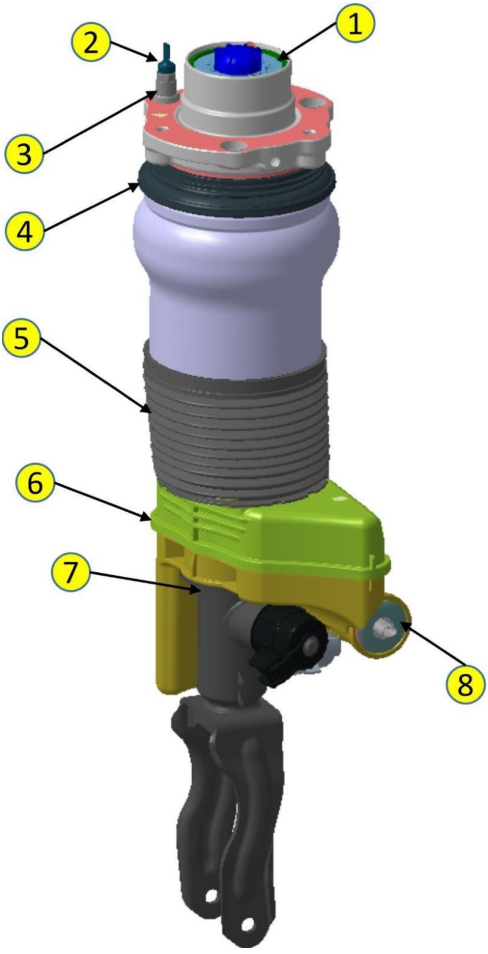
Front air spring check points

With the air suspension fully charged, use leak detector spray or a mild soap solution to check the connections for leaks as shown in the accompanying table.

<p>Top mount circlip (1) Air connection (2) Pressure retention valve (3) Upper air spring (4) Air spring gaiter (5) Spring body (6) Spring / damper seal (7) Shift valve (8)</p>

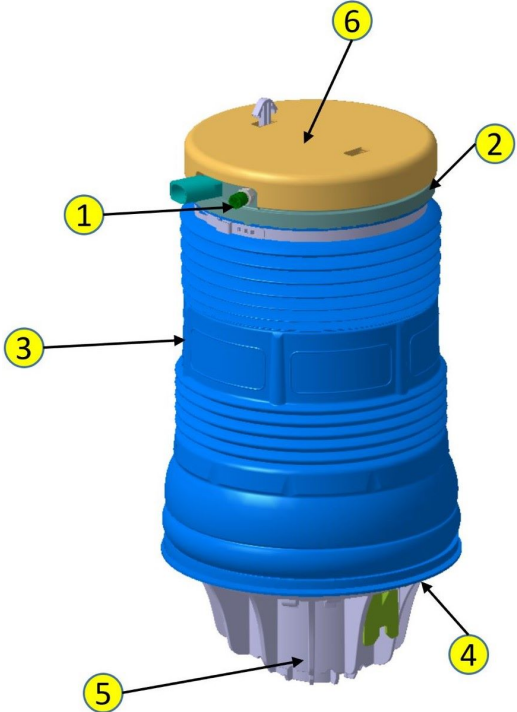
Rear air spring check points

With the air suspension fully charged, use leak detector spray or a mild soap solution to check the connections for leaks as shown in the accompanying table.

<p>Air connection (1) Upper air spring (2) Air spring gaiter (3) Lower air spring (4) Spring base / spigot (5) Shift valve (under isolator) (6)</p>

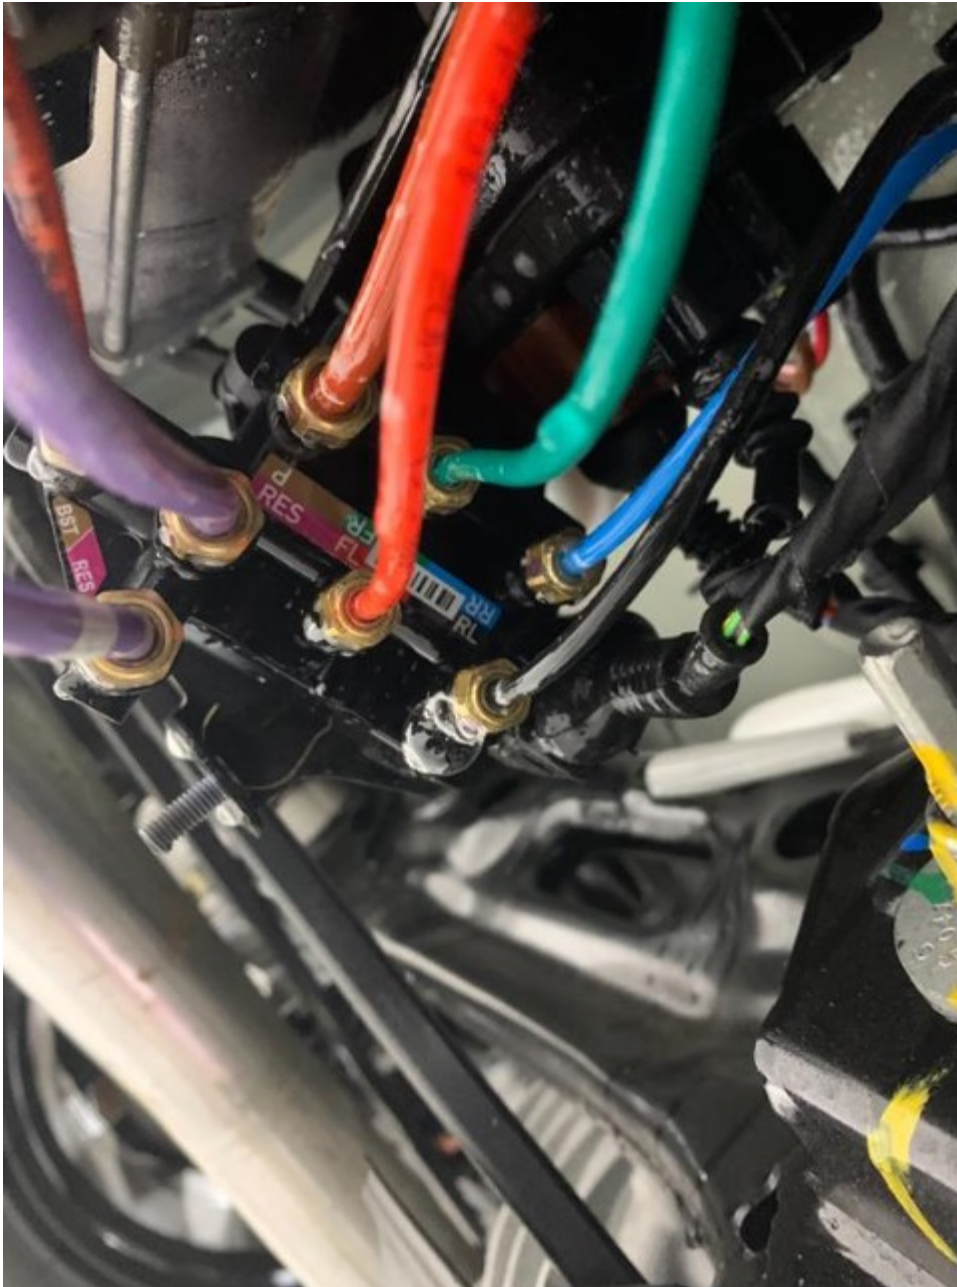
Figure 20

VERY IMPORTANT: In the event a leak is found at the air supply unit (Figure 20) a video and photographs of the leak is required to be attached to a new or existing DISS query

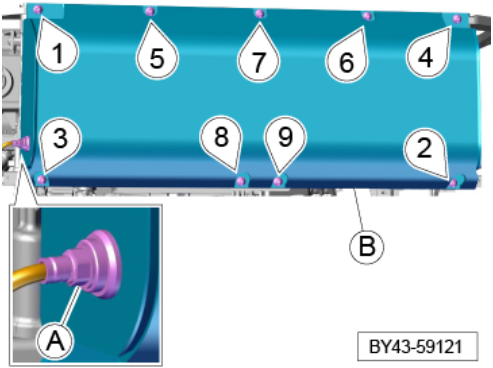
Check	Yes	No	Comments
Air pipe connection (A) Location – Refer to the repair manual depending on model
