# Technical Service Bulletin

<b>Topic</b>	Rotating display/screen - Fault diagnosis - Mechanical malfunction DTC B140107 is evident within 005F
<b>Market area</b>	Bentley: worldwide (2WBE), China 796 VW Import Comp. Ltd (Vico), Beijing (6796)
<b>Brand</b>	Bentley
<b>Transaction No.</b>	2075532/3
<b>Level</b>	EH
<b>Status</b>	Released for publishing
<b>Release date</b>	Sep 24, 2025

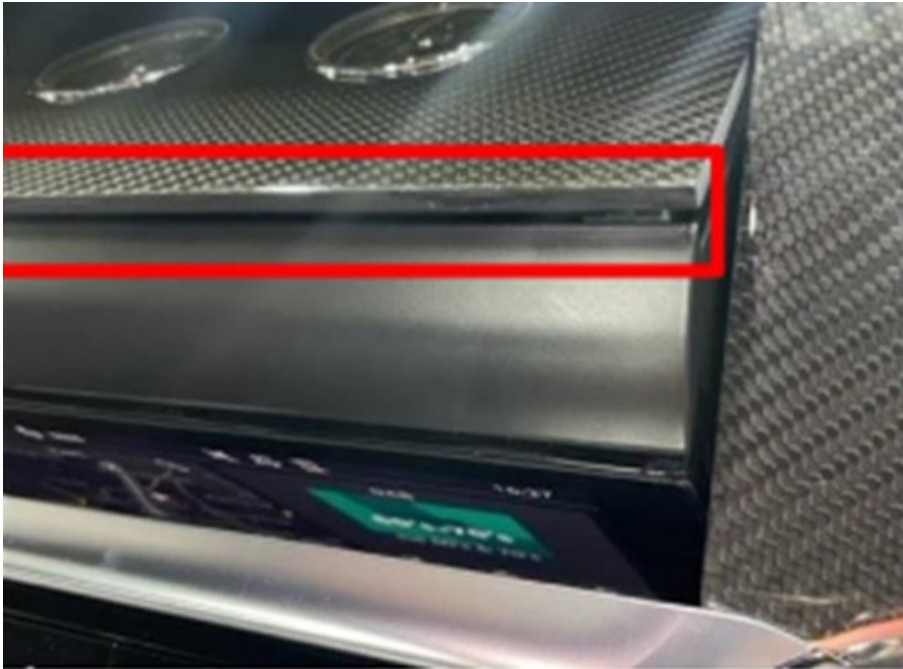
Figure 1

4) Figures 1 and 2 show an example of the display clocks and/or dials fascia unclipped)

**Please note: The BRD must be removed (Rep.Gr 91) to allow visual inspection of the panel at the back of the BRD for signs of unclipping (Figure 2)**

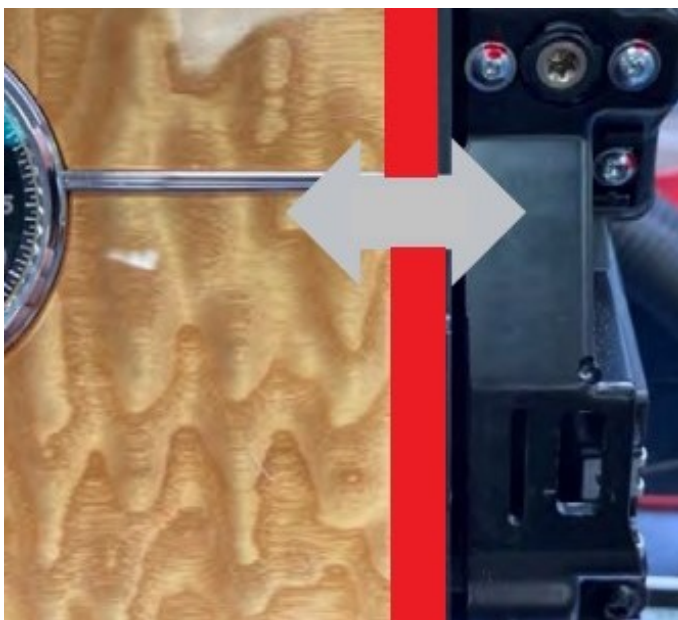
Figure 4

- **HINT: Referring to Figures 4 and 5, if there is a large gap on one side of the fascia panel and a small gap on the opposing side or a report of clashing with driver fascia or clunking the operative should check to confirm the bearings of the unit have not displaced as shown in Figure 6**

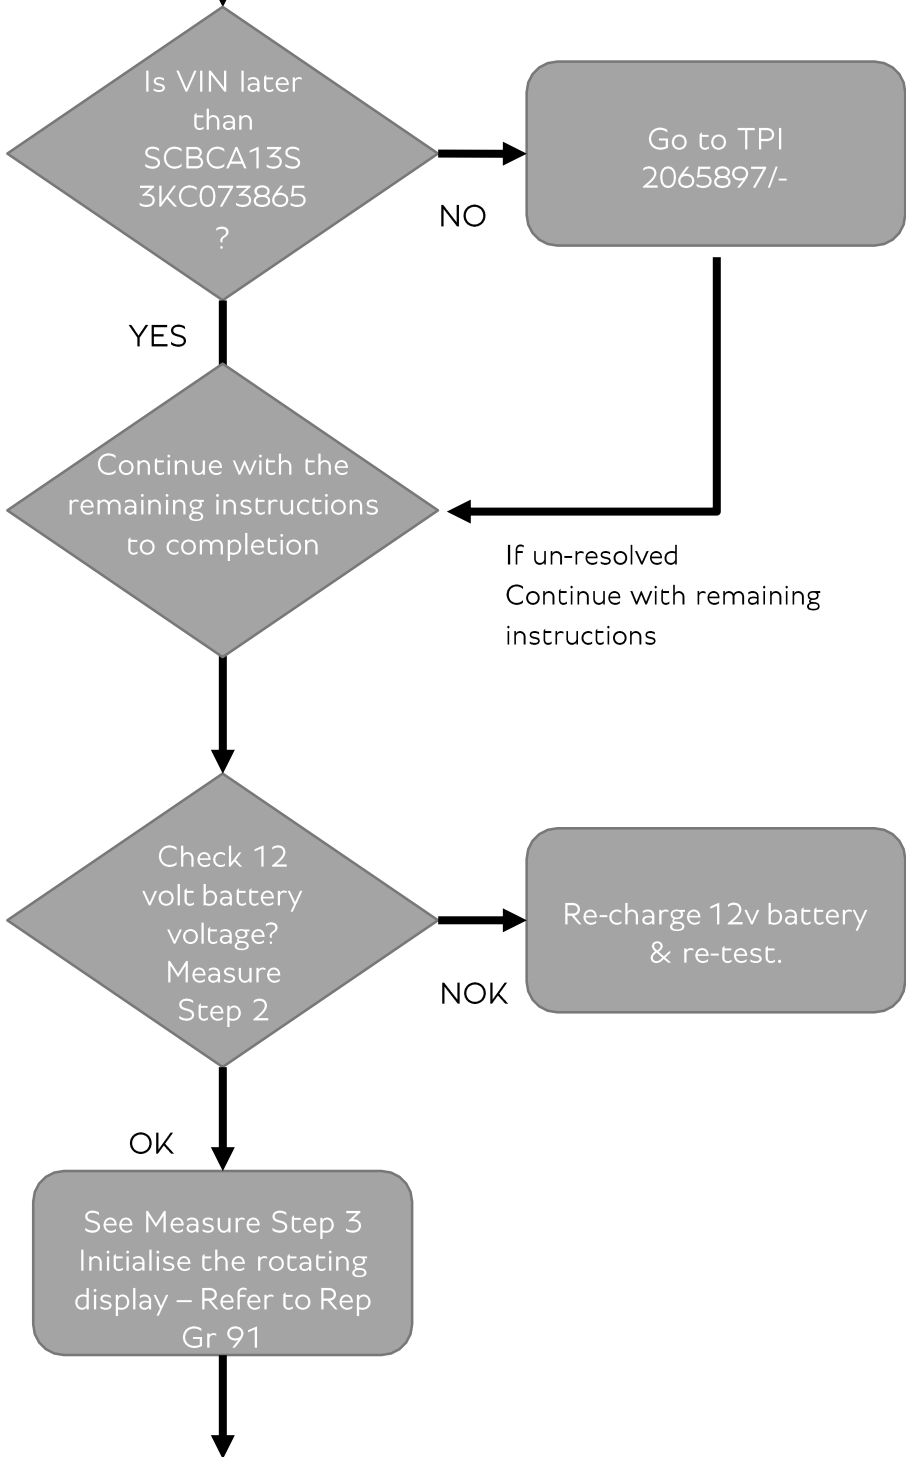
Confirm symptom is relevant for TPI.  
DTC B140107 Mechanics of display unit 1 for multimedia system  
mechanical malfunction is evident within 005F.

Bentley Rotational Display (BRD) operational issues.

See Measure Step 1

Note: for the BRD to rotate it must be correctly balanced.  
For example screen, plain & gauge fascia's fitted.  
x1 Balance weight removed for E revision screen & chrome pinstripe fascia's.
