Technical Service Bulletin

Topic	Rotating display/screen noise - Diagnosis for complaints relating to noise during operation and/or during a drive cycle
Market area	Australia E04 Bentley rest Asia and Australia (6E04),China 723 Volkswagen (Anhui) Automotive CO (6723),China 796 VW Import Comp. Ltd (Vico), Beijing (6796),Germany E02 Bentley rest Europe (6E02),Japan E03 Bentley Japan (6E03),Korea, (South) E08 Bentley South Korea (6E08),United Arab Emirates E06 Bentley Middle East and Africa (6E06),United Kingdom E01 Bentley UK (6E01),United States E05 Bentley USA and rest America (6E05)
Brand	Bentley
Transaction No.	2065895/6
Level	EH
Status	Released for publishing
Release date	Oct 7, 2025

New Continental GT

Various rotating display screen noise during operation

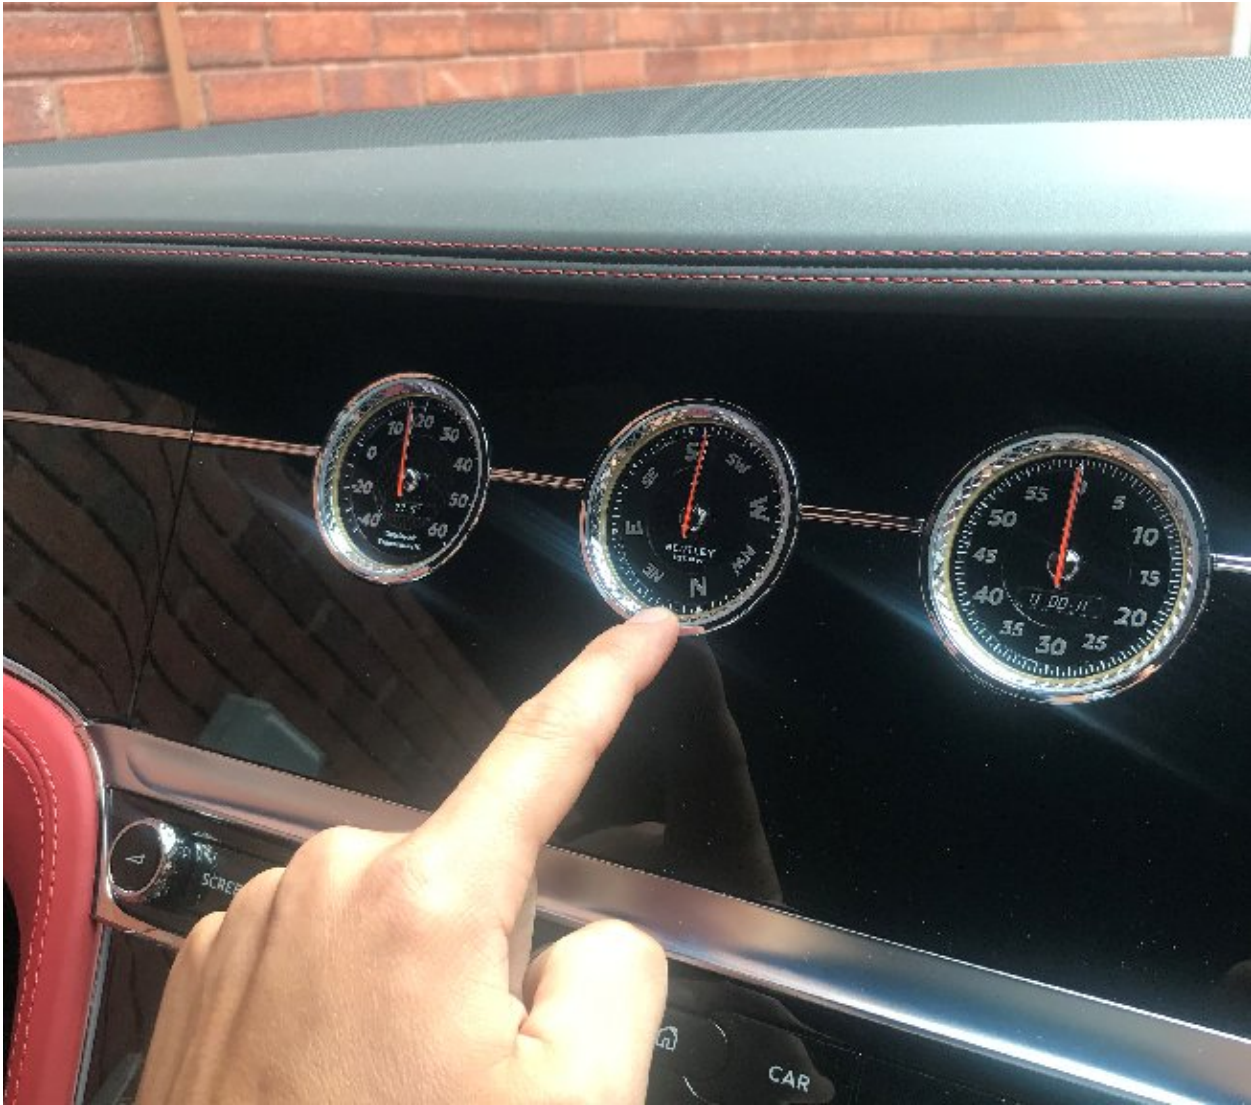
Figure 1

Scenario 1 - Squeak/creak/rattle from the dials during operation or graunching noise from the compass when the vehicle is being driven

When noise is evident from the dials, press on outer bezels (Figure 1) If the noise disappears when the bezels of the dials are pressed - Referring to Gr.91 - Replace the applicable dial(s)

In the event a graunching noise is evident from the compass when the vehicle is being driven - Referring to Gr.91 - Rotating display screen - to remove and fit - Replace the compass

The BRD does require removal when replacing the compass - Refer to Gr.91 - Rotating display screen to remove and fit to replace the compass

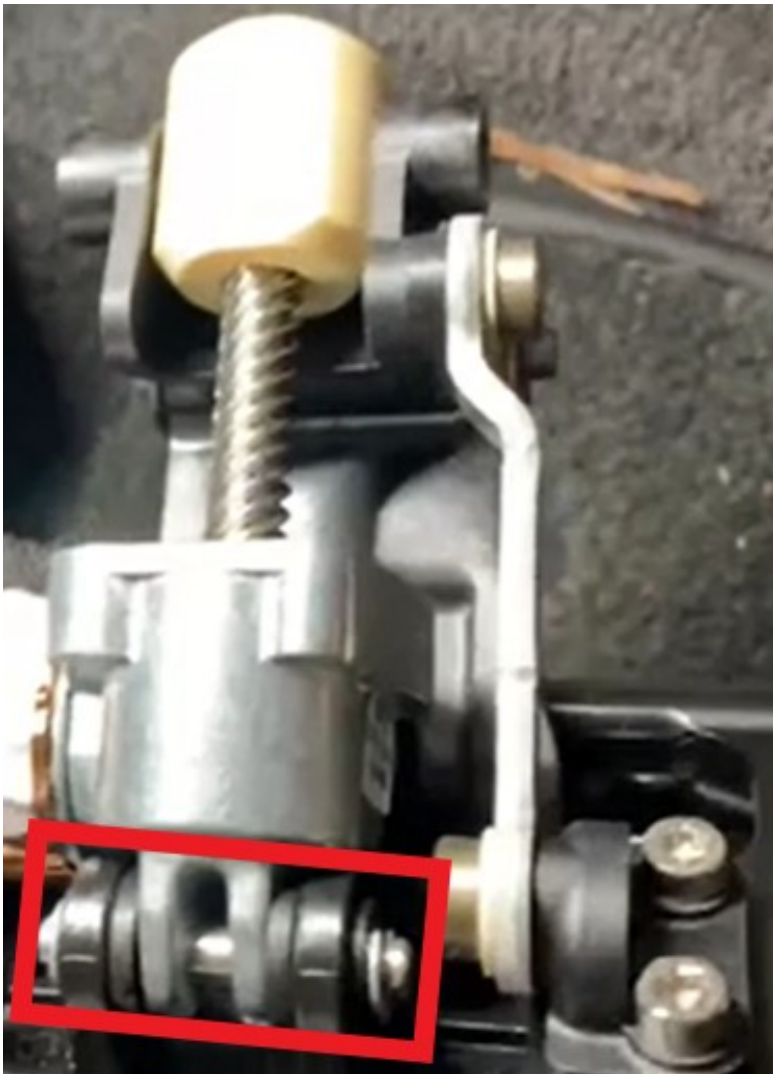
Figure 2

Scenario 2 - Creak/rattle from rotating display whilst driving

TIP: This symptom can in some cases be evident due to excessive movement within the rotating display motor pivot assembly (Figure 2)

- The operative should consider the motor pivot assembly

NOTE: To check the motor pivot assembly for excessive movement the rotating display should be removed - Refer to Rep.Gr 91

- Refer to the Bentley Hub and refer to the video referencing TPI 2065895/-
- Should the movement be as shown in the video, the rotating display unit should be replaced

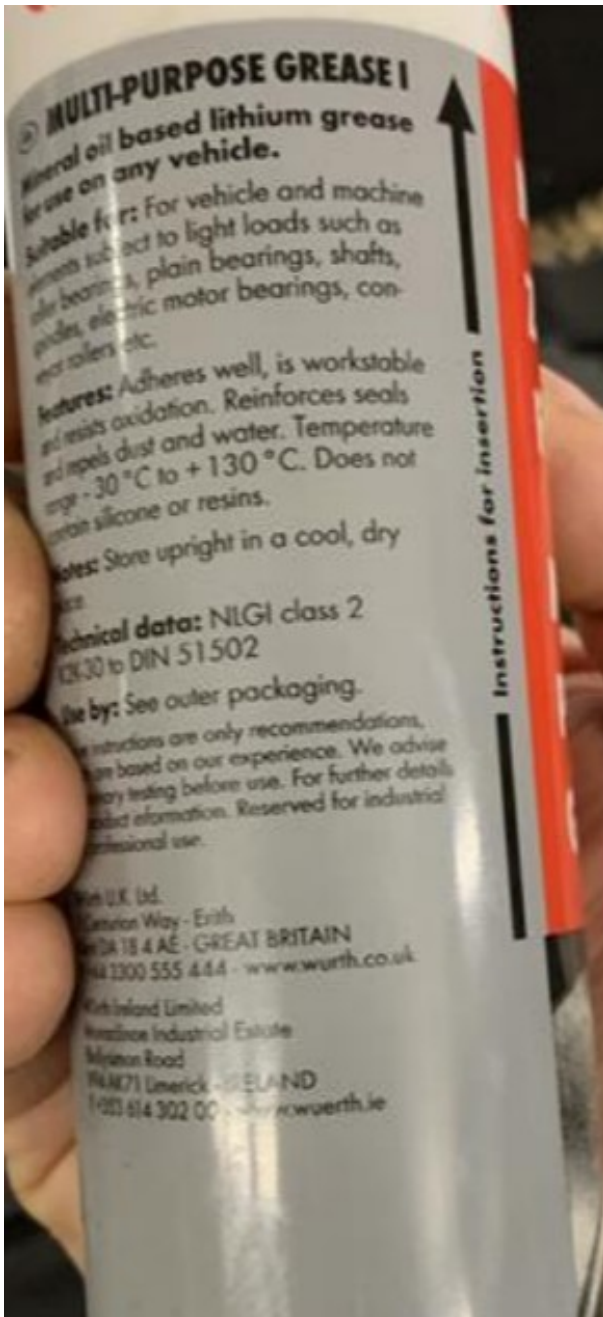
Figure 3

Scenario 3 - Squeaking noise from the rotating display whilst in operation (rotating)

- Refer to the videos located on the Bentley Hub (Video 1 - 2065895 and Video 2 - 2065895)
- Remove the rotating display - Refer to Rep.Gr91
- Apply a thin layer of multi-purpose grease (Figure 3) to the worm drive at the location shown in Figure 4

- Refit the rotating display
- Check the issue is now resolved
