BULLETIN NUMBER
SB25-J-001

CHARGE AIR COOLER (CAC) HOSE CLIP INSTALLATION

- 2022-2026MY Isuzu F-Series Vehicles
With a production date prior to 8/4/2025

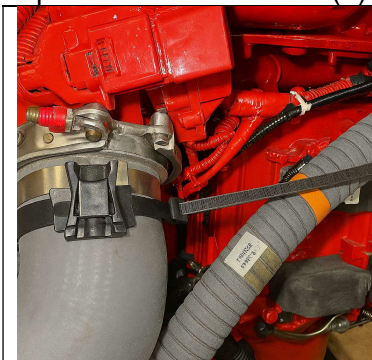
Figure 1

Some customers may complain about a whistling noise from the engine, lack of power, or a visible alarm from the check engine malfunction indicator light (MIL). Dealers may find that this issue is caused by a hole in the Charge Air Cooler (CAC) hose near the compressor inlet hose. Whenever the CAC hose is replaced, Isuzu recommends dealers also install a new hose clip to prevent the compressor hose from damaging the new CAC hose in the future.

- After completing the installation of the new CAC hose per the WSM, place the hose clip directly below the hose clamp and secure with one (1) zip tie as shown in Figure 1.
