TECHNICAL SERVICE BULLETIN

Chatter/Shudder During Low Speed Turning Events

25-2552

07 November
2025

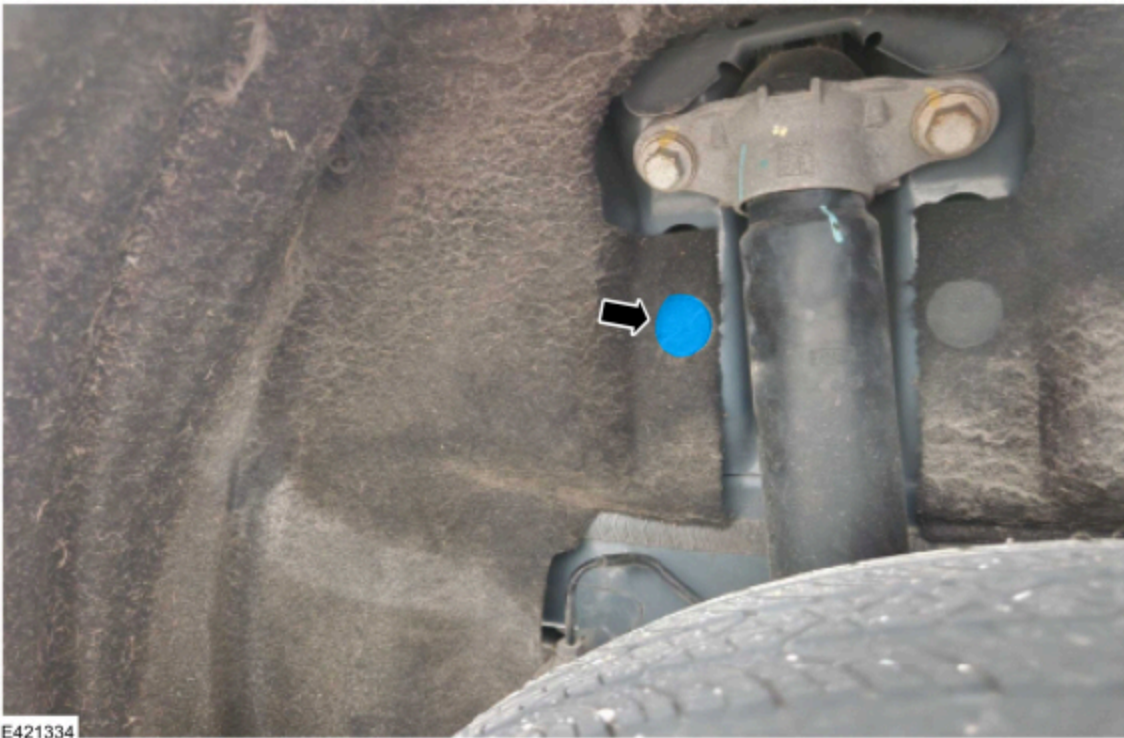
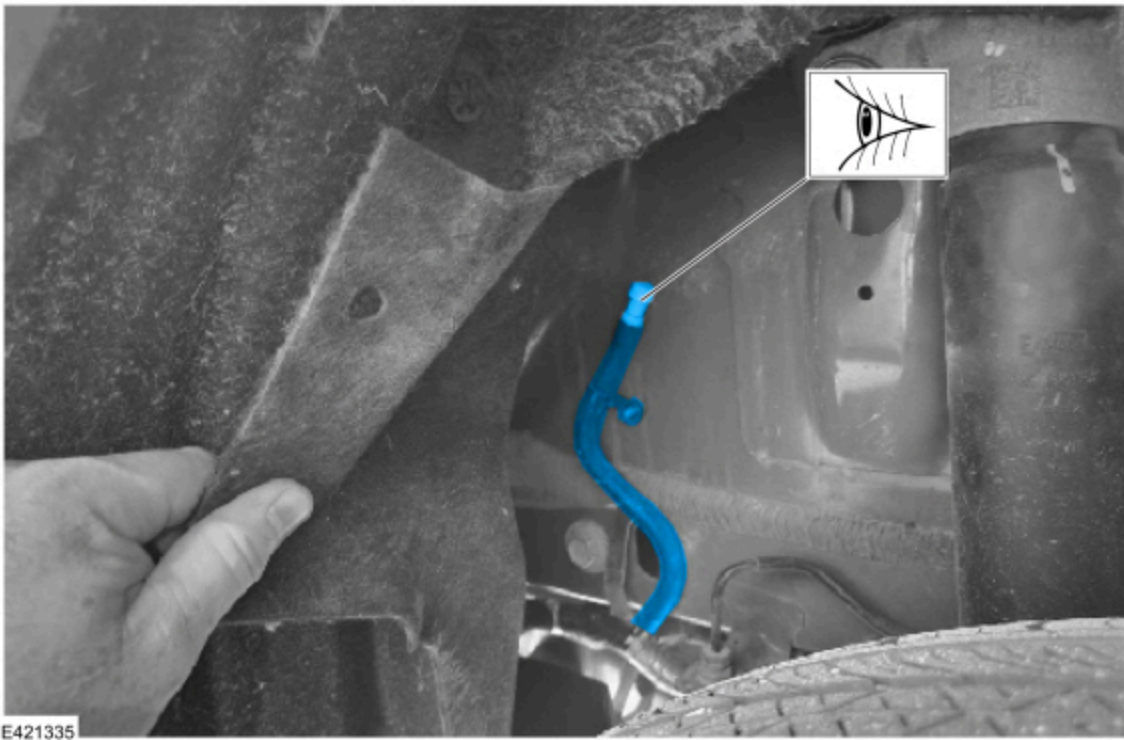
Figure 1

- Remove the right rear fender splash shield retaining pin and fold back the right rear fender splash shield to inspect the RDU vent hose. (Figures 1-2)

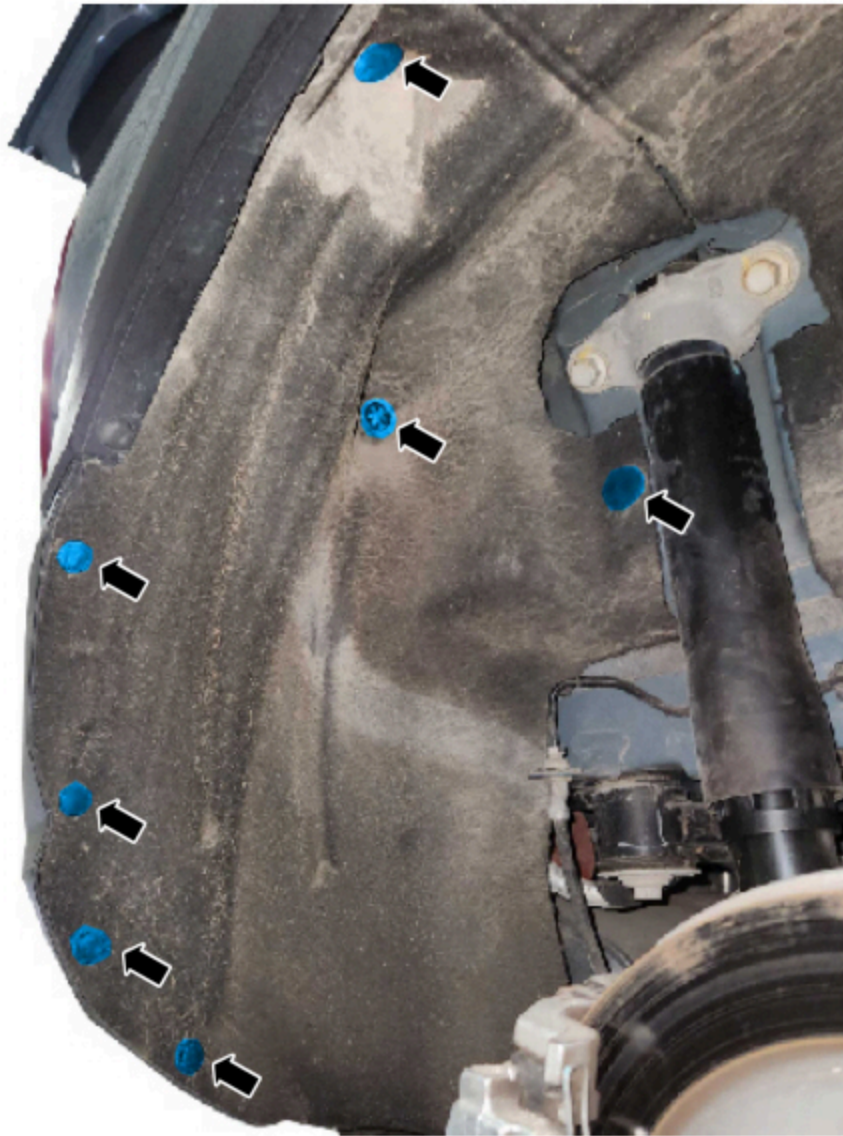
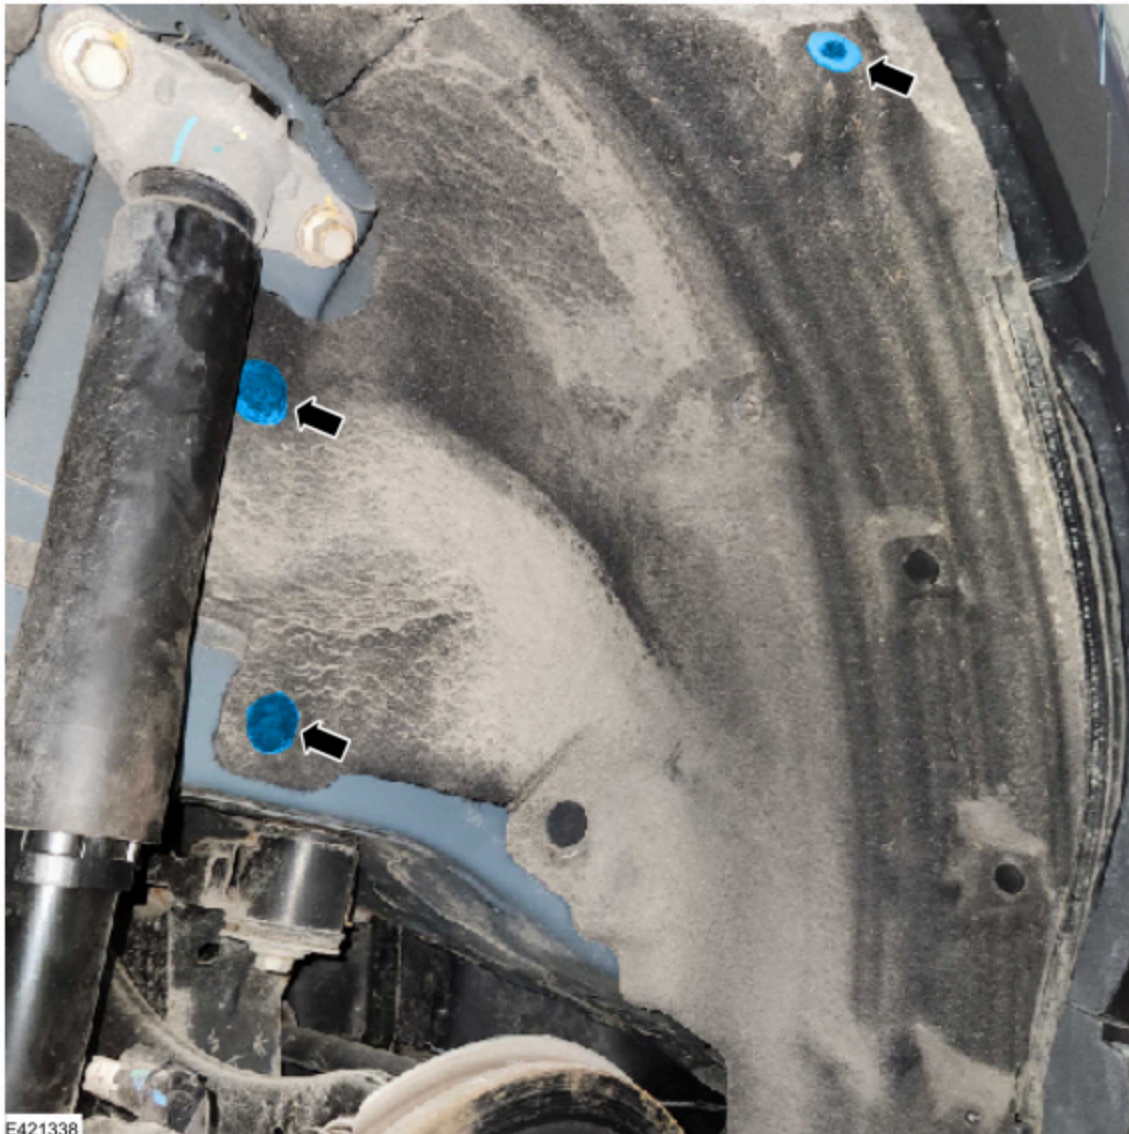
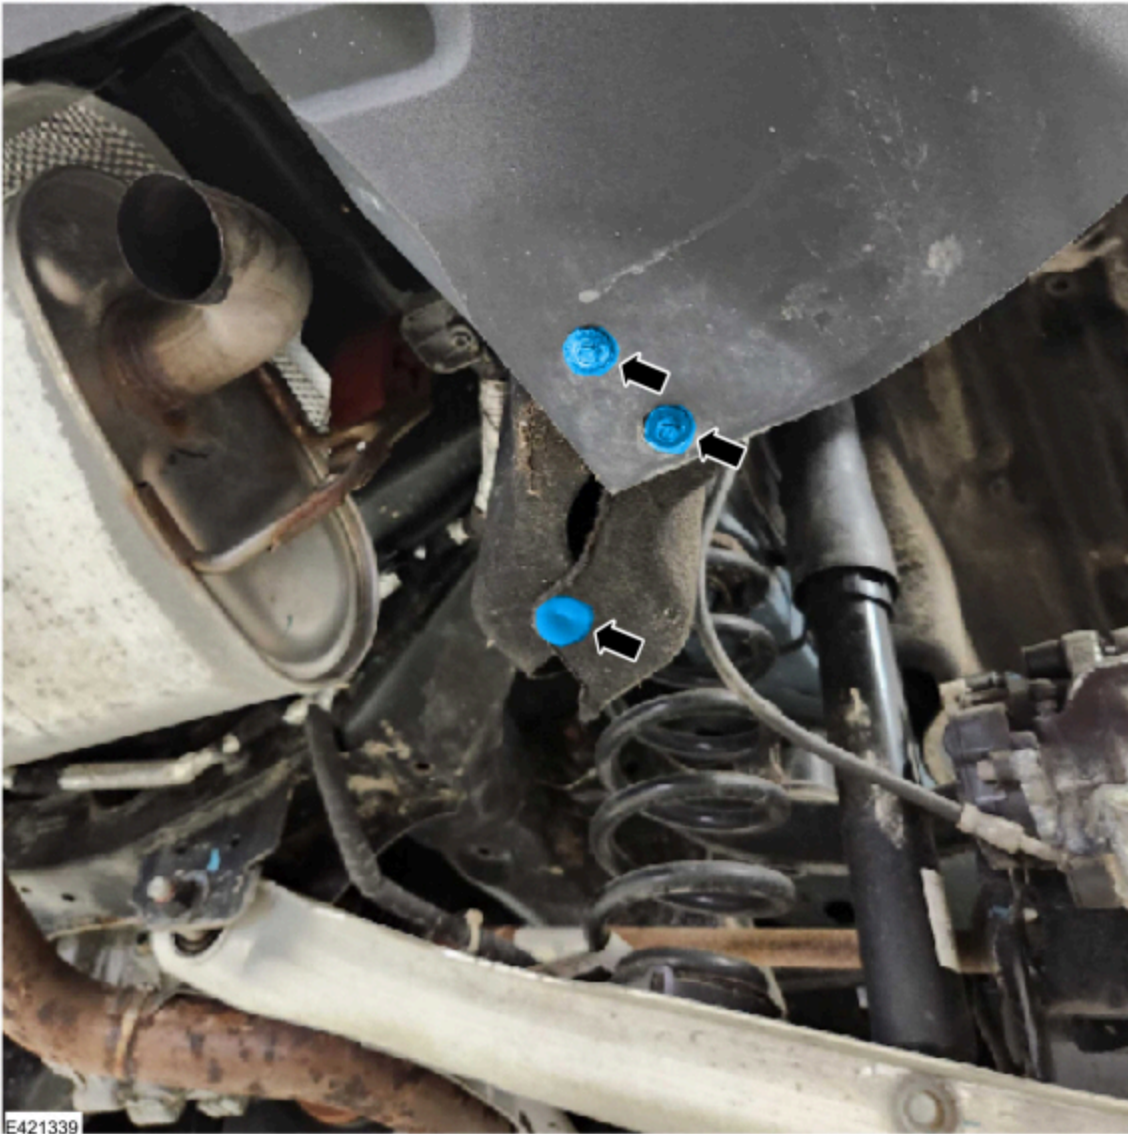
Figure 4

4. Remove the retainers and screws from the right rear fender splash shield shown in Figures 4-6. Lower and fold the right rear fender splash shield in front of the brake caliper to access the RDU vent hose and upper section of the wheel well.

26. Reassemble the right rear fender splash shield and secure using the retainers and locations shown in Figures 4-6.

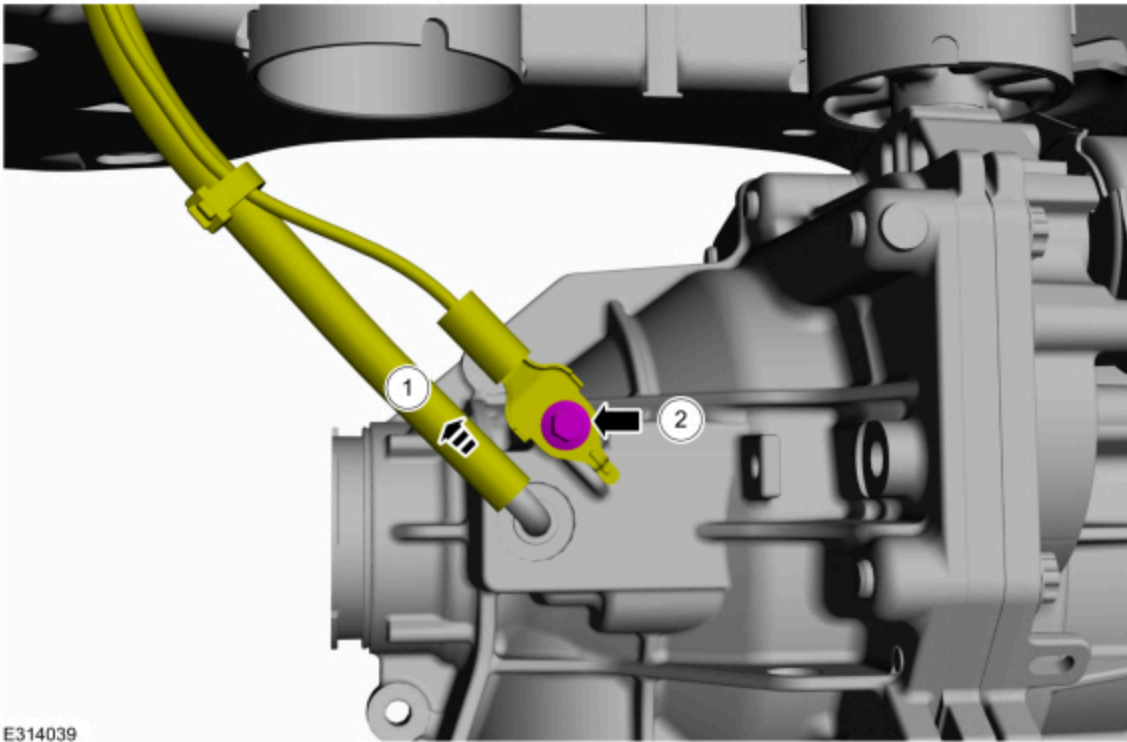
Figure 8 - Bronco Sport 1.5L / Escape/Corsair shown

11. Remove the rear differential vent hose and ground strap bolt from the RDU and position aside. (Figure 8)

14. Position the new RDU vent hose and ground strap assembly and attach the hose retainers. (Figures 7 and 10)
15. Install the bolt to attach the ground strap to the body. Tighten to 12 Nm (106 lb.in). (Figure 9)
16. Install the new RDU vent hose onto the RDU. (Figure 8)
17. Install the bolt to secure the ground cable onto the RDU. Tighten to 12 Nm (106 lb.in). (Figure 8)
18. Using the new retainer at the end of the new RDU vent hose, position the hose vertically so the form of the hose follows the inner arch of the wheel well. Use a tool or a marker to mark the location on the body to drill a hole. (Figure 11)

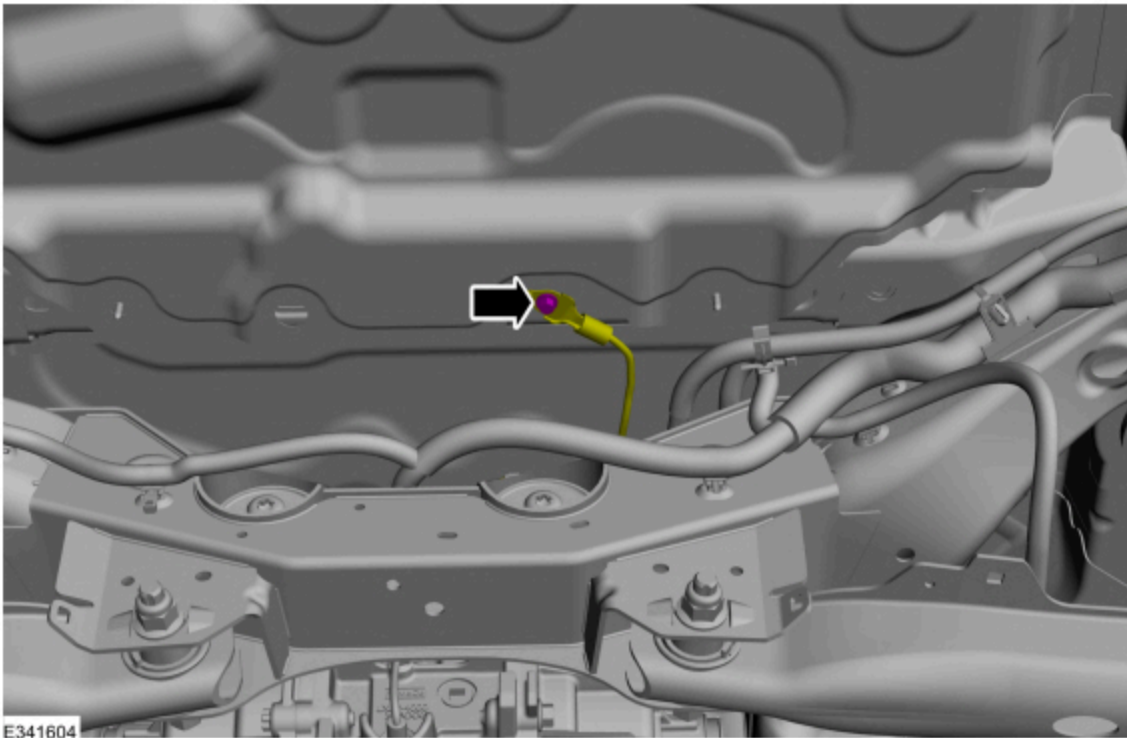
Figure 9

12. Remove the ground strap bolt from the body. (Figure 9)

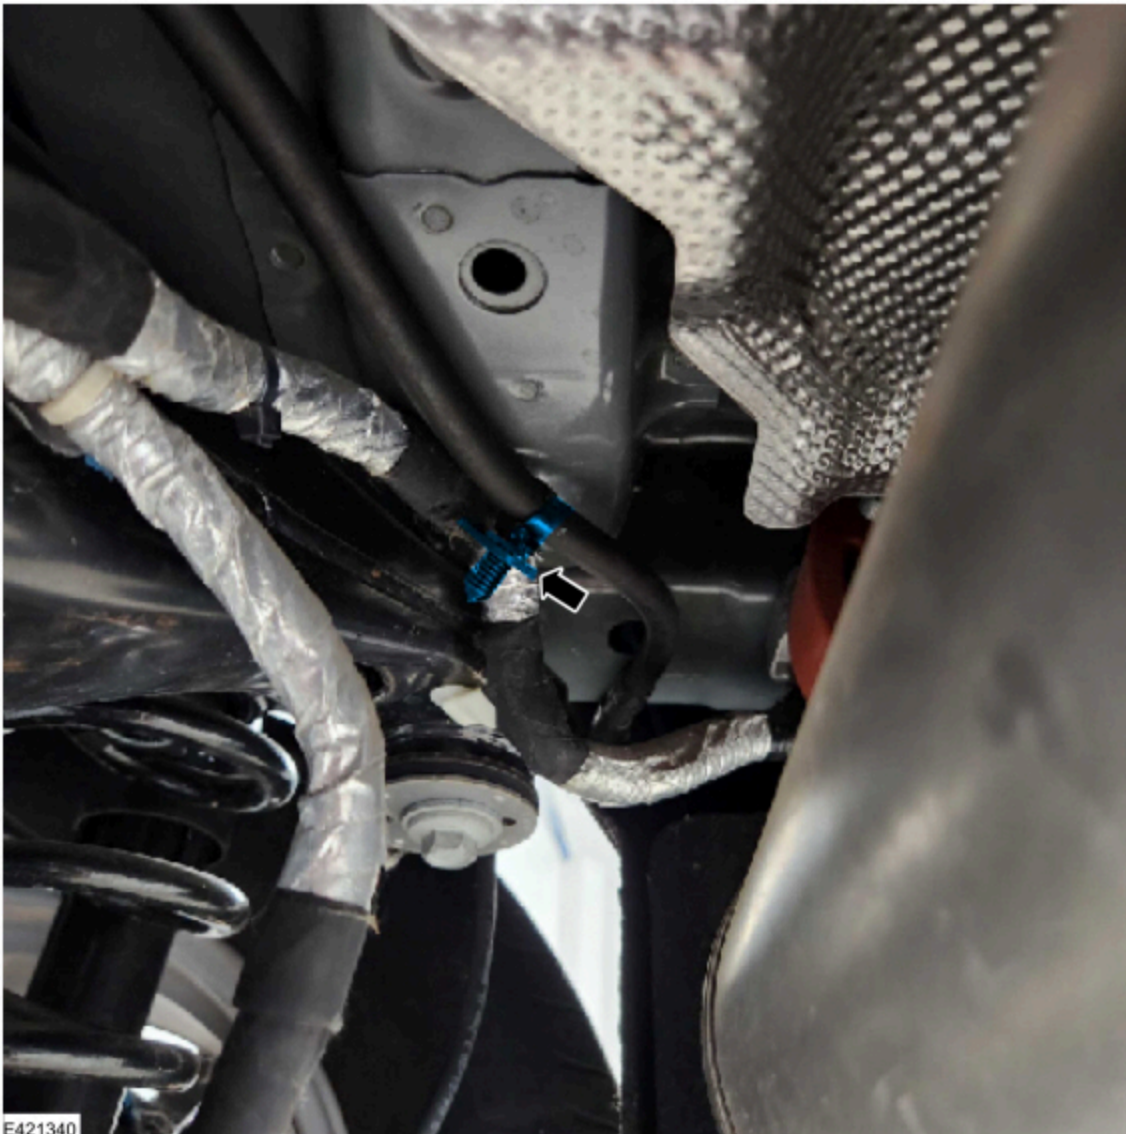
Figure 10

13. Detach the hose retainer and remove the RDU vent hose and ground cable assembly. (Figure 10)

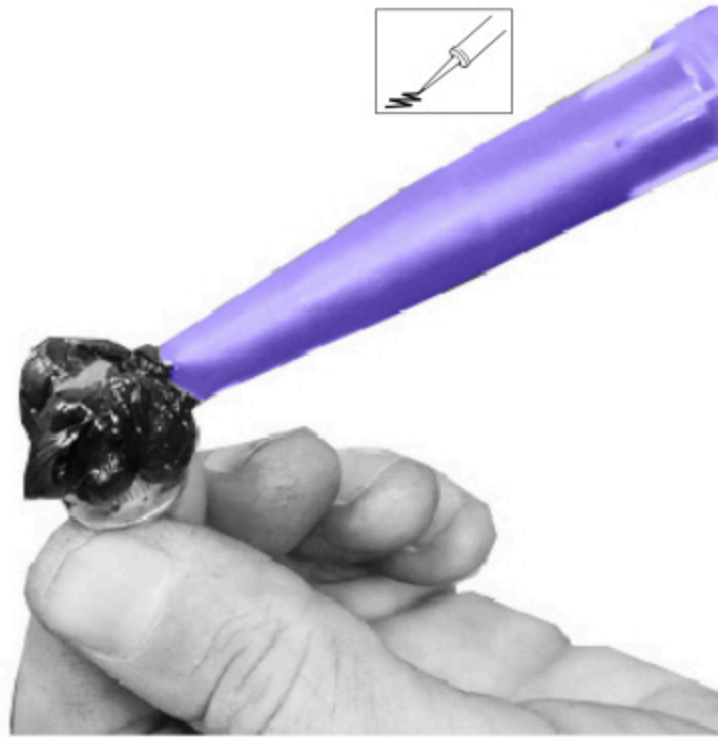
Figure 12

22. Apply a generous amount of Motorcraft® Seam Sealer to the body side of the stud rivet. (Figure 12)

CAUTION: Failure to properly seal the stud rivet could lead to water entry into the passenger area.
