Filon Roof Crack Repair

Bulletin Type:	SRP	Publication Date:	November 2025
Bulletin #(s):	25-017	Make(s):	Jayco & Entegra Coach
Job Code(s):	<i>If affected unit has warranty remaining, submit your claim following the normal process</i>	Model(s):	Cornerstone, Anthem, Aspire, Reatta XL, Reatta, Embark
Flat Rate(s):		Model Year(s):	2012-2026

FILON ROOF REPAIR INSTRUCTIONS

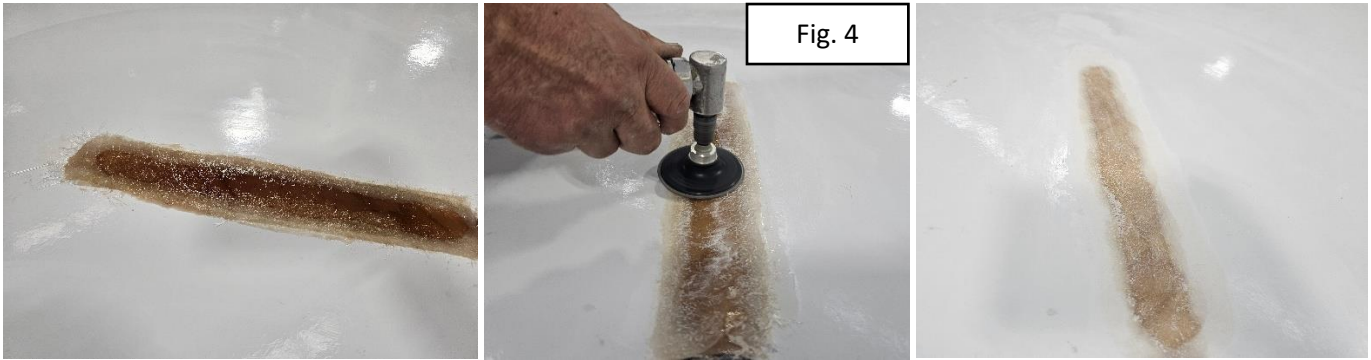
7. Once fully cured, sand the fiberglass mat, lightly, to be flush with the original filon. (Figure 4)

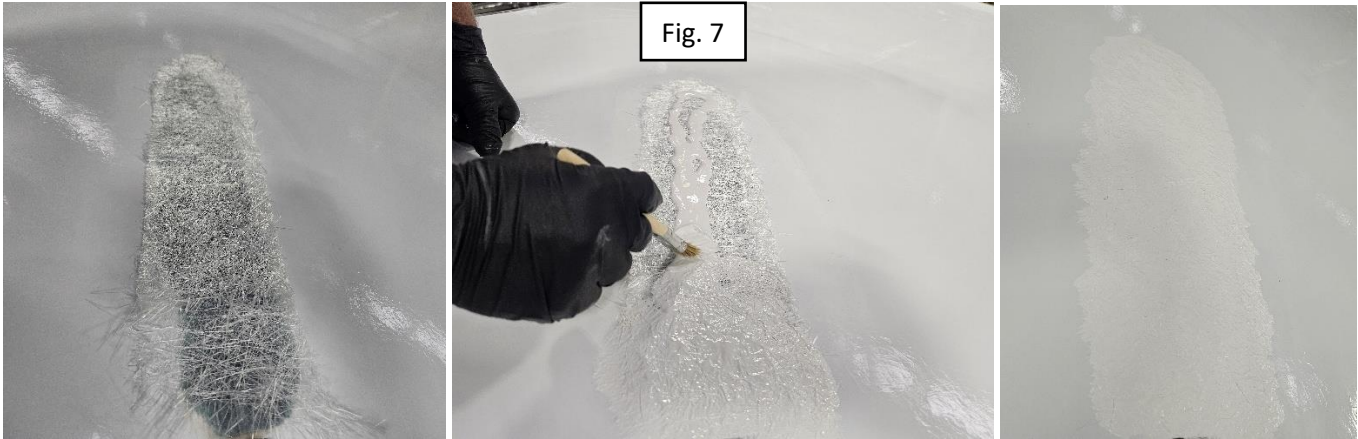
11. Use a rag or blower to remove and excess dust/debris from the area.
12. Apply a final layer of the fiber mat over the body filler. Cover the fiber mat and area with gelcoat, spreading it evenly across the entire surface. (Figure 7)
 - a. **Note: You will want to remove some of the fiber from the fiber mat to make the top layer thinner than the first two layers applied. This will help give a clean finished look that better matches the fiber in the rest of the existing roof.**
