# Technical Service Bulletin

GROUP <b>BODY ELECTRICAL</b>	NUMBER <b>25-BE-021H</b>
DATE <b>NOVEMBER 2025</b>	MODEL(S) <b>SEE BELOW</b>

**SUBJECT:** FUEL FILLER DOOR IMPROPERLY OPENING OR CLOSING

**Description:** Certain Tucson (NX4, NX4A) and Tucson Hybrid (NX4 HEV) vehicles may exhibit an improper fuel filler door opening or closing condition due to an inoperative fuel filler door release actuator. This bulletin provides instructions to replace the fuel filler door release actuator.

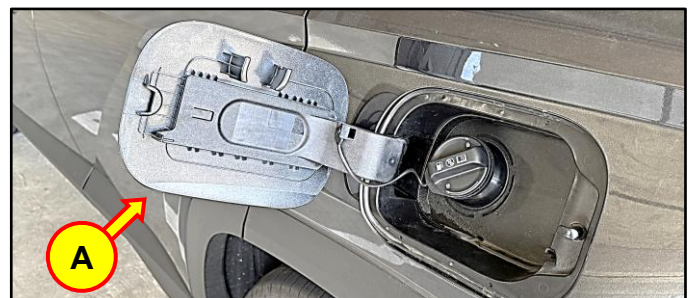
3. Wrap the mounting arm for the fuel filler door panel with a clean rag to prevent damage to the vehicle.

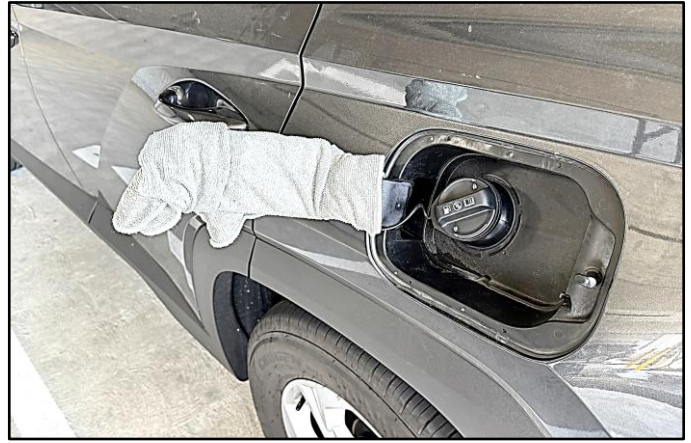
4. Spray a soap and water solution around the edge of the fuel filler door housing to aid in removal from the vehicle.

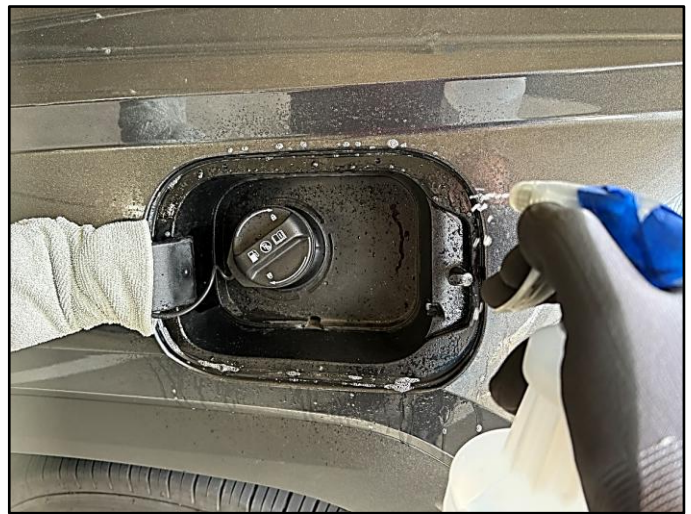
5. Remove the fuel cap.

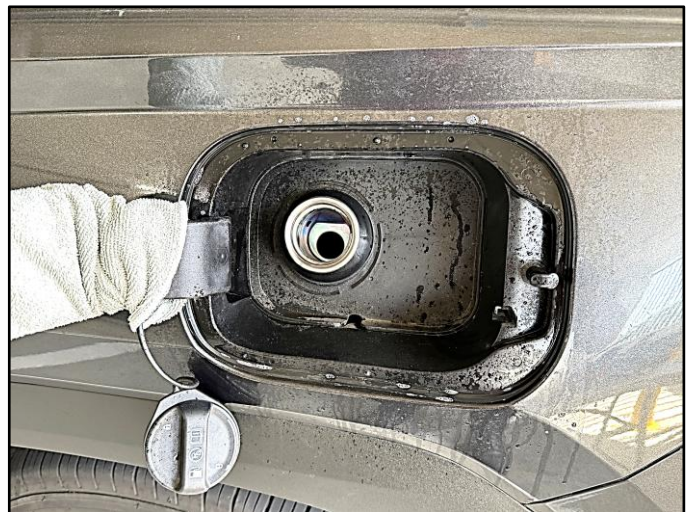
6. Insert a plastic trim tool under the gasket around the fuel filler door housing to begin removal.

Avoid tearing the gasket.

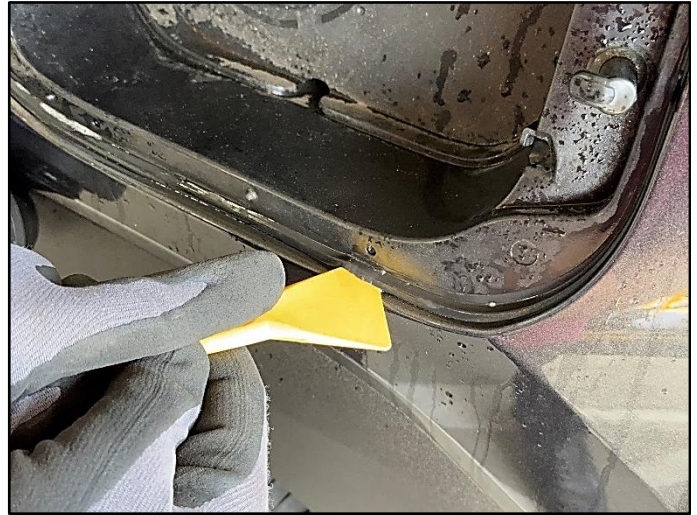
7. Use plastic trim tools to disengage the bottom clips (B).

4 clips – 2 on top & 2 on bottom of the fuel filler door housing.

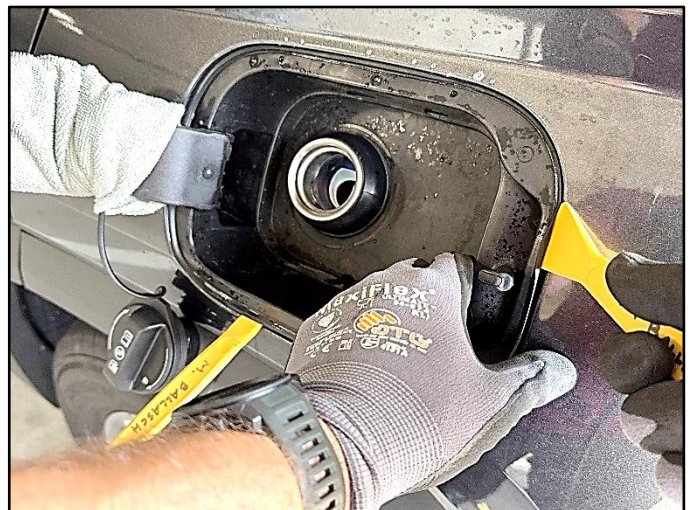
9. Disengage the top clips (C) with plastic trim tools.

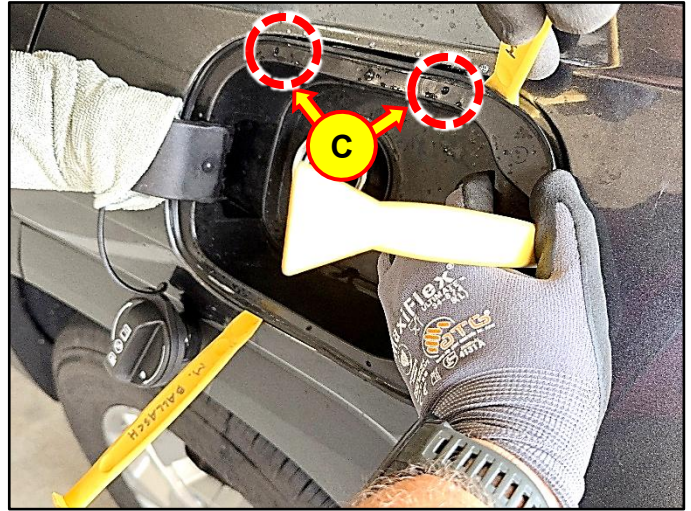
10. Gently pull out the fuel filler door housing and disconnect the connector (D) from the fuel filler door release actuator.

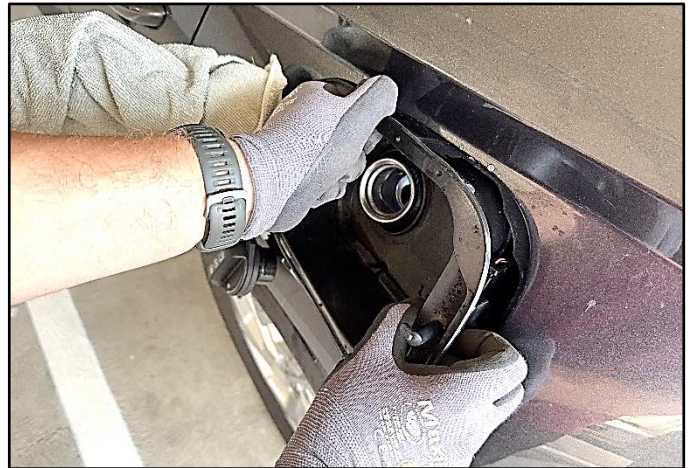
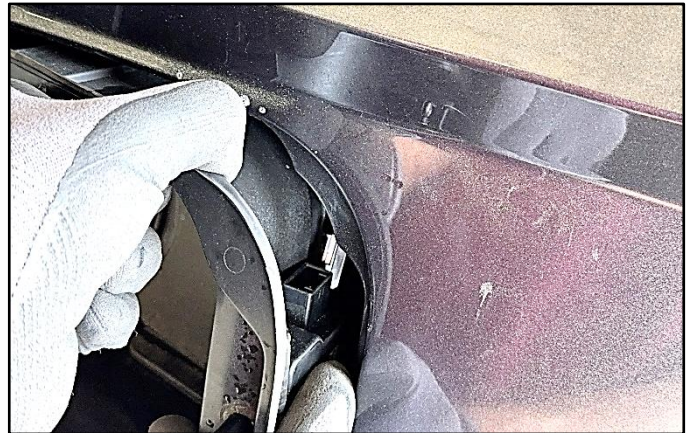
11. Use plastic trim tools to loosen the fuel filler door housing from the fuel filler neck assembly (E).

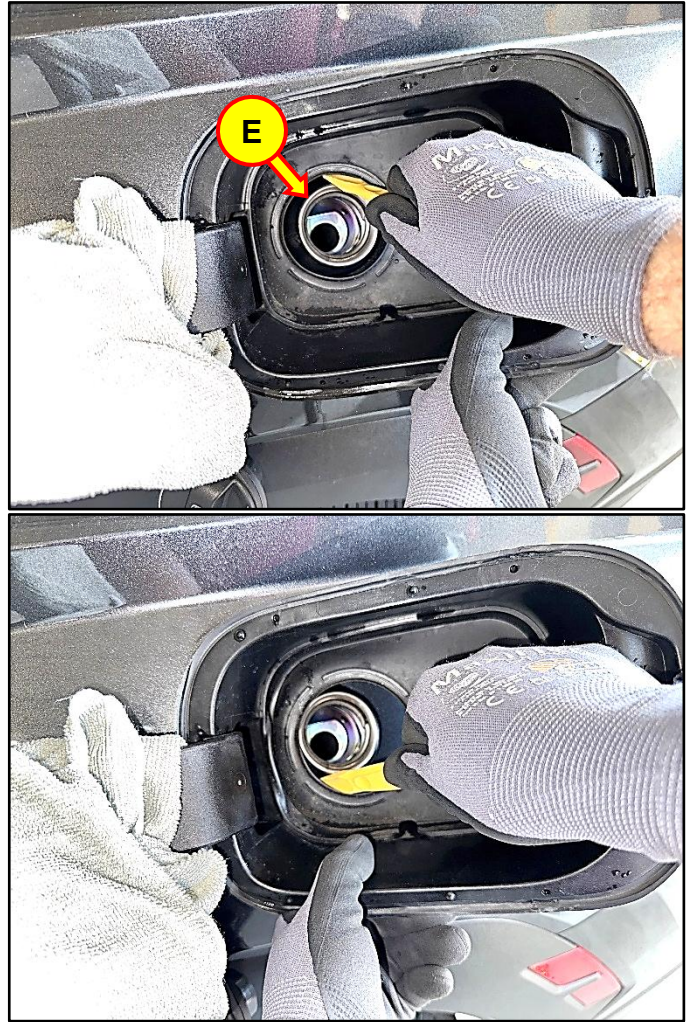
12. Remove the fuel filler door housing.

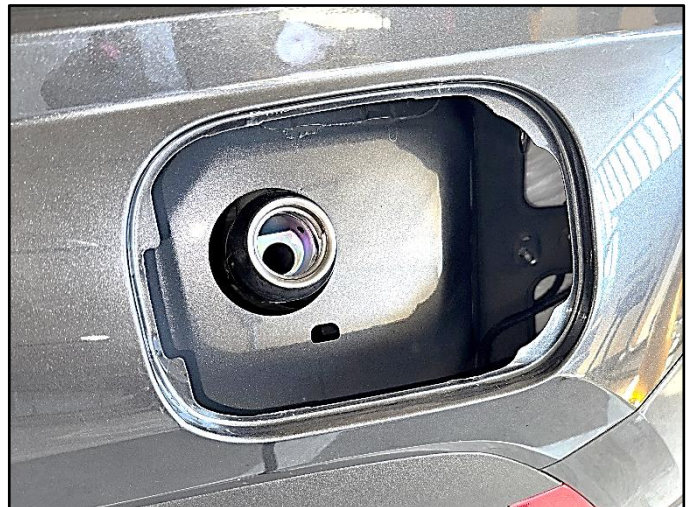
- Remove 3 screws then remove the fuel filler door release actuator (F).

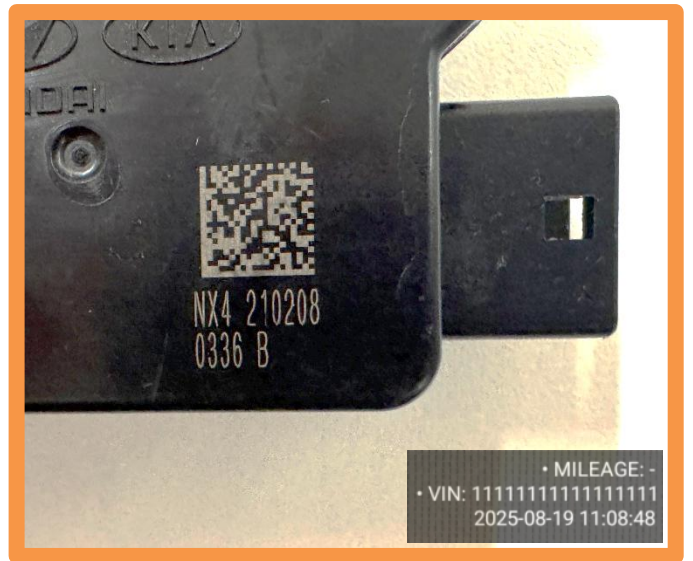
- Install the new fuel filler door release actuator onto the housing.

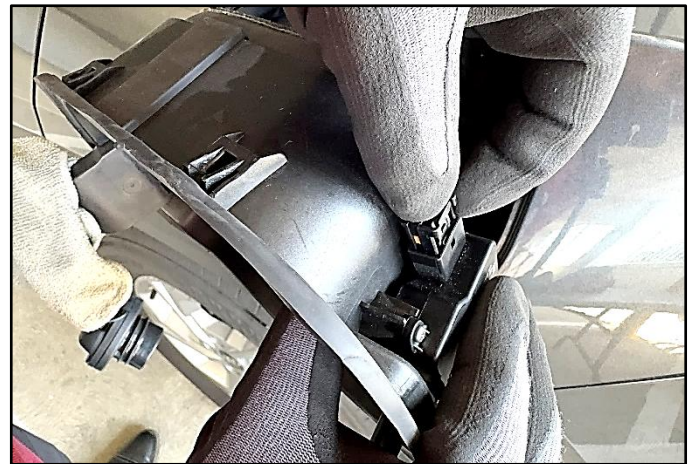
17. Reinstall all parts in reverse order of removal process.

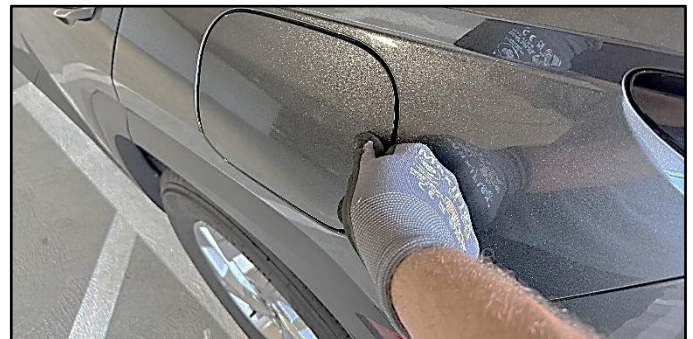
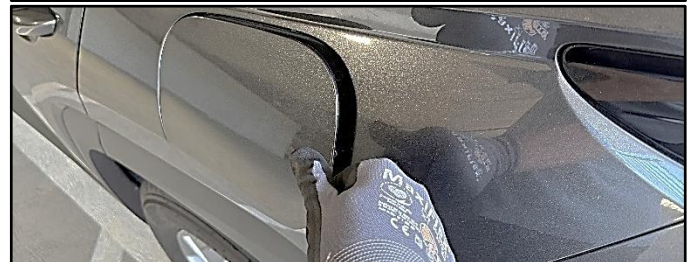
19. Verify the fuel door is working properly.
