SIM 54 01 25

PANORAMIC SUNROOF GLASS PANEL MOVES SLOWLY OR NOT AT ALL

2025-11-11

E-Series	Model Description	Affected Option Code
U25	MINI Countryman	402 Panoramic Moonroof

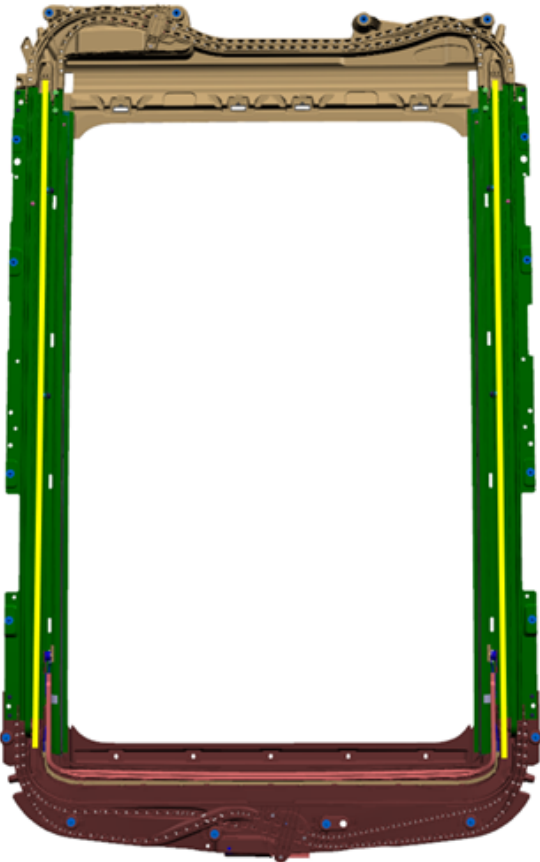
Contamination on the outer track(s) of the sunroof cassette. This can occur on either one or both side of the sunroof cassette.

Note: Yellow vertical lines are showing where the contamination occurs.

Clean and lubricate both (left and right side) outer channels on the sunroof cassette.

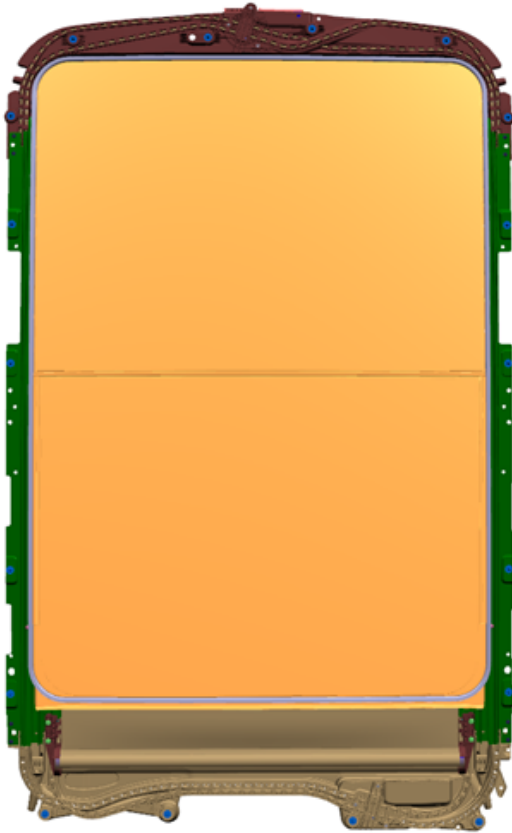
Note: The components highlighted in orange are showing the front and rear sunroof glass panels.

- Remove the front and rear sunroof glass panels following repair instructions listed in ISTA/AIR 54 13 250.

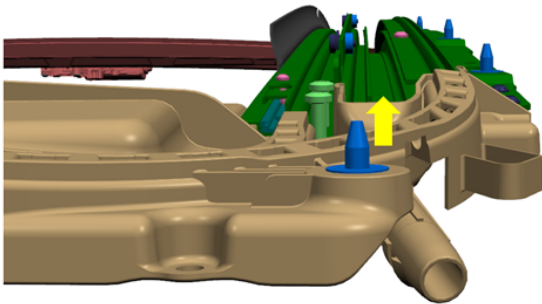
Note: The yellow arrow in the photo is showing the right rear outer channel of the sunroof cassette.

- Using a clean cloth, clean off the contamination on both rear outer channels of the sunroof cassette.

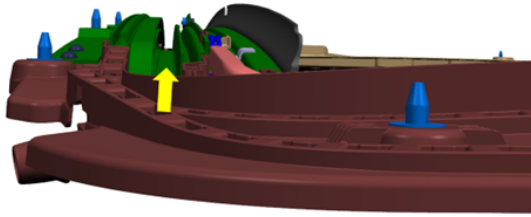
Note: The yellow arrow in the photo is showing the right front outer channel of the sunroof cassette.

- Using a clean cloth, clean off the contamination on both front outer channels of the sunroof cassette.

- Once both (left and right) front outer channels have been cleaned, lubricate the front outer channel using part number 83 19 2 460 509.
- Once the front outer channel is lubricated, close the sunroof using the switch in the FZD. Lubricate the rear outer channel using part number 83 19 2 460 509.
- After lubricating both front and rear outer channels, open and close the sunroof three times to distribute the grease across the outer channels.
- Reassemble the vehicle and verify the repair.
