## SERVICE BULLETIN

**APPLICABILITY:** 2020-25MY Outback & Legacy

**NUMBER:** 12-275-25

**SUBJECT:** Roof NVH / Diagnostic Procedure

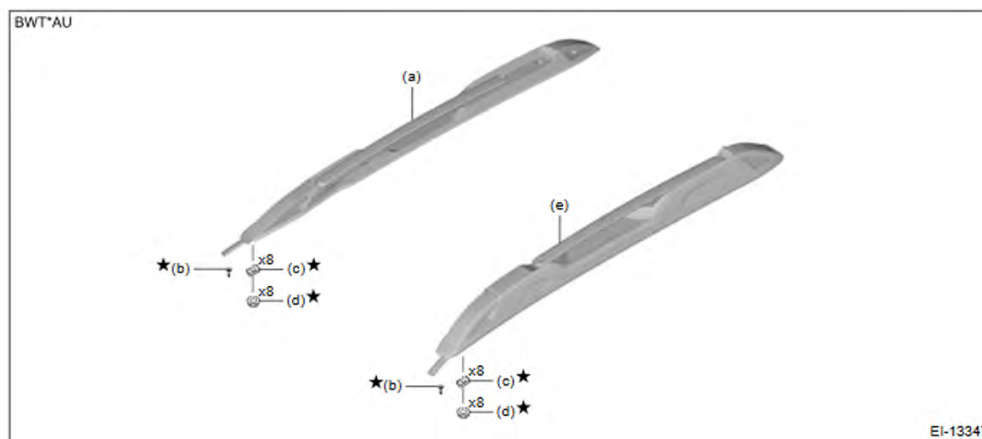
- (a) Roof rail ASSY RH
- (b) Rivet
- (c) Seal washer
- (d) Self-locking nut
- (e) Roof rail ASSY LH

**Note: The rivet is not needed for replacement, it is only used on the assembly line.**

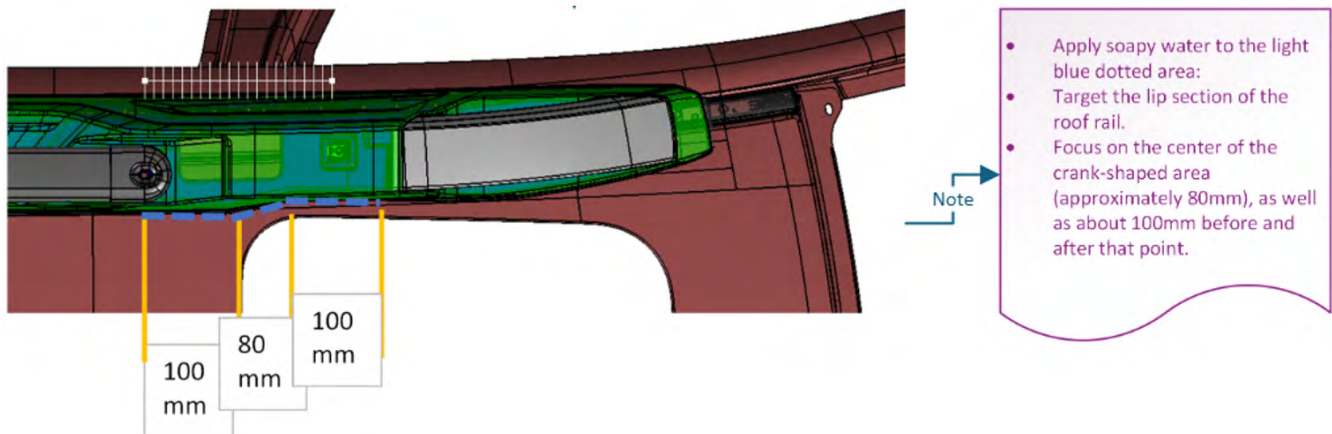
### Step 2: Apply soapy water mixture of 1:10 to the lip of both roof rail assemblies (as shown in the diagram below).

Gently shake the roof rail assemblies to work the soapy water into the gap between the lip and the roof.

- **Yes** – Perform the [Roof Rail Replacement/Repair Procedure](#).
- **No** – Go to Step 3.

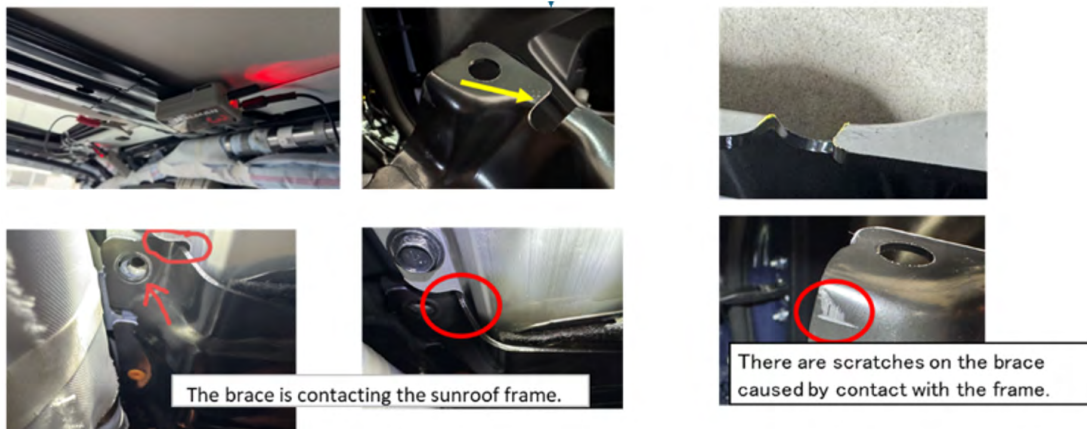
#### Step 4: Inspect the sunroof brace.

Check for any contact between the sunroof brace and surrounding components.

- **Yes** – Adjust the brace to eliminate contact.
- **No** – Go to **Step 5**.

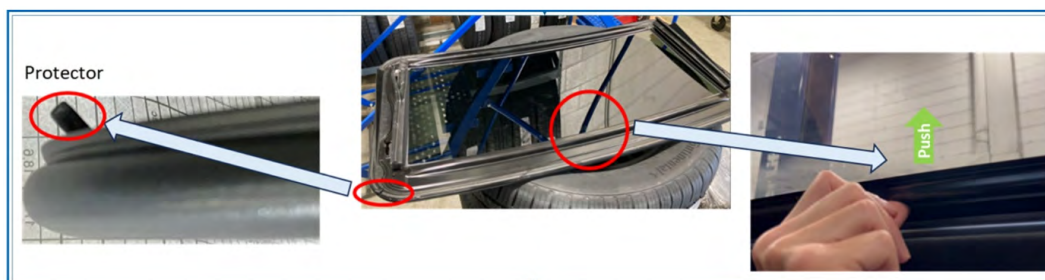
Apply pressure to the glass when the noise is heard.( see figure below)

- If this changes the noise, remove the glass and inspect the protector
- If the protector is protruding, check for contact marks between the body and the protector.
- If witness marks are present, apply tape and check if the noise changes.
- If the noise changes, replace the sunroof assembly.
- If the protector does not protrude inspect the sunroof lid area for contact marks on the body. Apply tape to contact areas and check if noise is still present.
- If the noise is still present, remove the sunroof assembly from the vehicle. Reinstall the glass into the sunroof assembly and check for noise by applying pressure to the glass with the assembly on the bench. If the noise is present, replace the sunroof assembly.

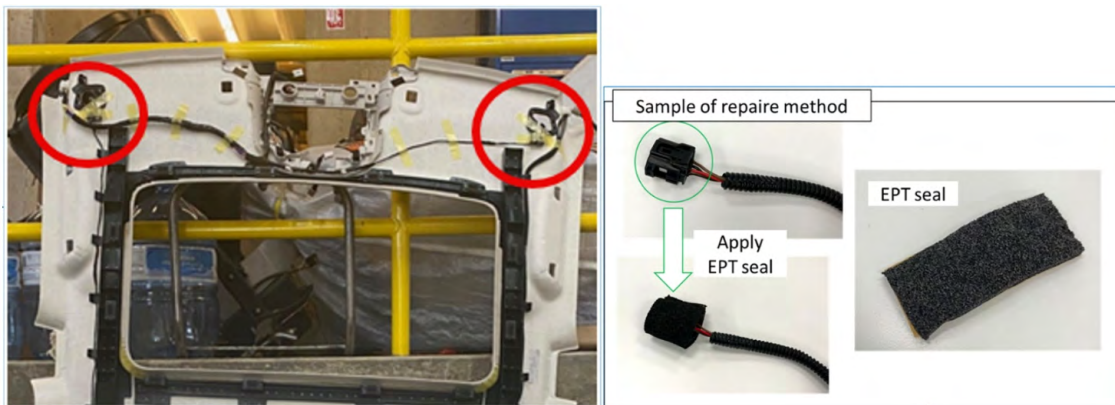
- Ensure all harnesses are firmly secured.
- Inspect electrical connectors if they contact the body apply EPT sealer (tape).

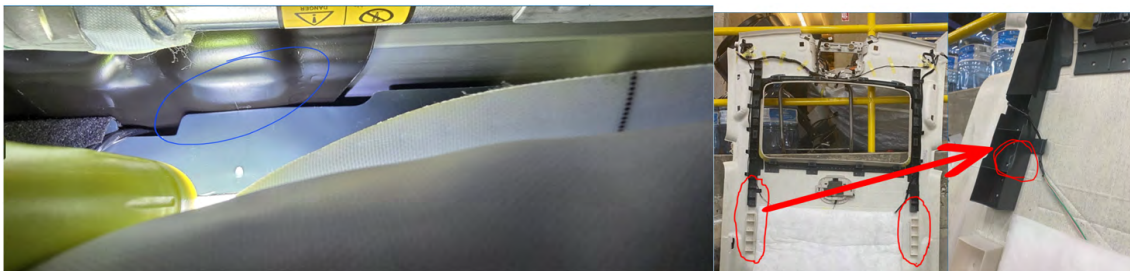
- Confirm no part of the headliner is contacting the body or sunroof assembly.

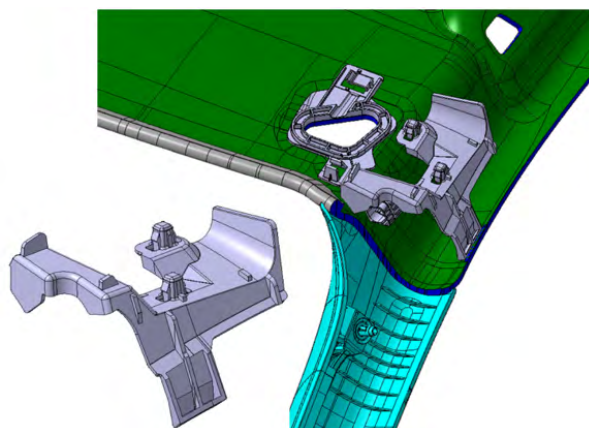
- Check that the A-pillar pads are tight and secure and if there are contact marks on the body.

- Apply EPT tape to any area with contact marks or potential interference from adjacent parts.

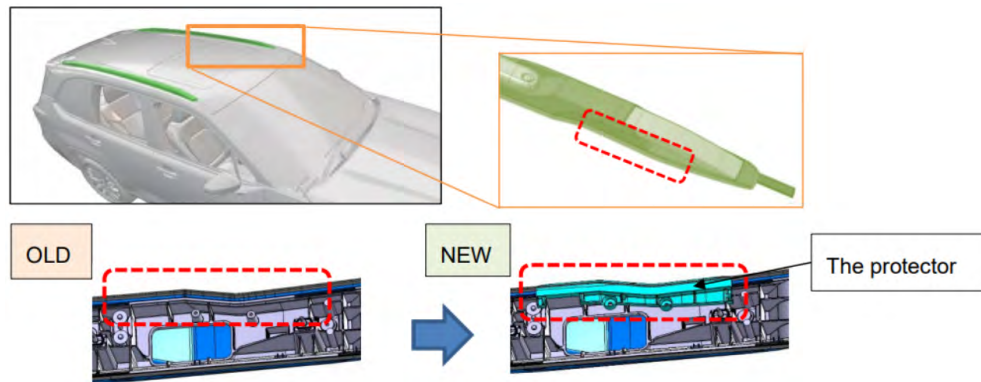
A new protectors can be added to certain roof rail assemblies. Check claims and repair history to determine if the roof rails have been replaced previously. If the part numbers installed on the vehicle are **91151AN03D**, **91151AN02D**, **91151AN01D**, or **91151AN00D**, the protectors can be added.

**Note:** If a new protector is added to the roof rail assembly, ensure that all old roof rail washers and adhesive have been removed before reinstallation.

If the vehicle is equipped with any other part number, or if you are unable to determine the installed part number, the entire roof rail assembly must be replaced. The service procedures for roof rails remain unchanged. Always refer to the applicable Service Manual and review the full requirements of the repair being performed. The Service Manual procedures contain information critical to performing an effective repair the first time, every time. This includes but is not limited to important SAFETY precautions, proper inspection criteria, necessary special tools, required processes and related one-time-use parts needed for a complete and lasting repair.

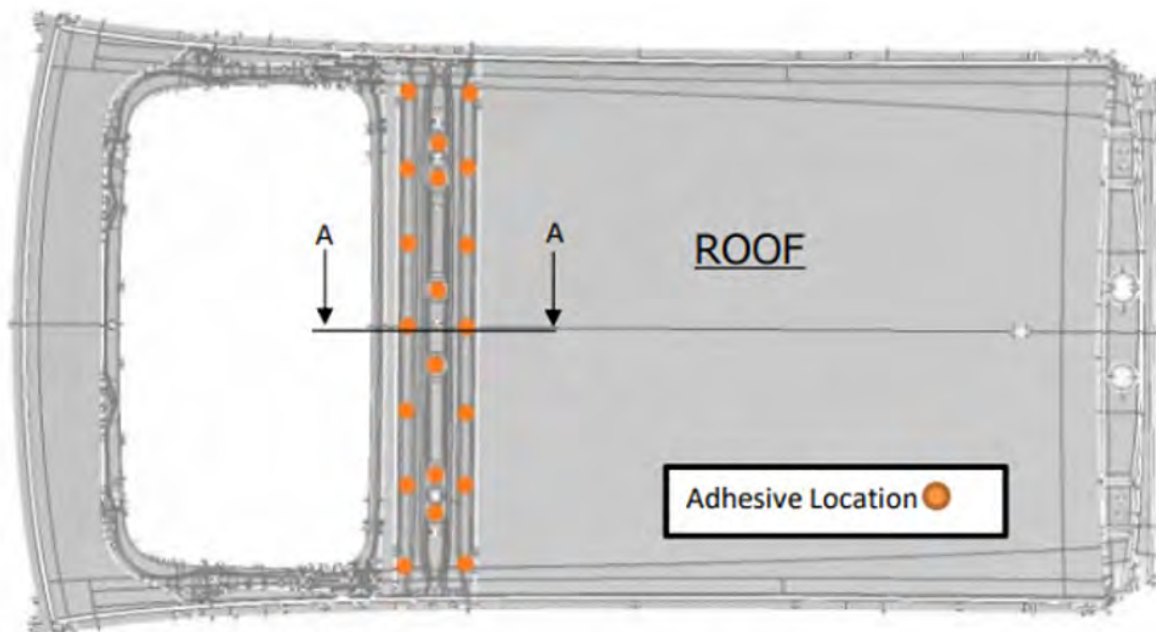
Examples of adhesive locations.

- Thoroughly clean all areas indicated in the photos where the repair adhesive will be applied with isopropyl alcohol (or isopropyl alcohol on a clean shop cloth).
- All application areas must be completely free of any foreign material (grease, dirt) which could prevent proper adhesion to either panel.
- Always allow the alcohol to dry completely before proceeding with application of the adhesive.
- Using the fine point tip of the applicator nozzle, CAREFULLY apply the adhesive between the brace and roof panel as indicated in the cross-section.
- Use a clean shop cloth to wipe away any excess adhesive protruding from the edges of the brace. Adhesive should not protrude from the edges of the brace.
- Perform the same operation on all repair sites.
- After the adhesive is fully cured, complete the repair.
- Follow the specific 3M product instructions for the applicable cure times.

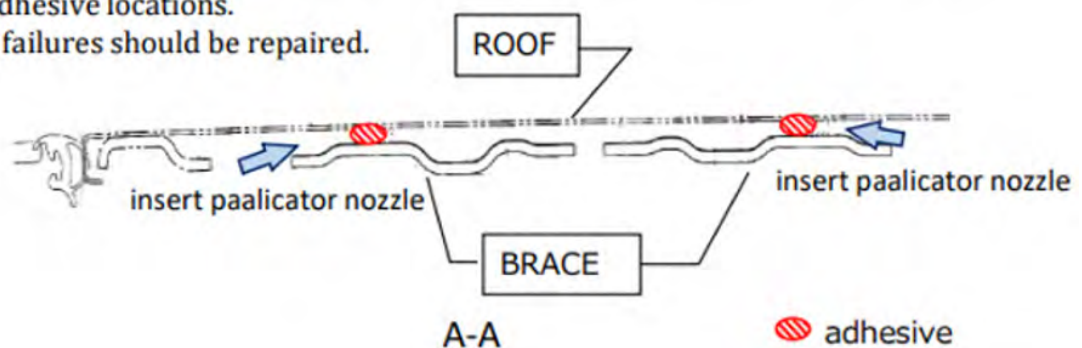
All areas with failures should be repaired.
