**Propulsion Warning with IEM P0CBC62**

| REF NO:<br><b>TJ 37523.1.0</b> | ISSUING DEPARTMENT:<br><b>Technical Service</b> | CAR MARKET:<br><b>United States and Canada</b> | |
| FUNC GROUP:<br><b>3233</b> | FUNC DESC:<br><b>Electric converter, high voltage</b> | Page 1 of 6 | |

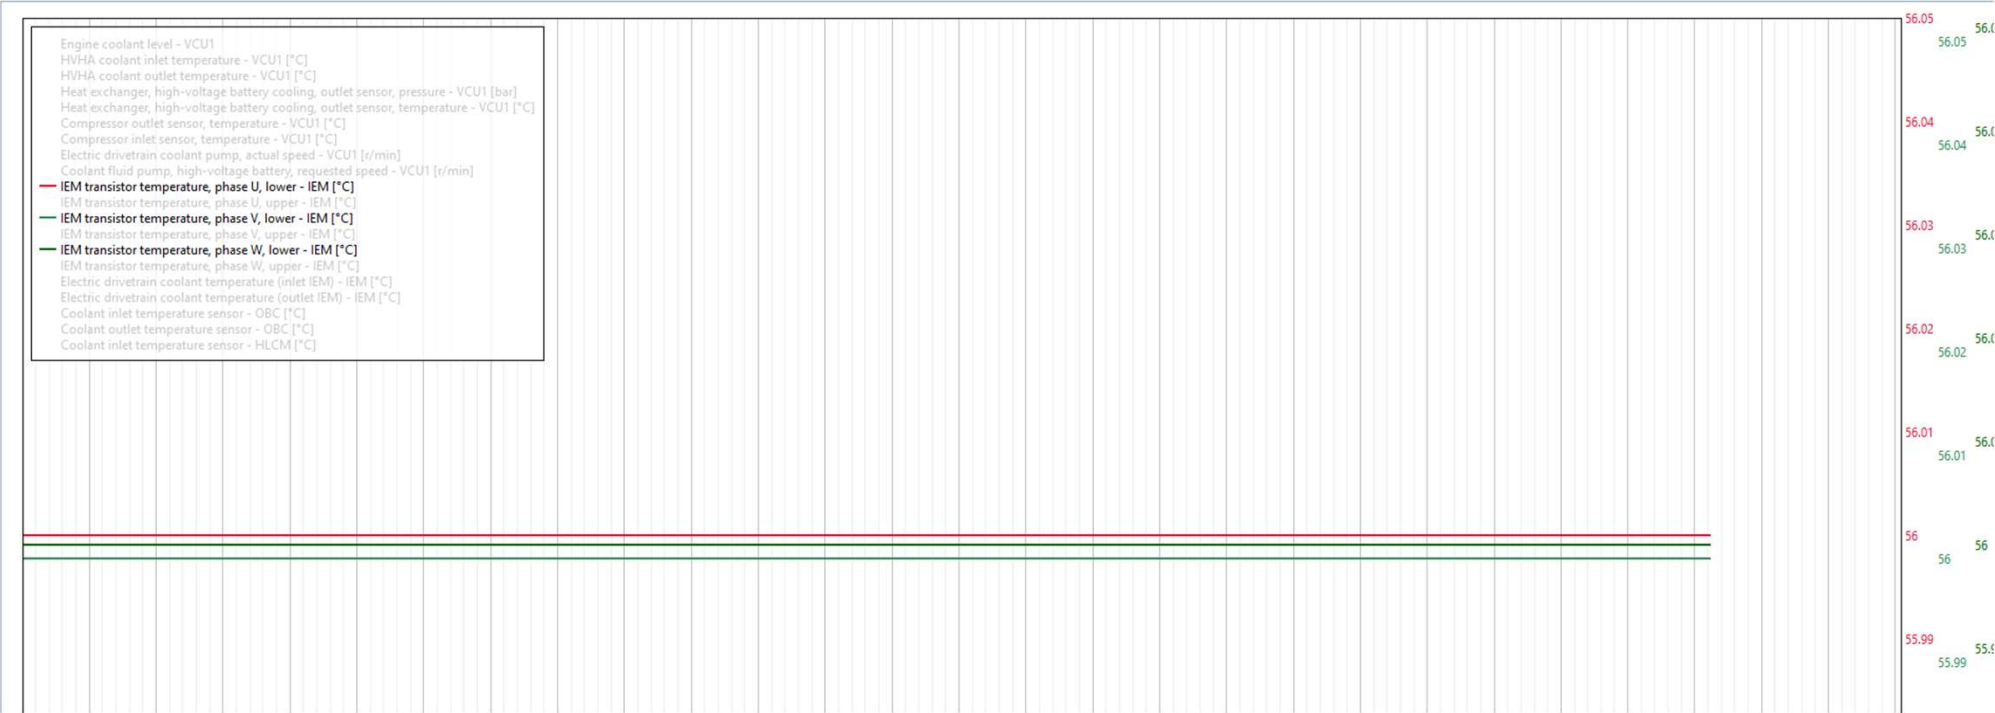
- Page 1: A diagram of a fault-free car during normal driving.
- Page 2: A fault-free car during aggressive driving—still only slight increases and temperatures remain below 65°C.
- Page 3: A car where the coolant one-way valve is faulty. Notice the large temperature fluctuations that frequently occur while driving. Once the temperature reaches 80–100°C (176–212°F), the IEM will set a DTC for temperature and switch to freewheeling mode.
  - If a car has a single motor, the vehicle will come to a stop.
  - In a car has dual motors, only half of the power will be available.

To determine if this coolant valve is faulty, the IEM transistor temperature parameters for phases U, V, and W can be monitored and plotted with VIDA.

**Tip:** During driving, the transistor temperatures for the three phases should be similar. However, the temperatures in the transistors can differ when the vehicle is at a standstill.

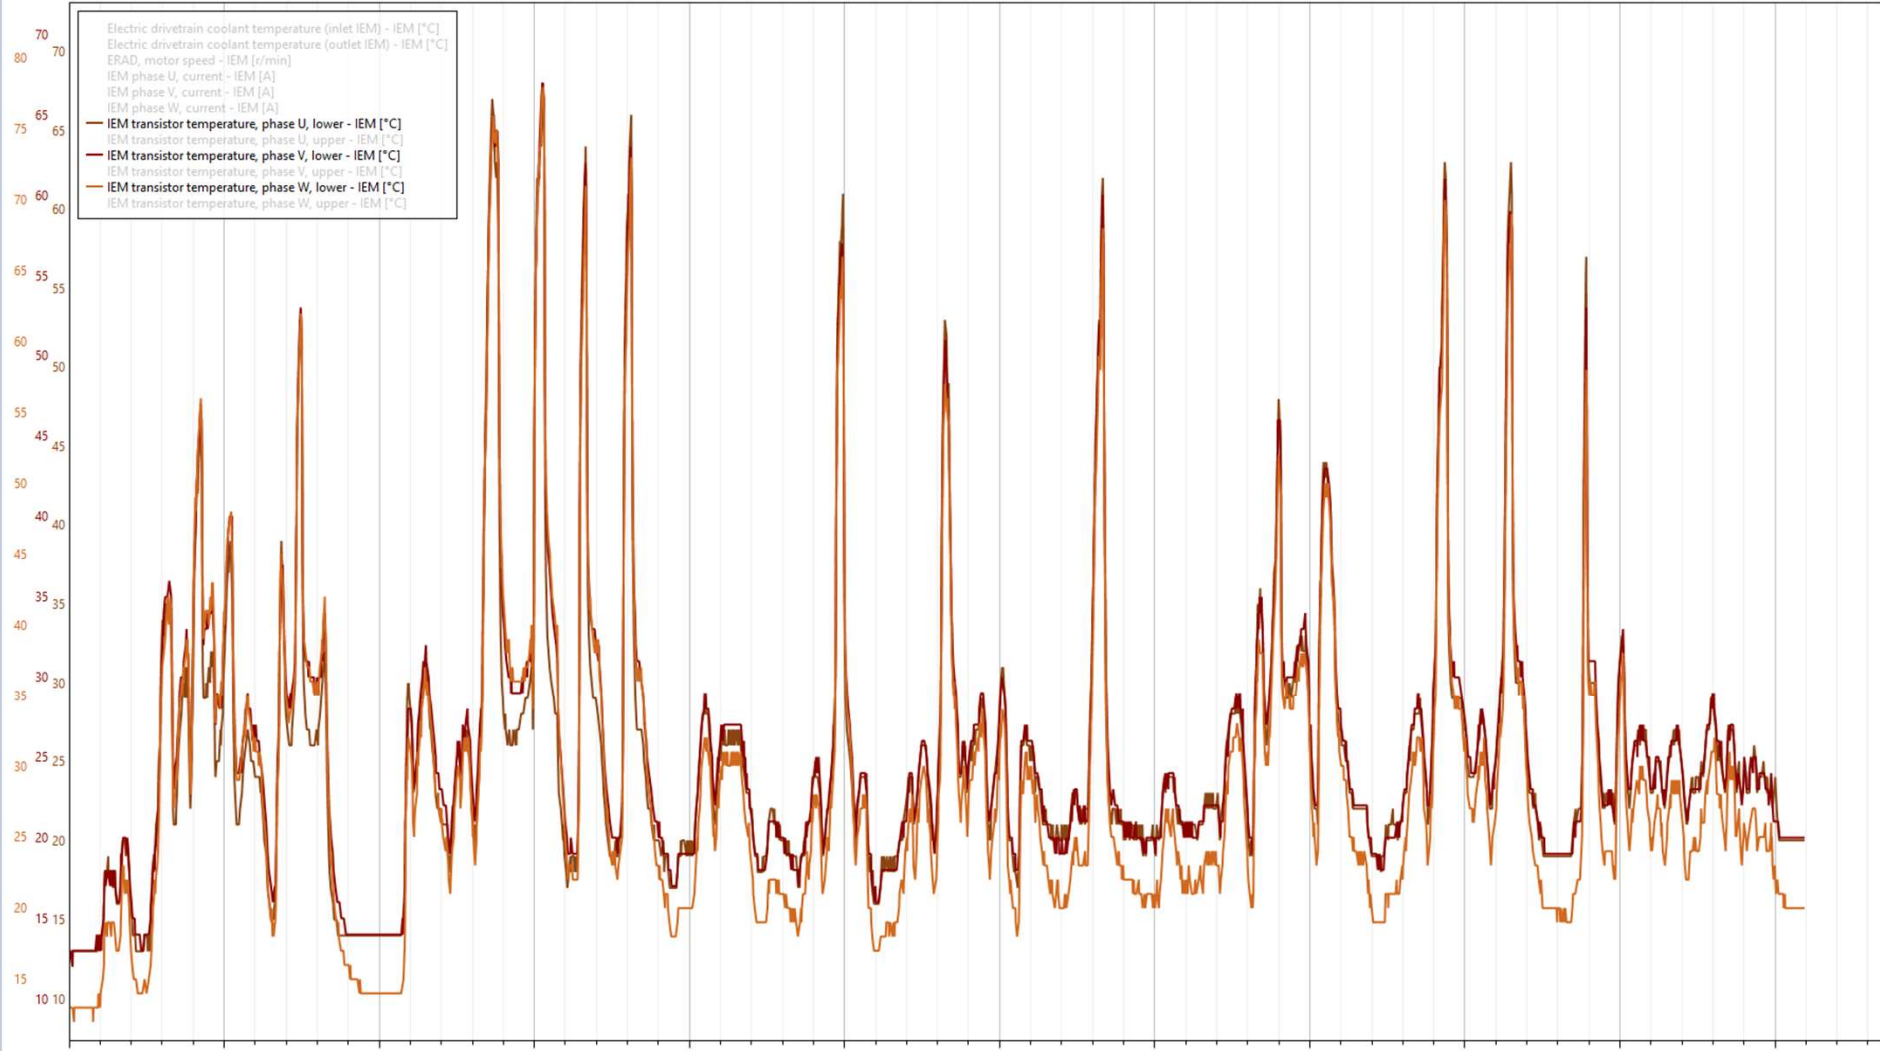
TJ 37523

There have been cases where the IEM has been replaced incorrectly for this DTC, and instead, a faulty one-way valve in the coolant system was the root cause.

If the vehicle behaves as shown on page 3, replace the hose with the one-way valve to avoid unnecessary replacement of the IEM.
