Service Bulletin

Bulletin No.: 00-06-01-026R

- Subject:** Engine Replacement After Severe Internal Engine Damage – Replace Intake Manifold
- Models:** 2025 and Prior GM Passenger Cars and Trucks (including Medium Duty) Equipped with Gasoline, CNG or LPG Engine
- Attention:** This bulletin also applies to any of the above models that may be Export from North America vehicles.

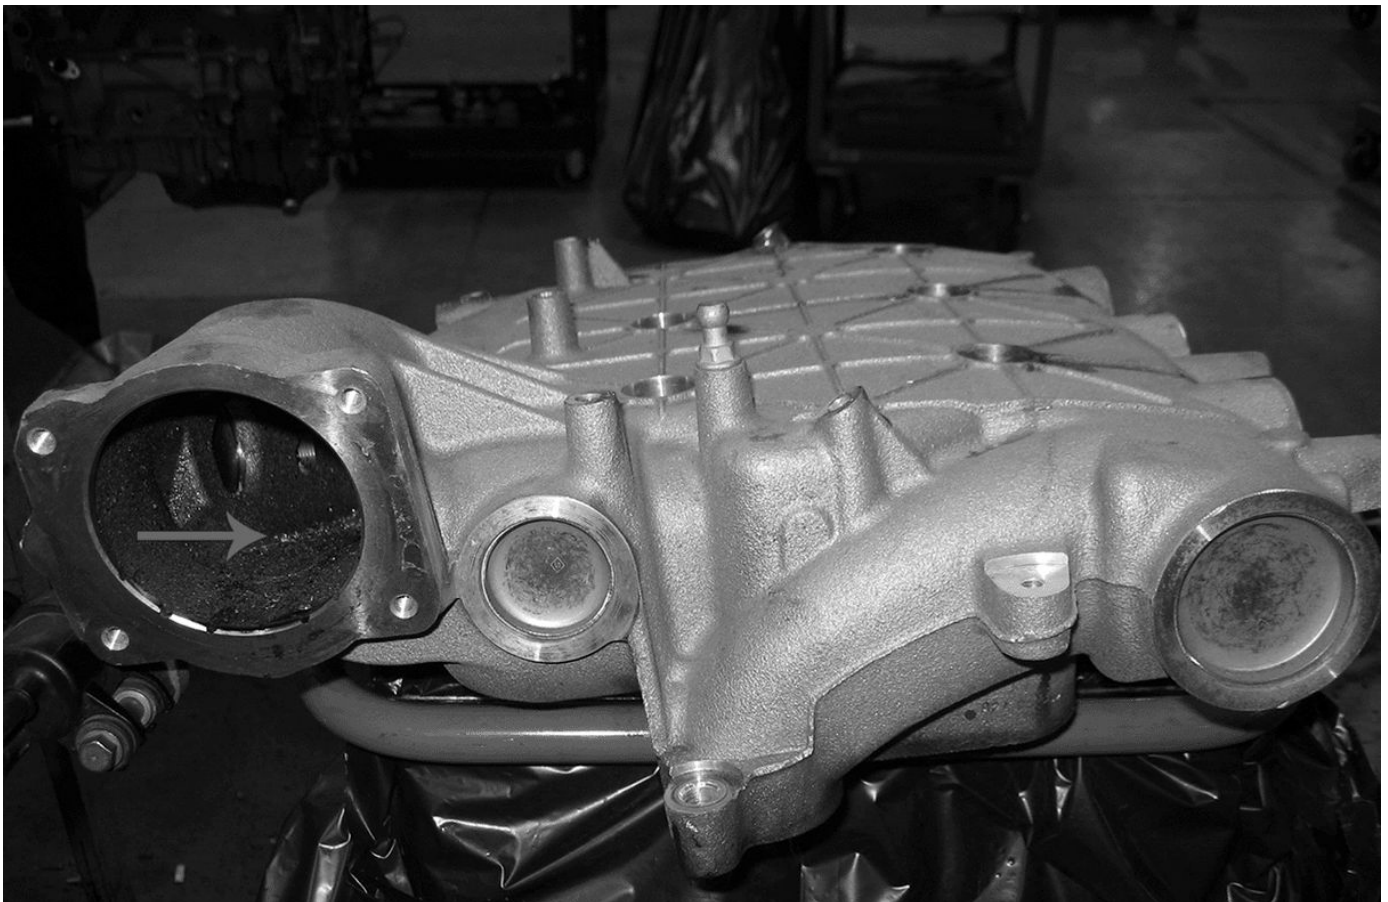
Typical Intake Manifold Debris Views After Internal Engine Damage View of Debris in Aluminum Intake Manifold – Throttle Body Opening

- After removing the intake manifold from the engine, the technician **MUST** carefully inspect all of the cylinder head intake ports to see if the valve heads are still present and not bent. Usually when the valve heads are missing or sufficiently bent, internal engine component debris will be present to varying degrees in the intake port of the cylinder head. If this debris is present in **ANY** of the cylinder head intake ports, the intake manifold should be replaced.

- This replacement is required due to the complex inlet runner and plenum configuration of most of the intake manifolds, making thorough and complete component cleaning difficult and nearly impossible to verify the complete removal of debris. Reinstallation of an intake manifold removed from an engine with deposits of internal engine component debris may result in the ingestion of any remaining debris into the new Genuine GM Part service engine. This will cause damage or potential failure of the new Genuine GM Part service engine long block.

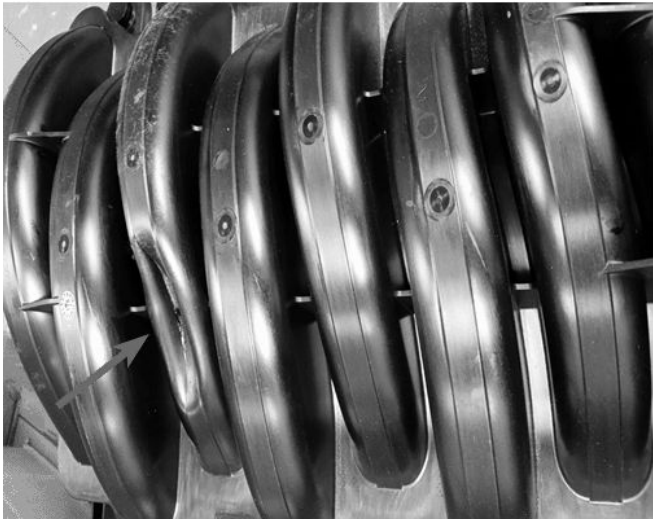
4565440

View of Intake from GEN 5 V8 that Experienced Lifter Collapse and/or Broken Valve Spring

- ⇒ If **ANY** of the above were to occur, the intake manifold **MUST** be replaced and the catalytic converters must be inspected or subsequent severe engine damage will occur. This replacement is required due to the complex inlet runner and plenum configuration of most of the intake manifolds, making thorough and complete component cleaning difficult and impossible to verify the complete removal of all debris.
