Preview Solution CBR-2528-1

## Mack Chassis - PR (4) - Pioneer Bug Screen Hitting Bumper

Published 13 November 2025

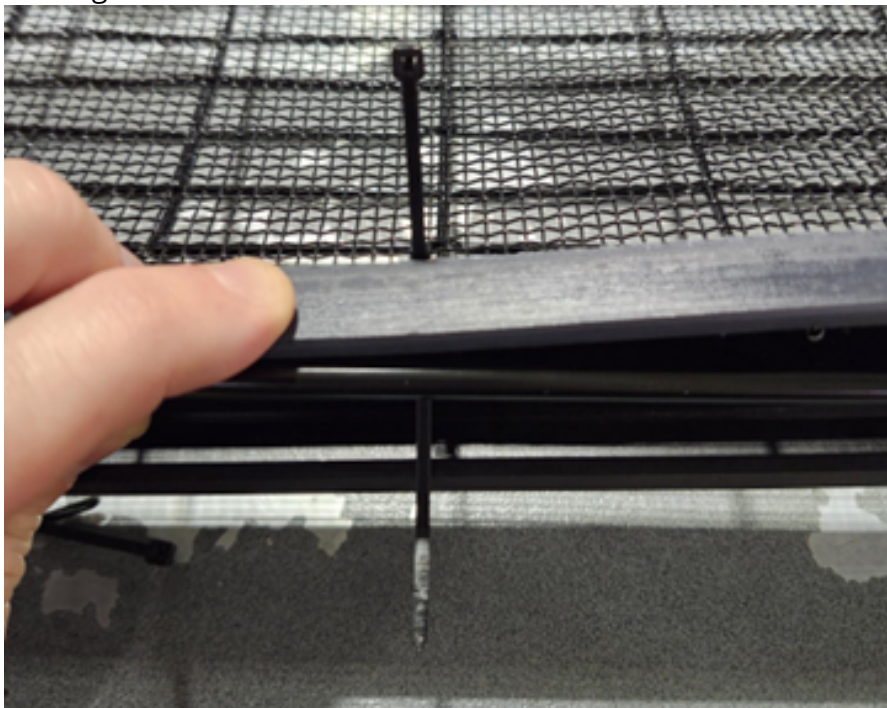
The purpose of this CBR is to address reports of the bug screen behind the grill hitting the bumper.

1. Open hood to access the bottom of the grill.
2. Use cable tie listed in parts needed to secure the bottom of bug shield to bottom of the grill

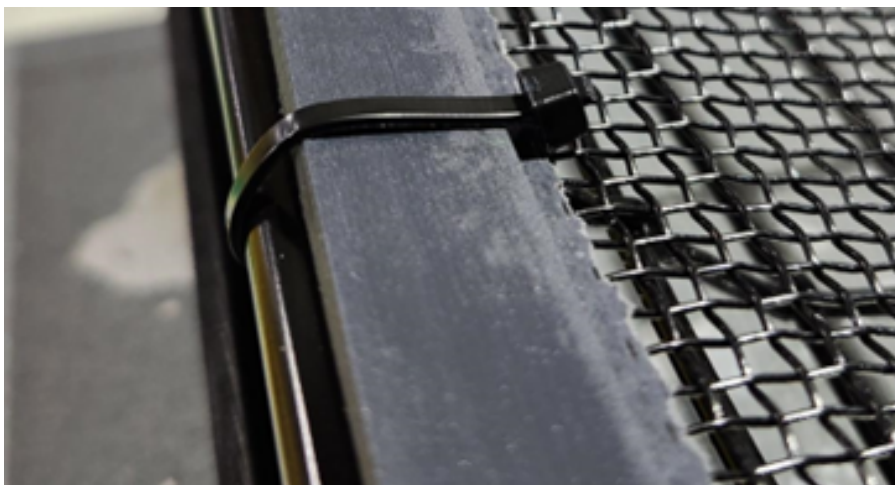
3. Secure in a fashion so that the cable tie head does not hit the bumper.

4. Check for if the bug shield is still hitting the bumper, if so please use IMPACT operation 8611-05-02-01 Front Bumper, Adjustment.
