## EMISSIONS RECALL

ID No. AB5R0\*  
Release Date 11-11-2025

### AB5R0\* EMISSIONS RECALL

All 2018-2021 model year Hino Conventional trucks.

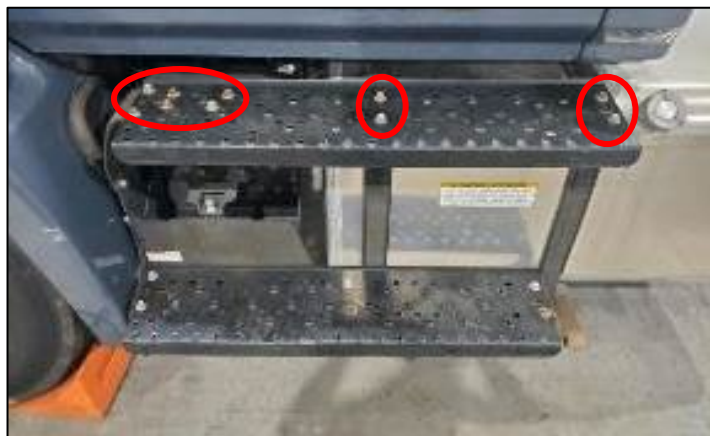
1. Remove and retain the ten bolts securing the driver side upper step.  
Remove and retain the upper step.

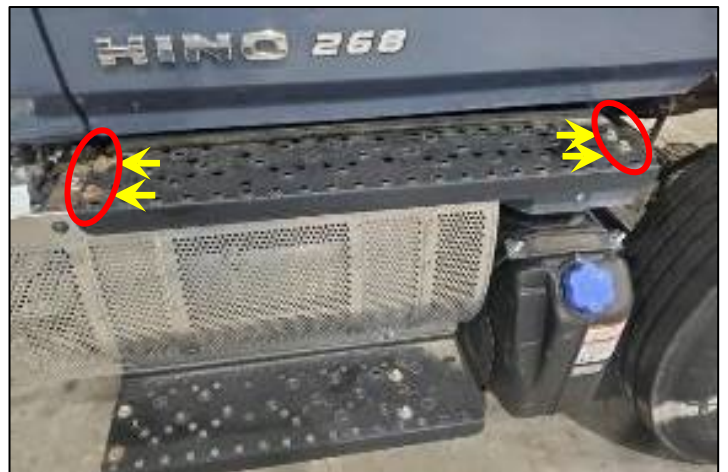
6. Remove and retain the four bolts securing the passenger side upper step. Remove and retain the step.

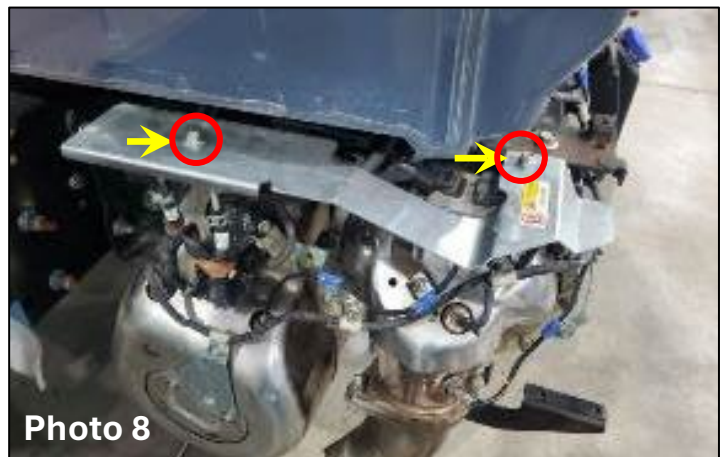
8. Remove and retain the two bolts and the nut securing the splash shield. Remove and retain the splash shield.

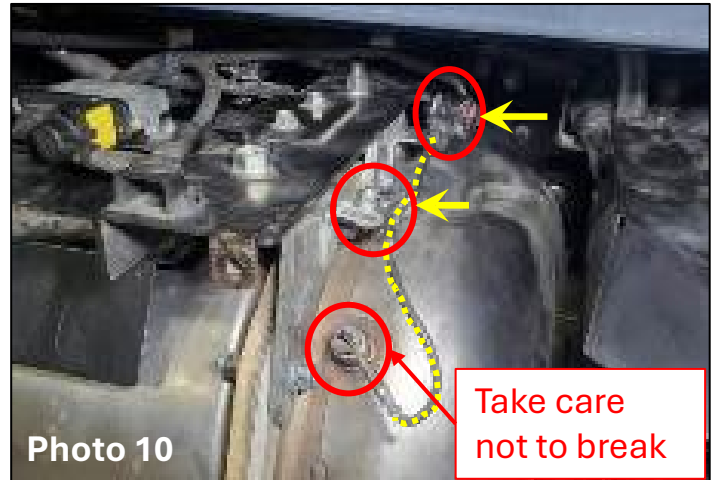
View photo 10

**10.** Disconnect the SCR inlet temperature sensor wiring harness connector. Remove and retain the nut securing the P-clip. Remove and retain the temperature sensor.

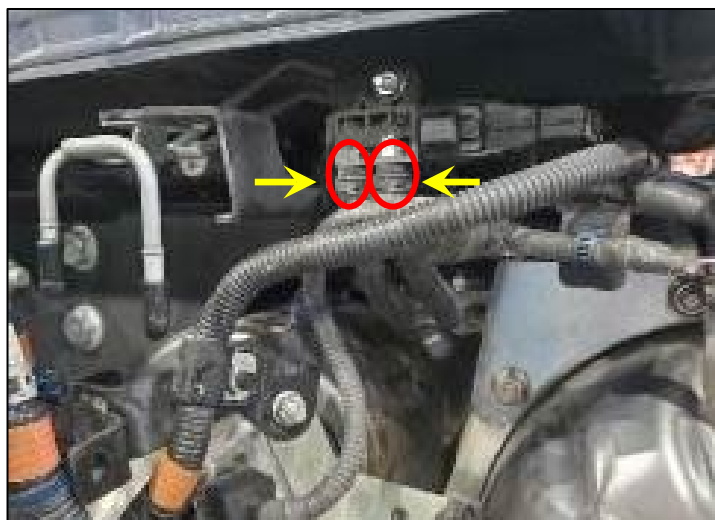
Photo 15

**15.** Release the two clamps and disconnect the differential pressure sensor hoses.

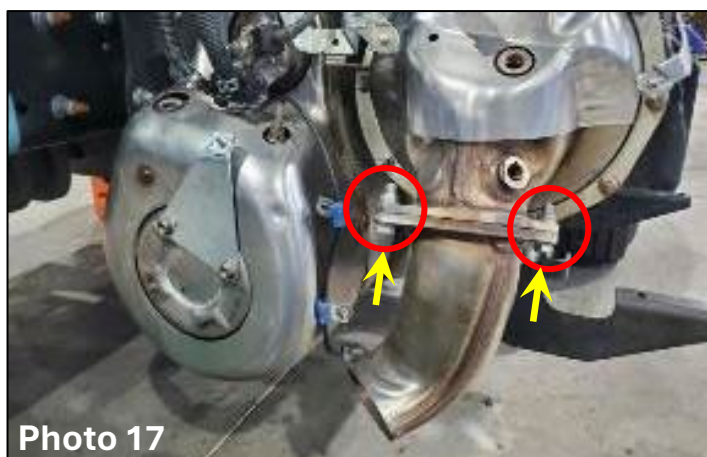
**17.** Remove and discard the two bolts and nuts securing the tail pipe. Remove and retain the tail pipe and discard the gasket.

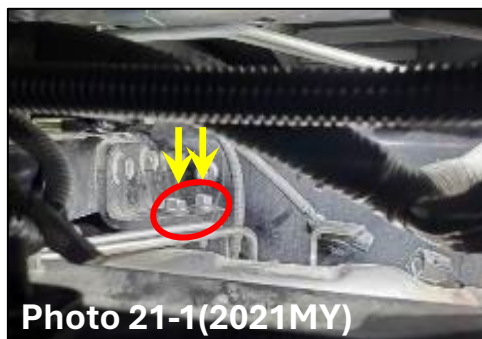
**21.** Remove and retain the two bolts securing the DPF to the frame bracket.

**NOTICE:** Location varies by model year. 2021 MY location is photo21-1, 2018 to 2020 MY location is photo21-2 near the DEF injector.

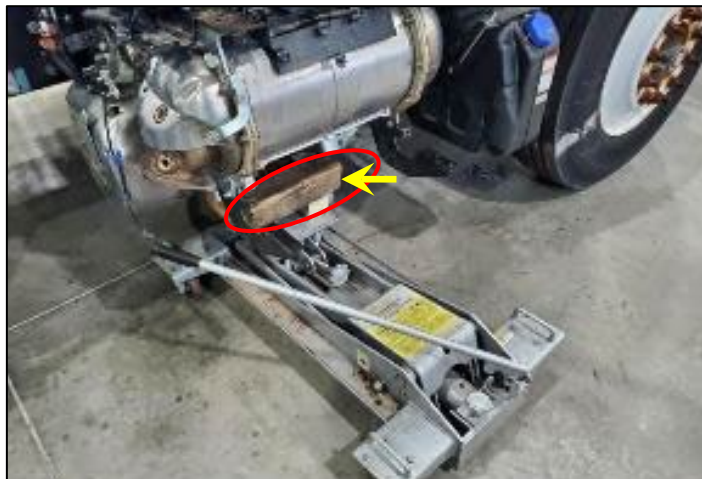
**22.** Place a jack under the DPF / SCR assembly. Support the assembly with a block of wood and secure to the jack.

**WARNING:** Ensure the DPF / SCR assembly is stable on the jack.

**NOTICE:** Do not support the assembly by the lower step mounts.

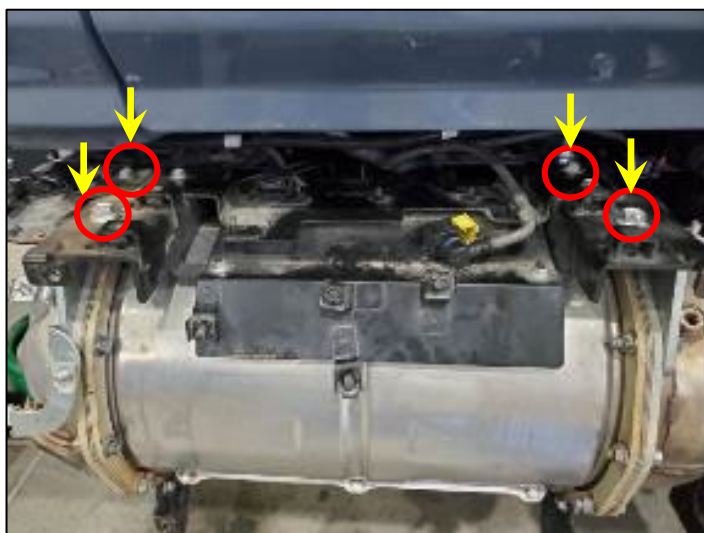
**23.** Remove the two bolts and the two nuts securing the DPF / SCR assembly to the frame brackets. Carefully lower and remove the assembly from the vehicle.

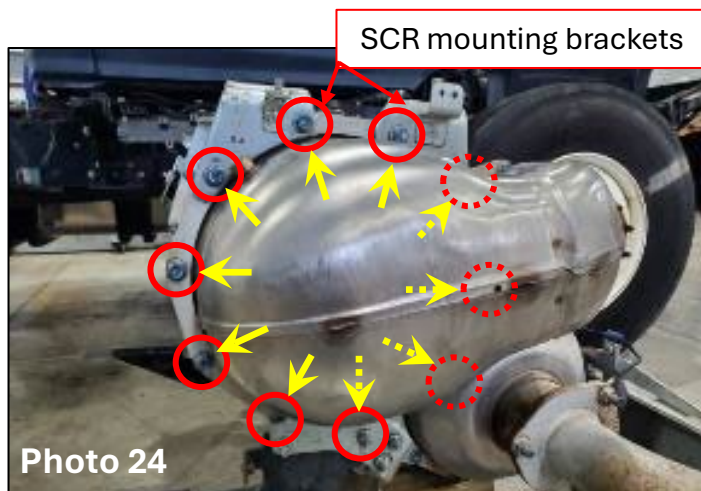
**24.** Remove and discard the ten bolts and nuts securing the SCR mixing chamber to the SCR. Remove and discard the SCR mounting brackets.

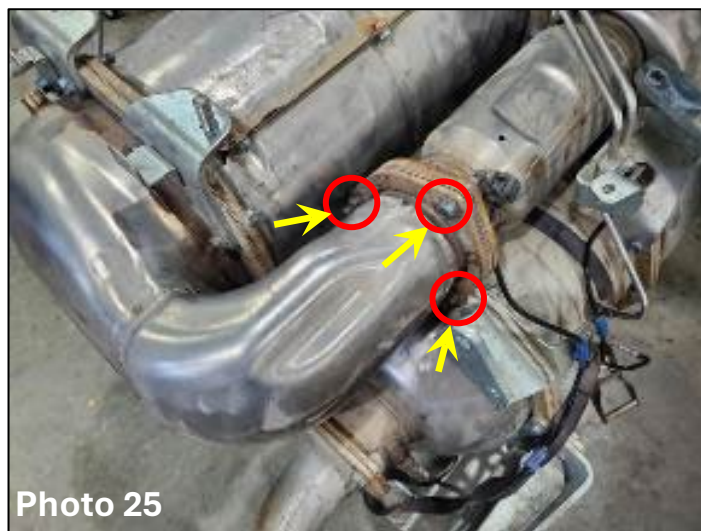
**25.** Remove and discard the three bolts and nuts securing the SCR mixing chamber to the pipe.

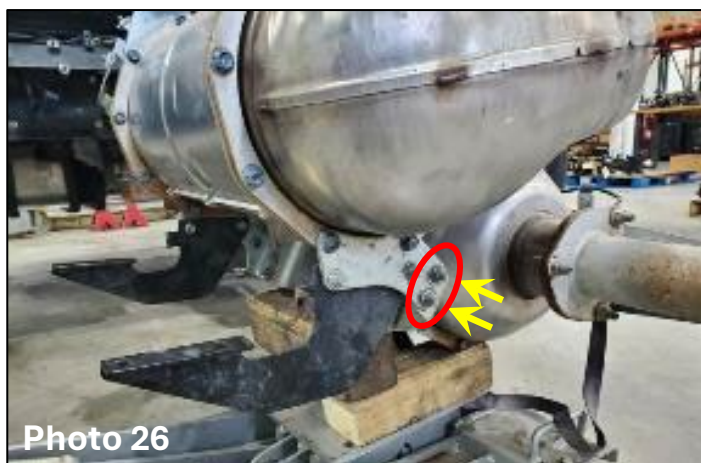
**26.** Loosen but do not remove the two bolts and nuts securing the SCR support bracket to the DOC. Remove and discard the SCR mixing chamber and the two gaskets.

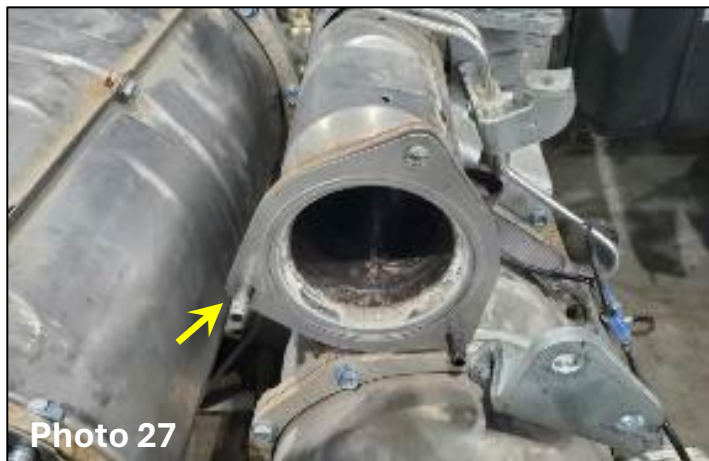
**27.** Install the supplied bolt retainer plate (17537E0850) and the exhaust pipe gasket(17451E0060).

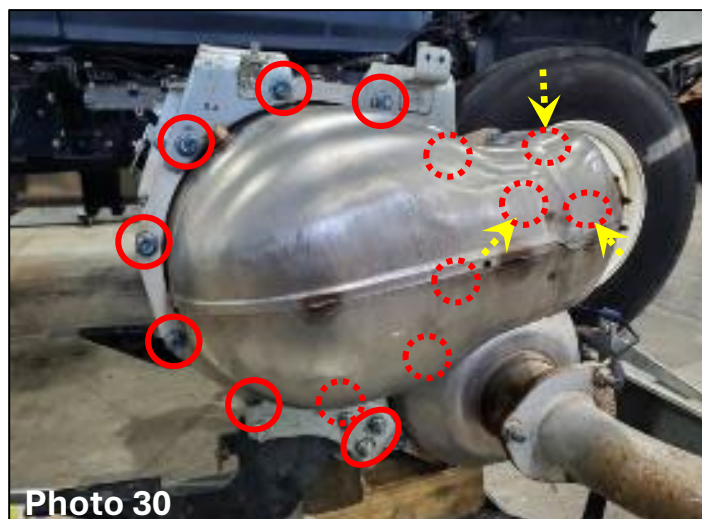
**View  
Photo 30,31**

**30.** Install the supplied bolt (SZ10510091) and three supplied nuts (SZ17810007) to the exhaust pipe flange. Tighten all fifteen bolts and nuts to the specified torque.

**Specified Torque:** 52 ft-lb (70 Nm)

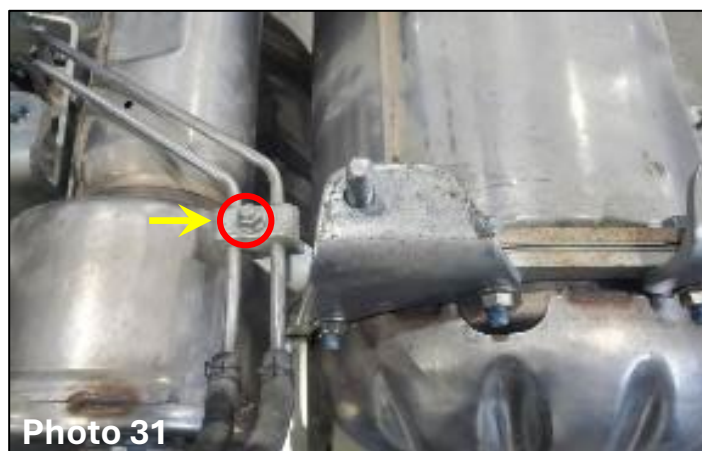
**31.** Remove and retain the nut securing the pipes to the SCR mounting bracket.

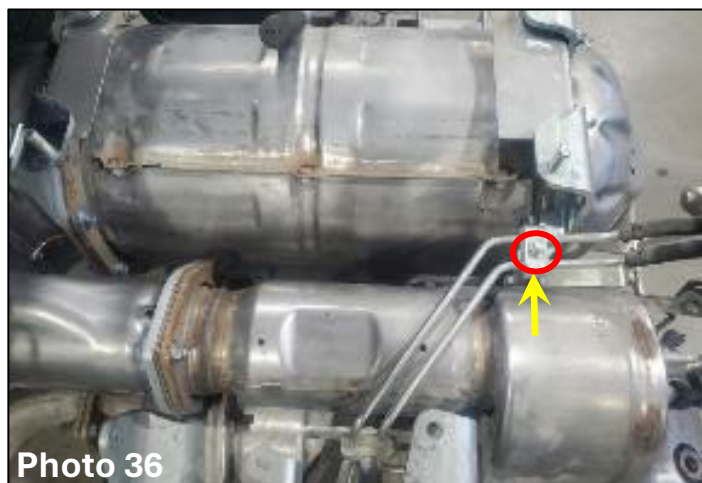
**36.** Install the nut removed in Step 31 securing the pipes to the SCR mounting bracket. Tighten to the specified torque.

**Specified Torque:** 6 ft-lb (8 Nm)

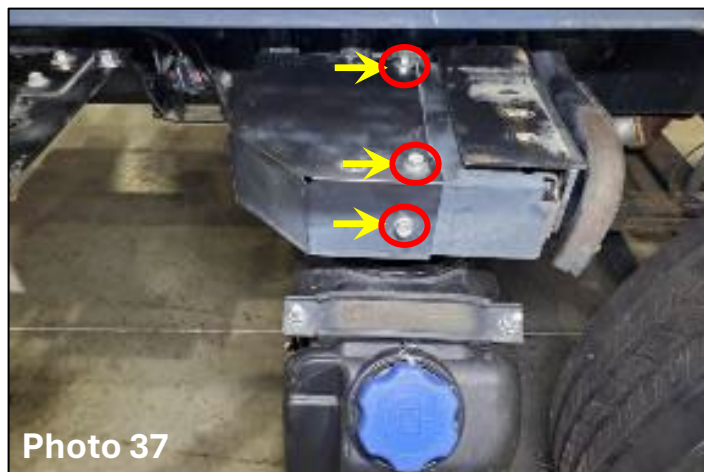
**37.** Remove and retain the three bolts securing the DCU cover. Remove and retain the cover.

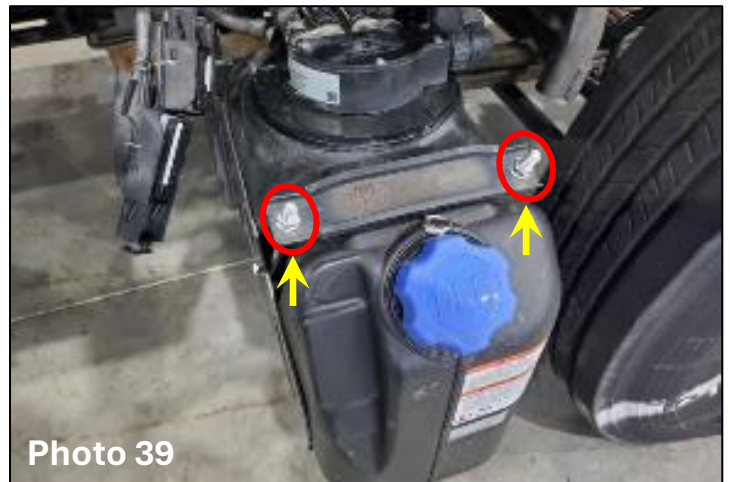
View  
Photo 39

**39.** Loosen the two nuts securing the DEF tank hold down. Remove and retain the hold down and J-bolts.

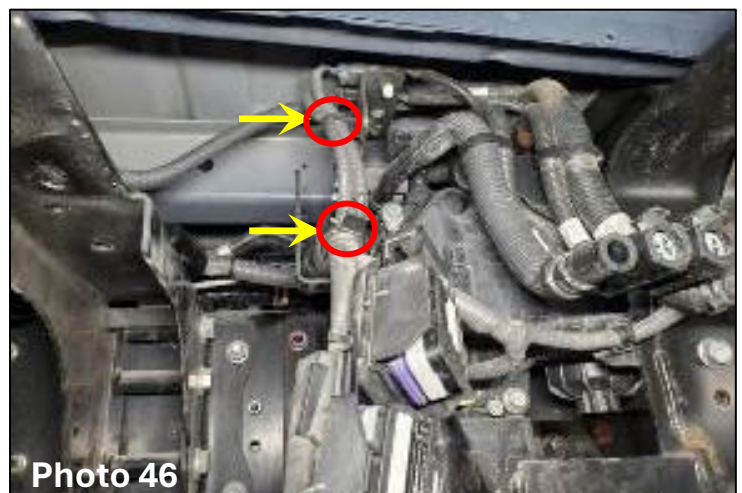
**46.** Install the supplied DEF system wiring harness (82121E3D40 or 82121E3D50). Ensure two wiring harness clamps are secured.

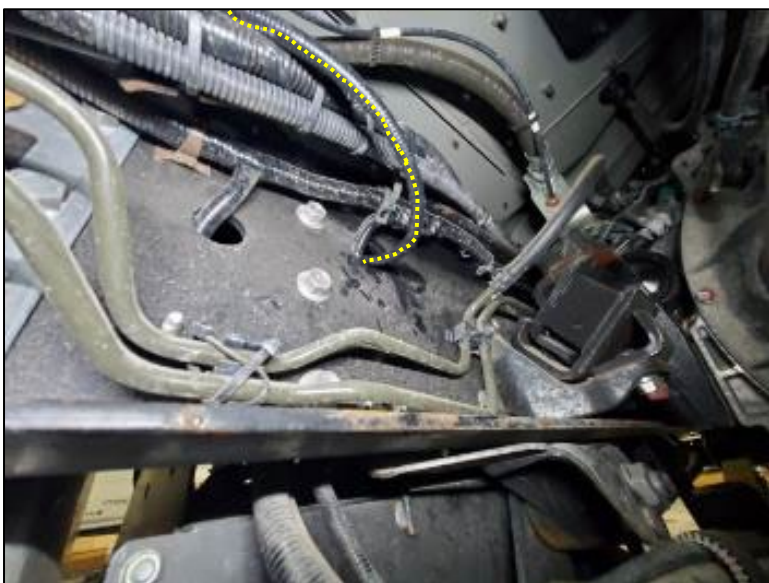
Photo 51-3

**51.** Route the DEF system wiring harness along side the frame wiring harness. Insert the battery connections through the hole(Photo 51-3) in the driver side frame rail near the motor mount. Secure to the frame harness at yellow tape marks(Photo 51-1,-2) with zip ties (S478371230). Make a loop of any excess harness and secure with zip ties (Photo 51-2) near the brake modulator valve. (Refer to next page)

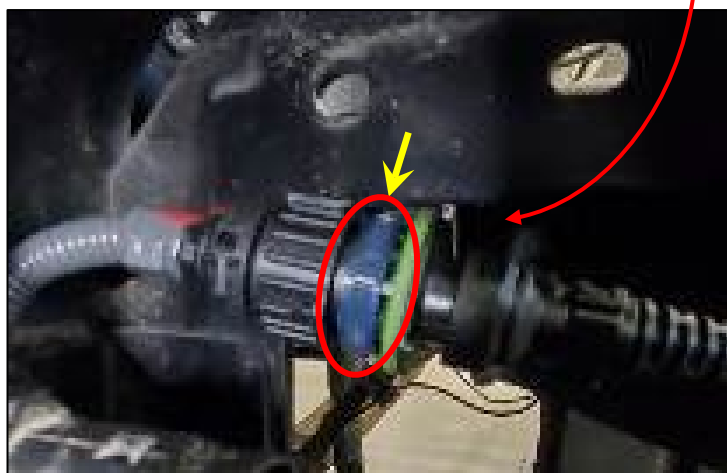
**53.** Install the supplied wiring harness clamp (8271148060) at front side of tank as shown. Install the DEF pump wiring harness connector.

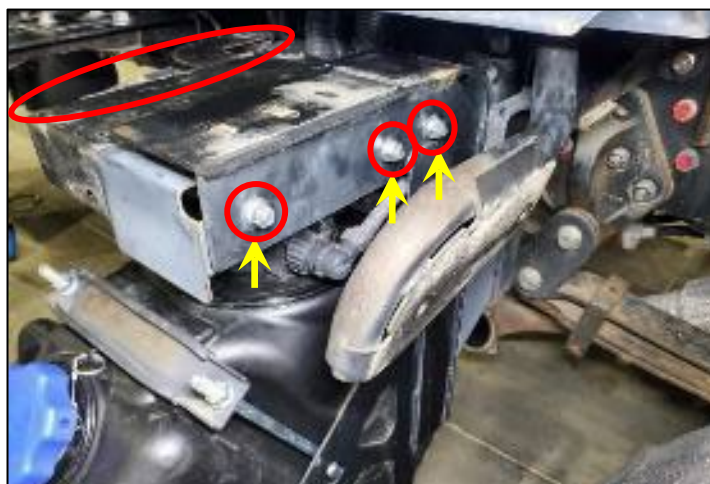
**54.** Install the DCU and the three nuts removed previously and the DCU wiring connectors. Tighten the nuts to the specified torque.

**Specified Torque:** 16 ft-lb (22 Nm)

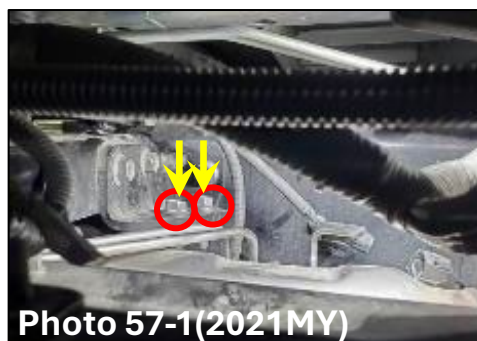
**57.** Install the two bolts removed in Step 21 securing the DPF to the frame bracket and tighten to the specified torque.

**Specified Torque:** 63 ft-lb (86 Nm)

**NOTICE:** Location varies by model year. 2021 MY location is photo 57-1, 2018 to 2020 MY location is photo 57-2 near the DEF injector.

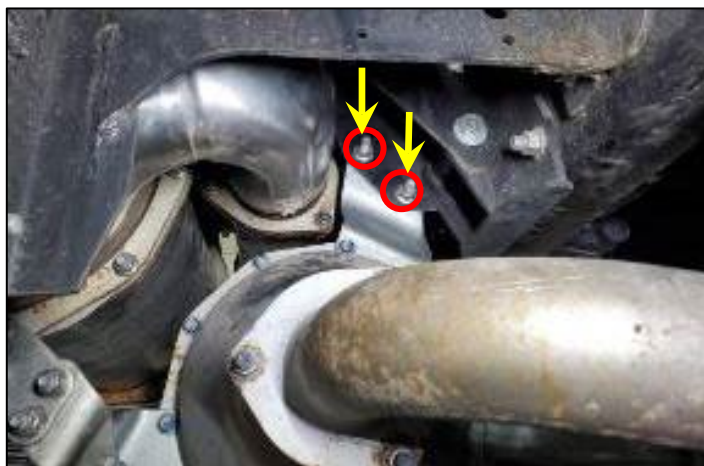
Photo 58

**58.** Install the two nuts and the two bolts removed previously securing the DOC to the frame bracket and tighten to the specified torque.

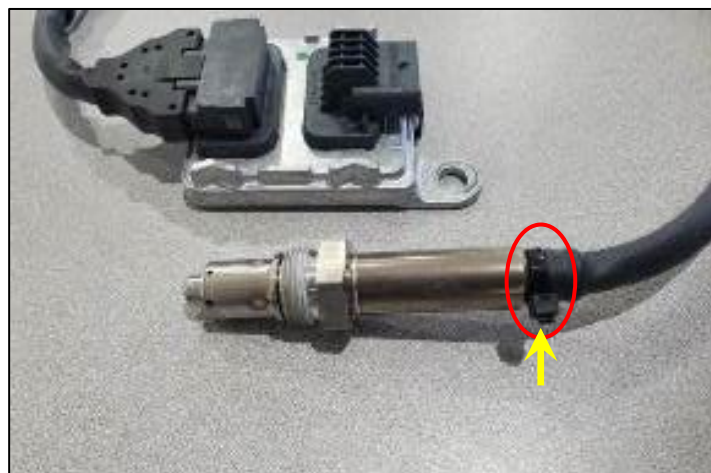
**65.** Install the supplied zip tie (S478371220) on the upstream NOx sensor (89463E0390) as shown. Ensure the wires are not exposed.

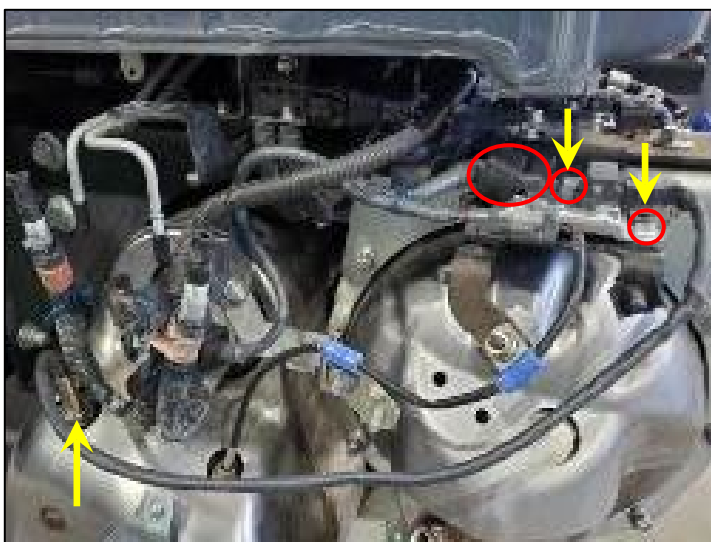
Photo 66

**66.** Install the upstream NOx sensor and the two supplied nuts (9415180600). Install the wiring harness connector and the sensor probe. Tighten to the specified torque.

Sensor Probe – 37 ft-lb (50 Nm)

Sensor Nuts – 5.5 ft-lb (7.5 Nm)

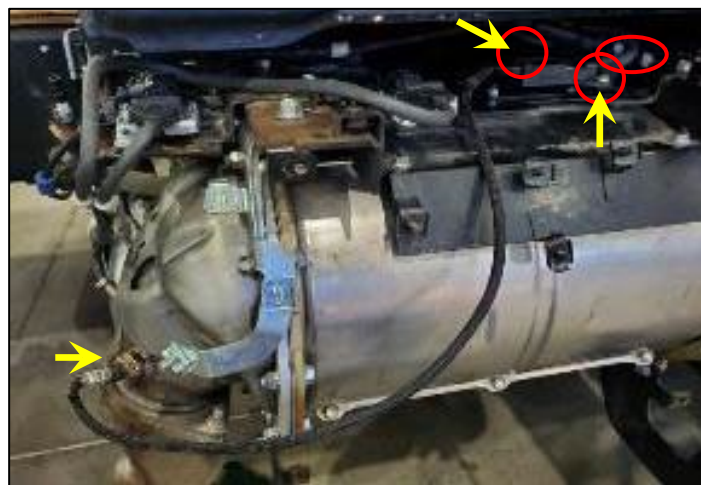
**72.** Install four of the supplied P-clips (21576E0160) on the PM sensor wiring as shown. Install but do not tighten four of the supplied nuts (SL151-00809) in the location shown. Route the sensor wiring to avoid sharp bends. Tighten the four nuts to the specified torque.

**Specified Torque:** 23 ft-lb (31 Nm)

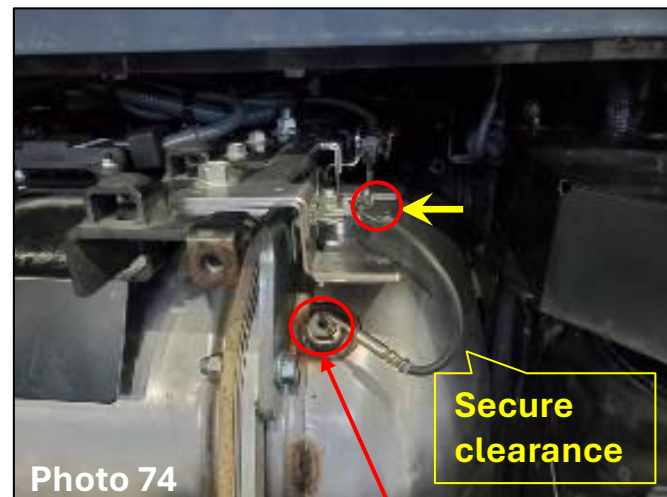
**74.** Install the SCR inlet temperature sensor. Install the nut securing the P-clip. Tighten the sensor probe and the nut removed previously to the specified torque.

Take care not to break

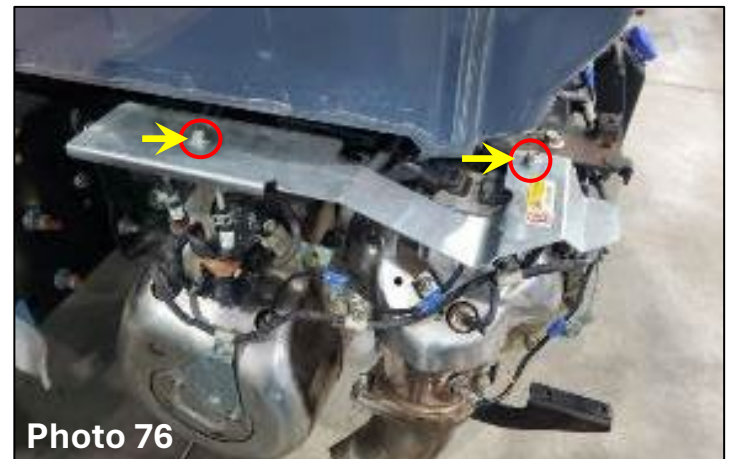
**76.** Install the splash shield and the two bolts and nut removed previously. Tighten to the specified torque.

**Specified Torque:** 16 ft-lb (22 Nm)

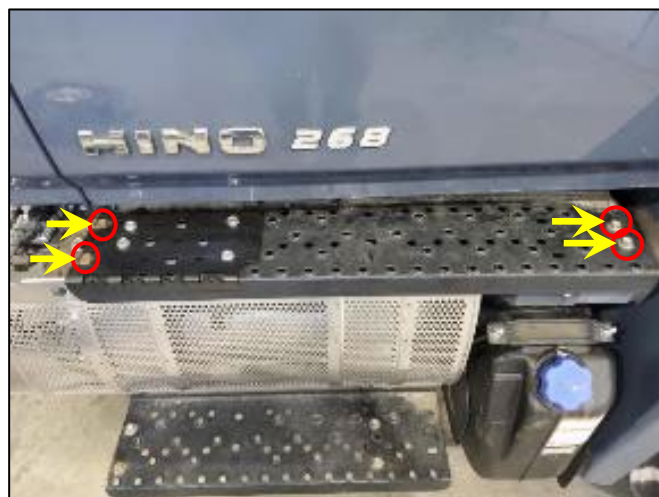
**79.** Install the upper step and the four bolts. Tighten to the specified torque.

**Specified Torque:** 29 ft-lb (40 Nm)

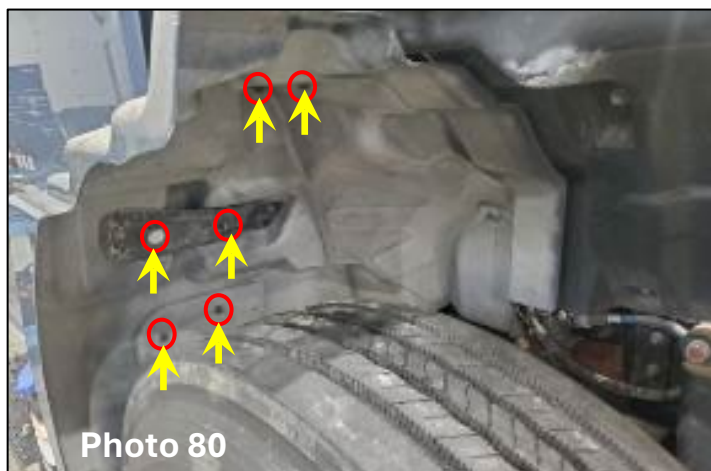
**View photo 80**

**80.** Install the passenger side fender and the six bolts and the nut removed. Tighten to the specified torque.

**Specified Torque:** 10 ft-lb (13 Nm)

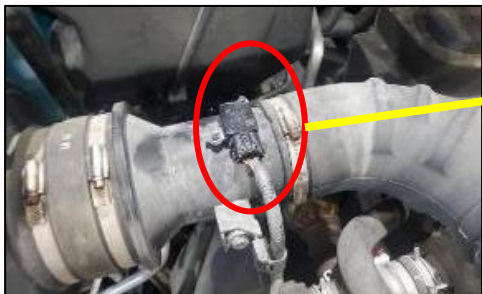
- 84.** Install the supplied MAF sensor (22204E0010). Tighten the screws (SK31900410) to the specified torque.  
**Specified Torque:** 1 ft-lb (1.5 Nm)

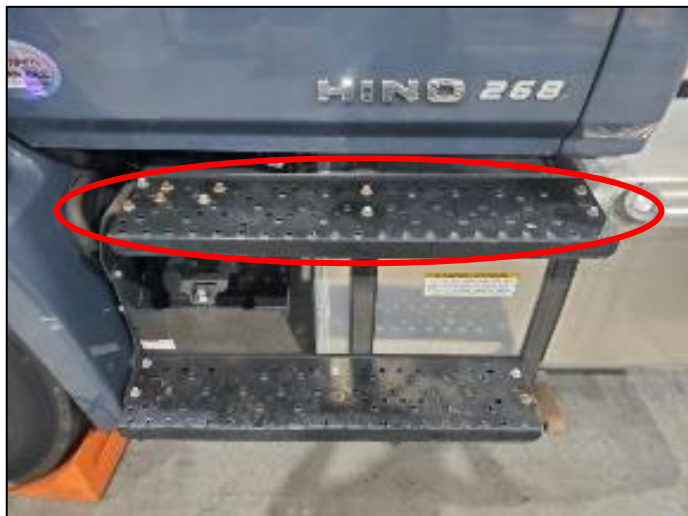
- 86.** Install the driver side upper step and the ten bolts. Tighten to the specified torque.

**Specified Torque:** 29 ft-lb (40 Nm)

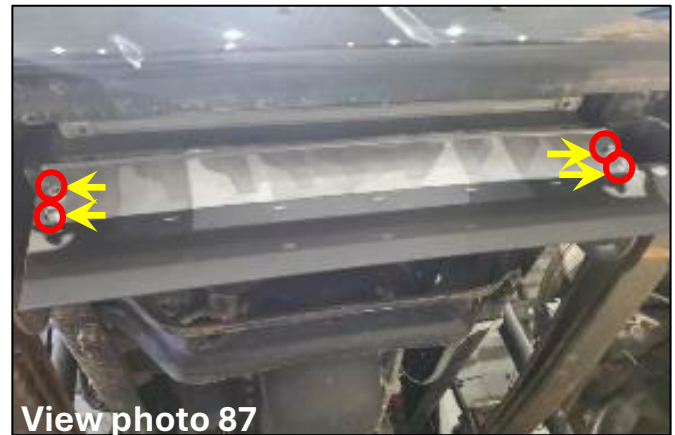
Install the air baffle(S160JE0120) and four bolts (SH69130616) on the bottom of the radiator. Tighten to the specified torque.

**Specified Torque: 7 ft-lb (9.5 Nm)**

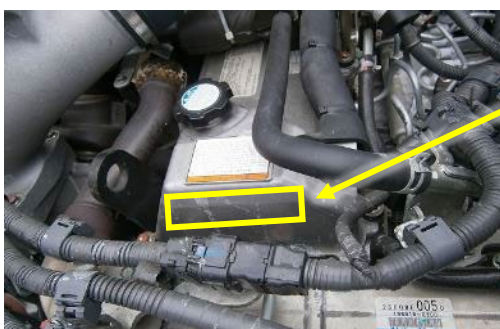
#### Power change label

**88.** Install the supplied “Power change label”(11283E0010) on front of the head cover. And Install the “CAUTION label”(11293E0U30)to the driver side sun visor.

THIS VEHICLE'S ADVERTISED HORSE POWER HAS BEEN CHANGED FROM 230HP TO 260HP. ( THIS CHANGE IS PURSUANT TO CONSENT DECREE, NO.25-10144 )

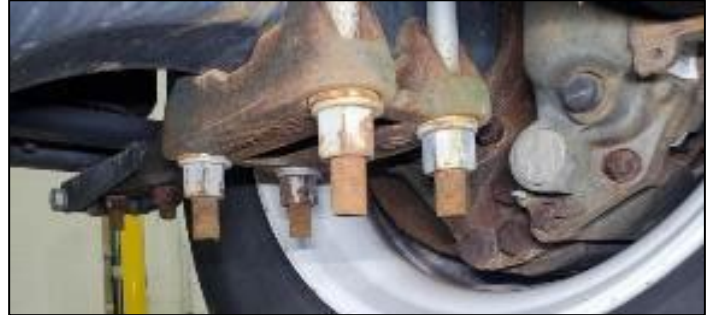
**90.** Remove and discard the rear U-bolts.

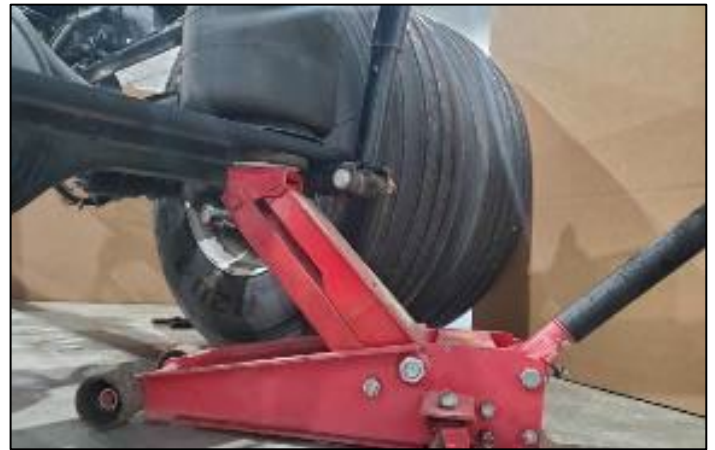
**91.** Place a jack under the air spring and lift until the spring seat can be removed.

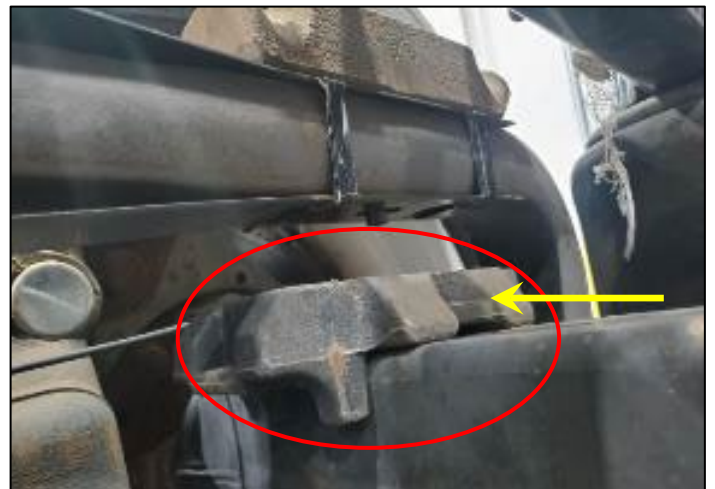
**92.** Remove and discard the spring seat and install the supplied spring seat (48481EW071 or 48481E0200).

**NOTICE:** Check the diameter of the center pin.

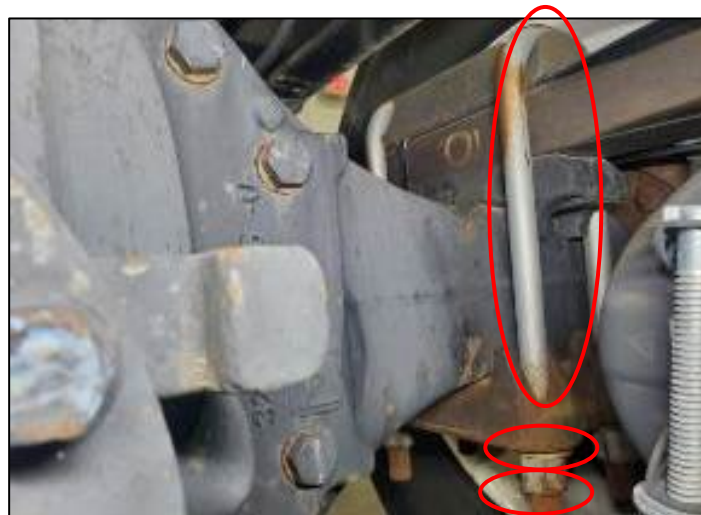
**94.** Repeat the previous steps on the other side of the vehicle. (Step 90-93)

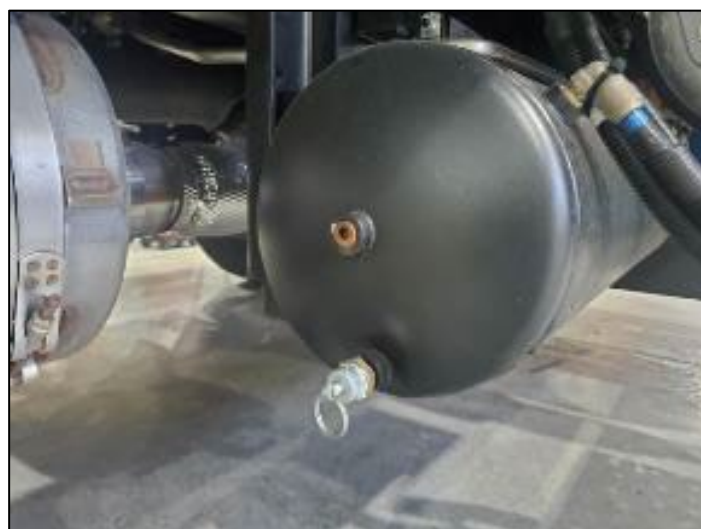
**95.** Completely empty the compressed air system by opening the drain valves on both air tanks.

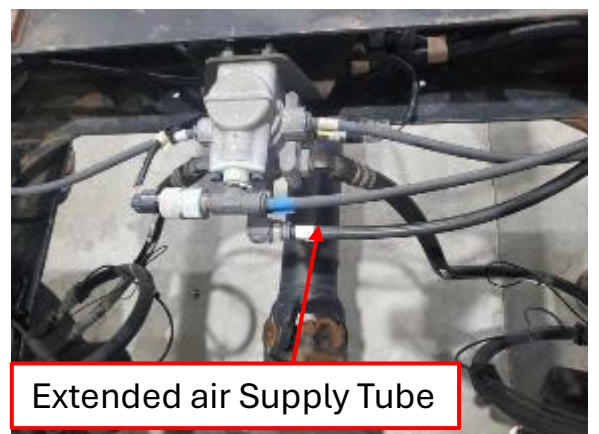
**101.** Remove and discard the cut tubing. Install the extended air supply line to the park brake relay valve. Install zip ties (S478371230) to secure the tube as above.

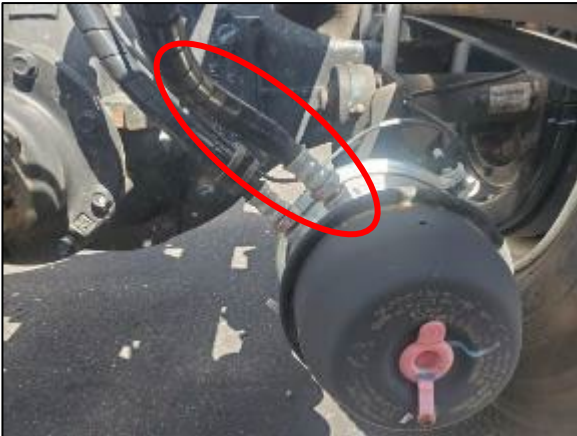
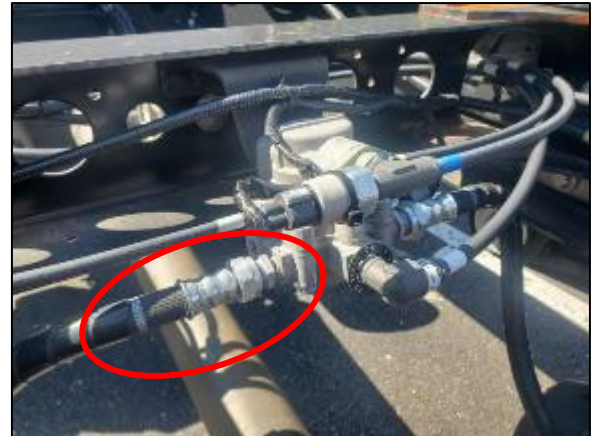
**102.** Remove and discard the park brake hose and the fittings from the park relay valve and the brake chambers.

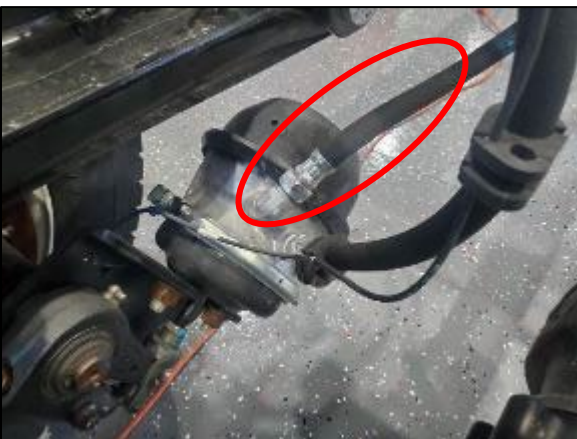
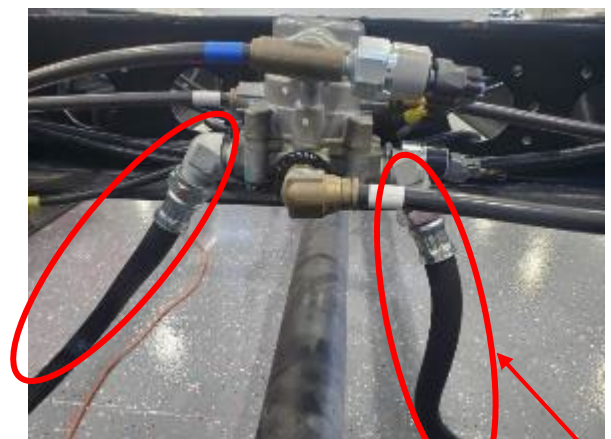
**103.** Install the supplied fitting (SZ40713010) on the park brake relay valve and the brake chamber. Install the supplied park brake hose (S4703E0W80). Tighten to the specified torque.

### Specified Torque:

**Fittings** - 25 ft-lb (34 Nm)

**Brake Hose** – 30 ft-lb (41 Nm)

**104.** Repeat Steps 102 and 103 on the other side of the vehicle.

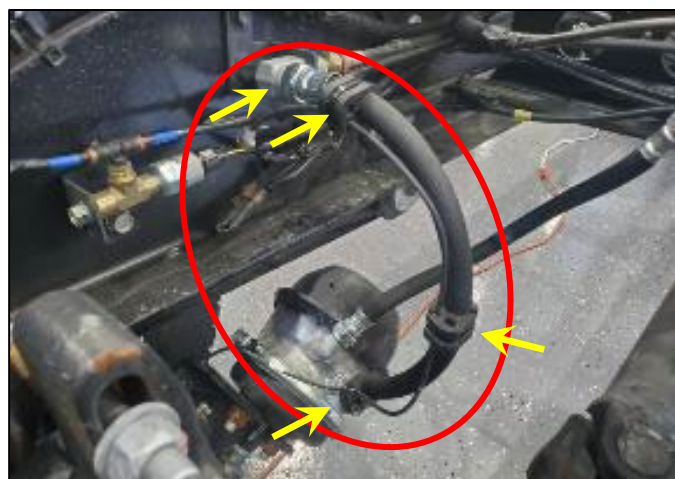
**106.** Remove and discard the service brake hose. Install the supplied service brake hose (S4073E0W90). Secure the ABS sensor wiring to the service brake hose with the supplied zip ties (S478371230). Tighten to the specified torque.

**Specified Torque:** 30 ft-lb (41 Nm)

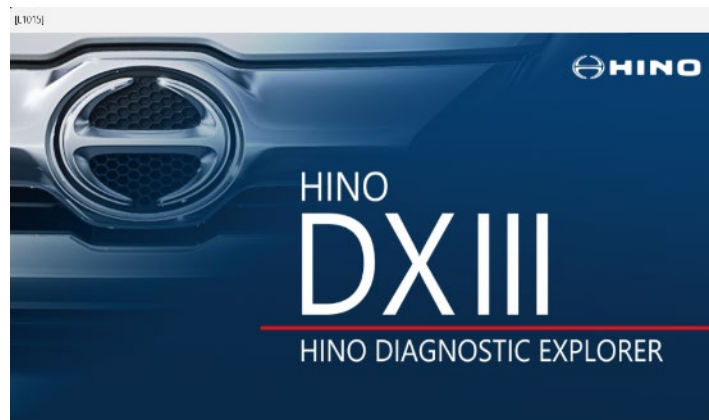
**108.** Connect DX-III to the vehicle.  
Turn the ignition to the ON position.

**NOTICE:** Ensure DX-III is updated to the latest software version available.

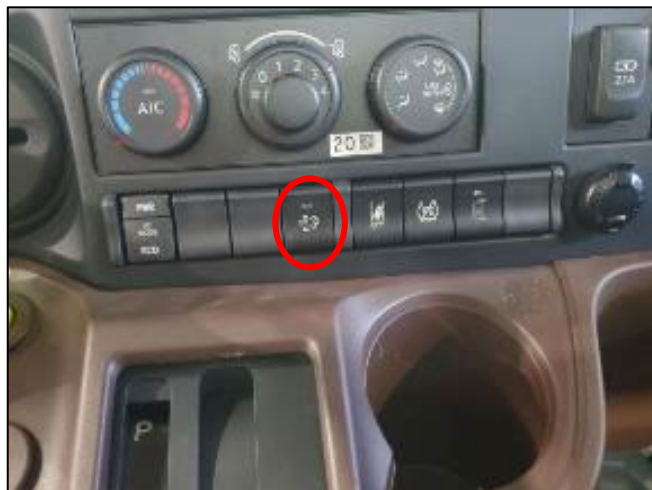
**117.** Start the engine and perform Manual Regeneration by pressing the Manual Regen Button (DX Data does not need to be recorded).
