## [Customer Satisfaction Campaign](#)

This notice applies to your <Model Year> Grand Design <Brand> <Model>, VIN <VIN>

## Customer Service Campaign

### Visual Inspection for Momentum and Solitude Upper Deck Wall Securement

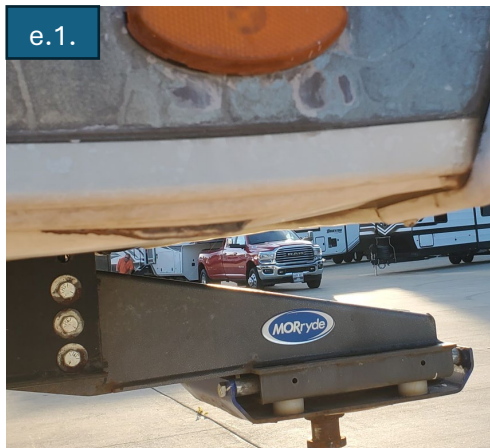
1. Screw cover separation around the front bulkhead - see *Photo Example e.1.*
2. Deformation or cracks at the expansion joint located under the upper deck slide outs - see *Photo Example e.2.*

If any of these conditions are present, please contact Grand Design Customer Service via the information provided in your cover letter for next steps.
