FRONT CAP BADGE REPAIR

| Bulletin #(s): | 25-026 | Make(s): | Jayco |

| Incident: | Debris/dirt behind front cap badge |
| Affected Units: | 2024 - 2026 Jayco Eagle FW, Eagle HT FW, Eagle TT |

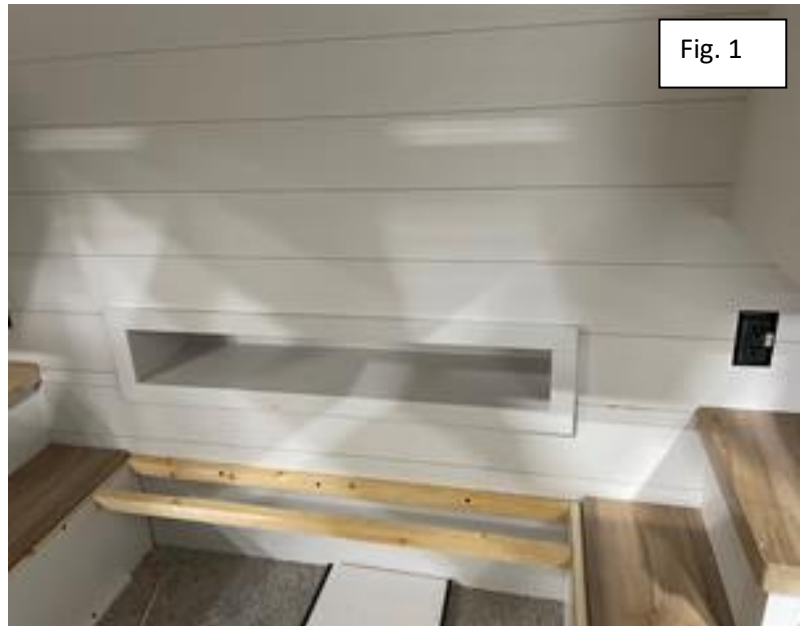
Fig. 1

1. Go inside coach and remove insert in front bedroom. (Figure 1)
 - a. Note: Insert may vary based on floorplan.

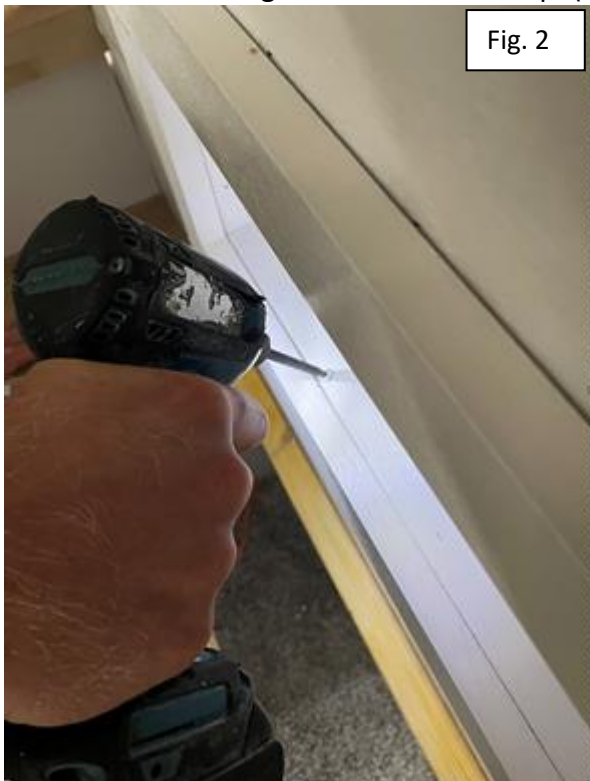
Fig. 2

2. Remove screws on the inside of the insert to remove. (Figure 2)
3. Remove insert to gain access behind cap. (Figure 3)

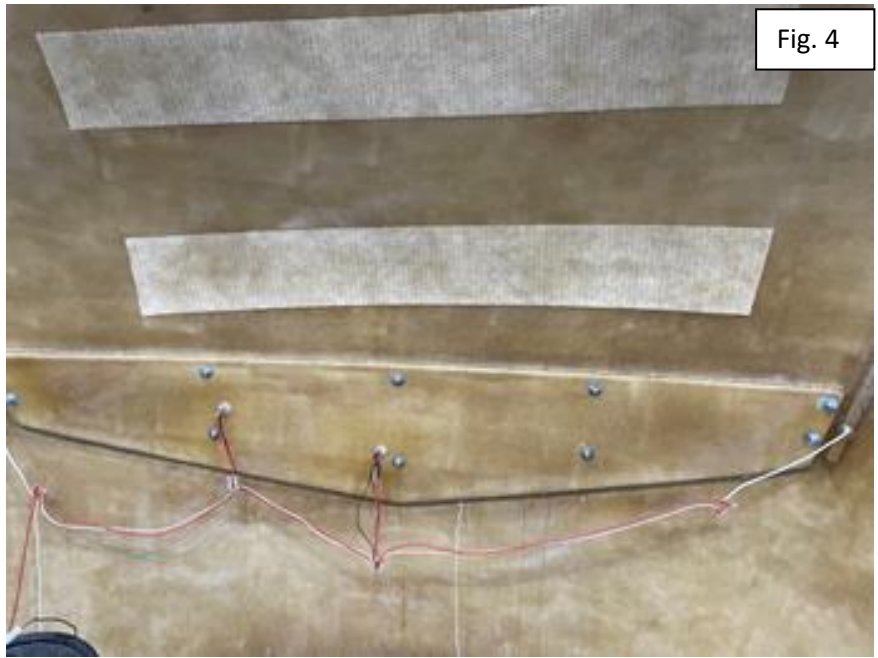
4. Remove the nuts on the back of the 10 studs securing the badge to cap using a 9mm socket. (Figure 4)

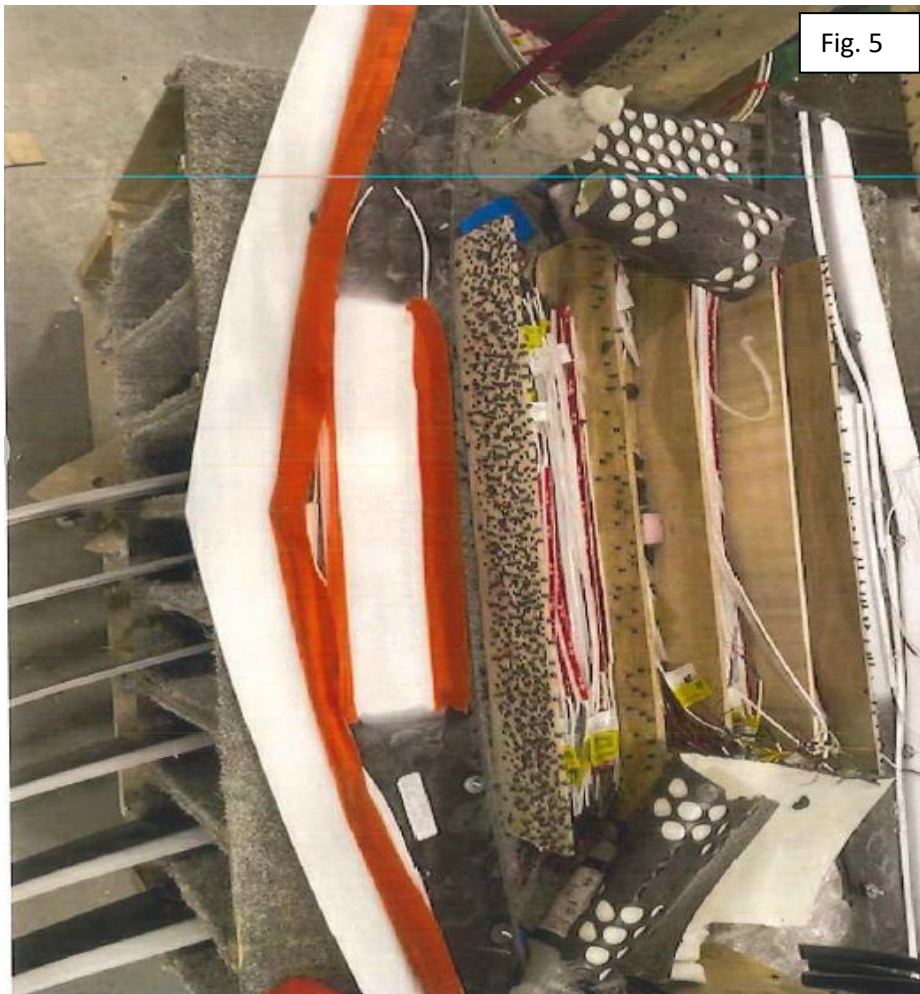
5. Once badge has been cleaned carefully tape off the lights so that the clear section of the badge can be painted using a white 2x primer/paint. (Figure 5)

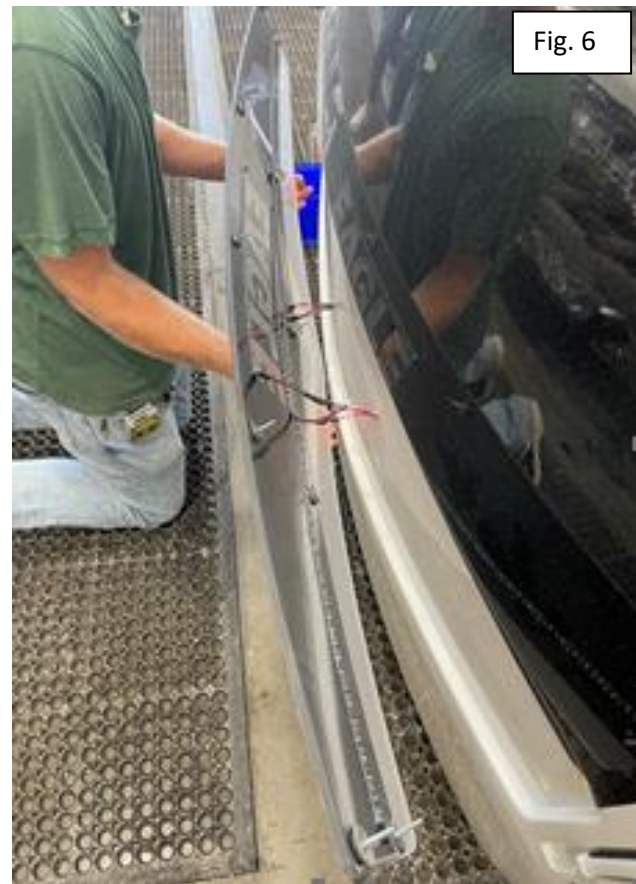
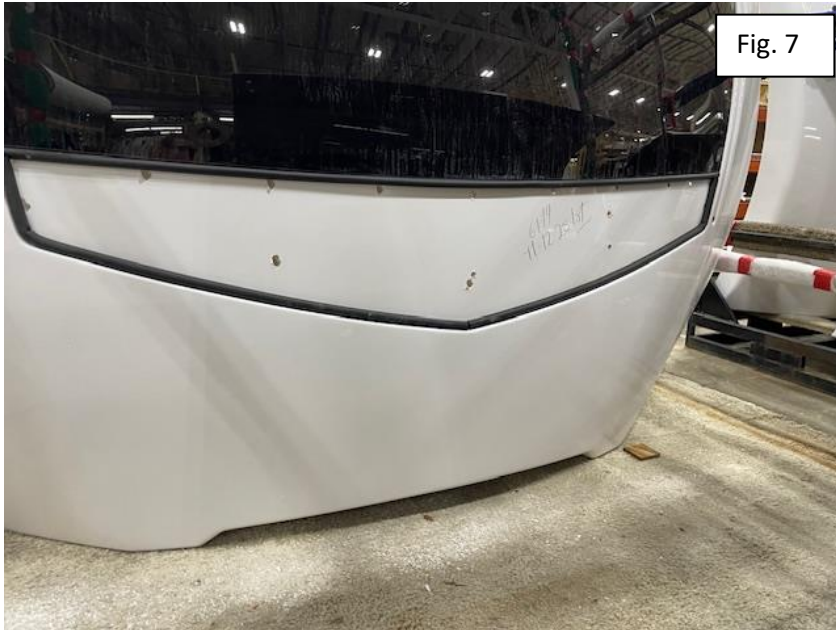
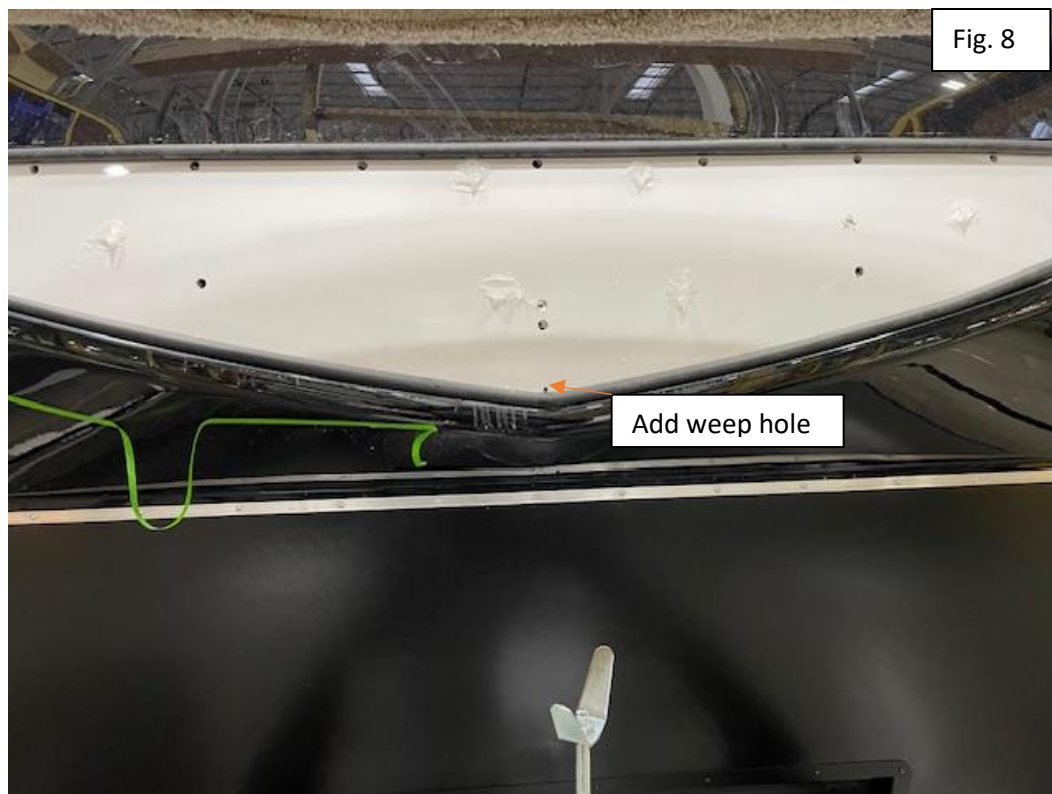
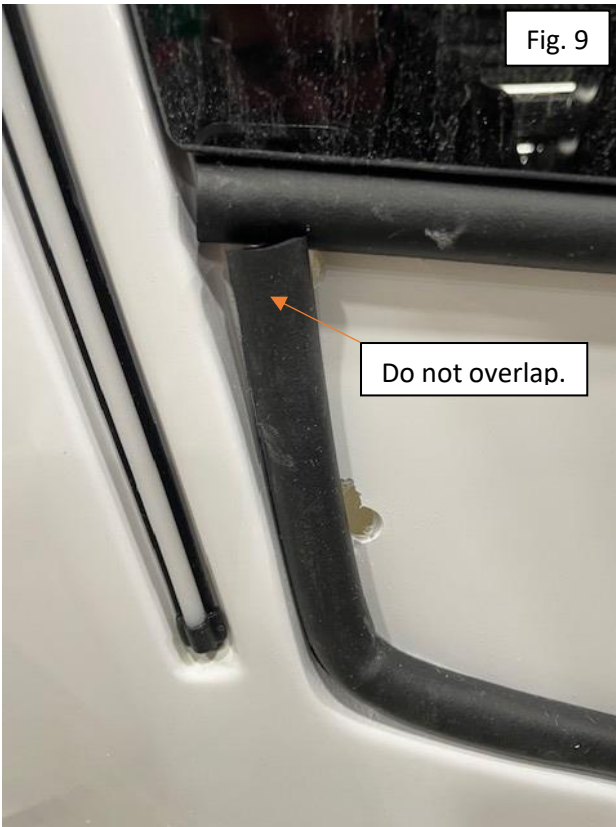
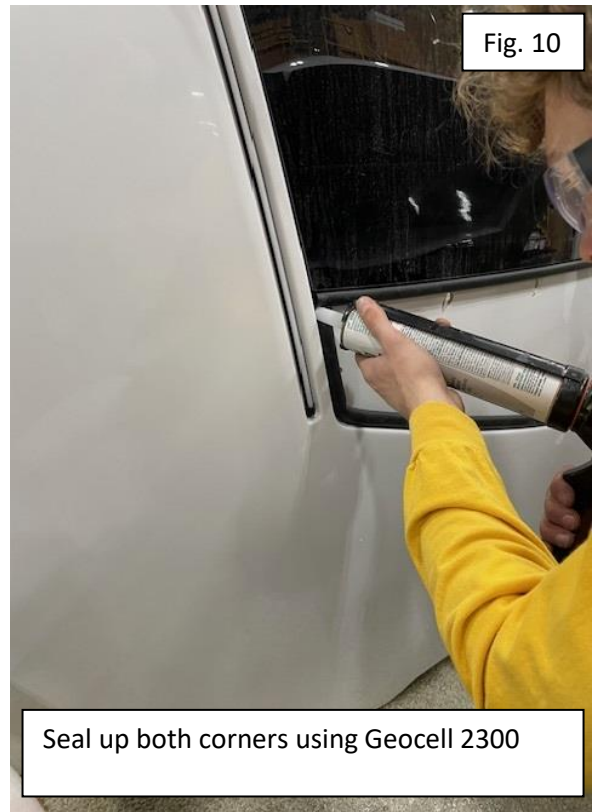
- Carefully pull badge out and clean behind the badge and the cap. (Figure 6)
- Apply bulb around the entire indentation. Run a continuous piece along the top and bottom, splicing only in the top corners. (Figures 7 - 11)
- Drill 3/8 "hole at the bottom of the opening. (Figure 8)

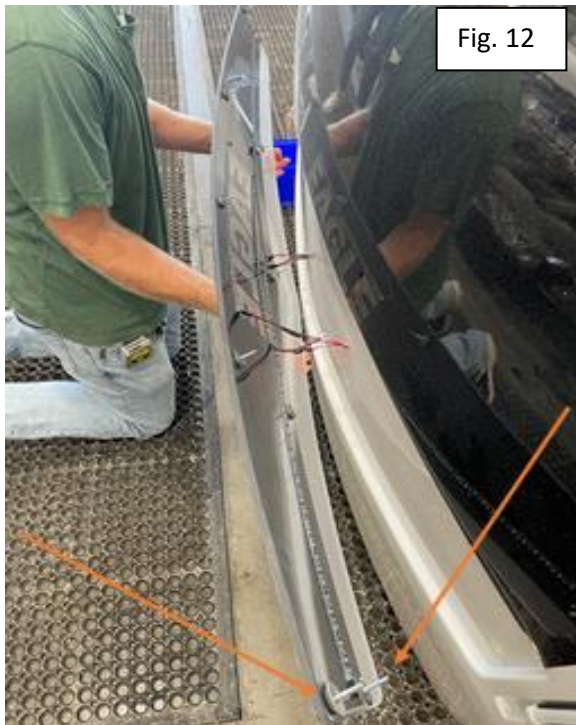
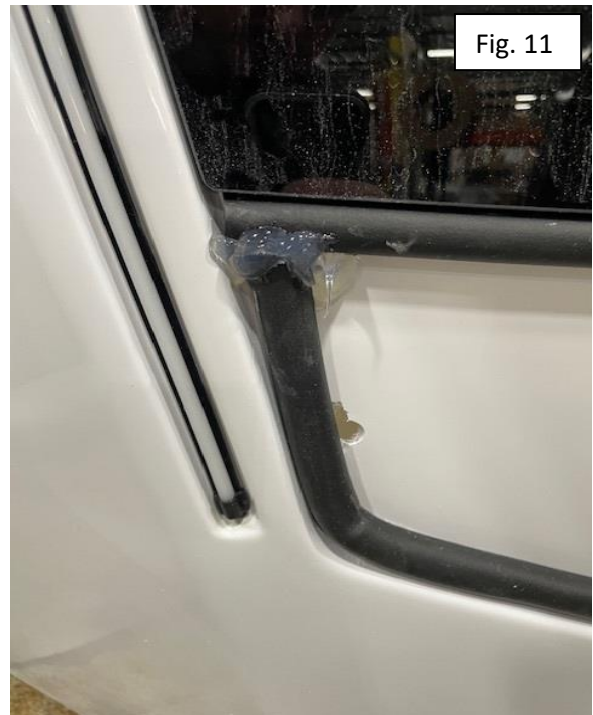
9. Ensure washers are on each stud and re-install badge (Figure 12)
10. Ensure wires are pulled back through the cap and that washers are placed back on the studs. Reinstall nuts at 8 in./lbs. Reseal the wire holes using geocell 2300. (Figure 13)

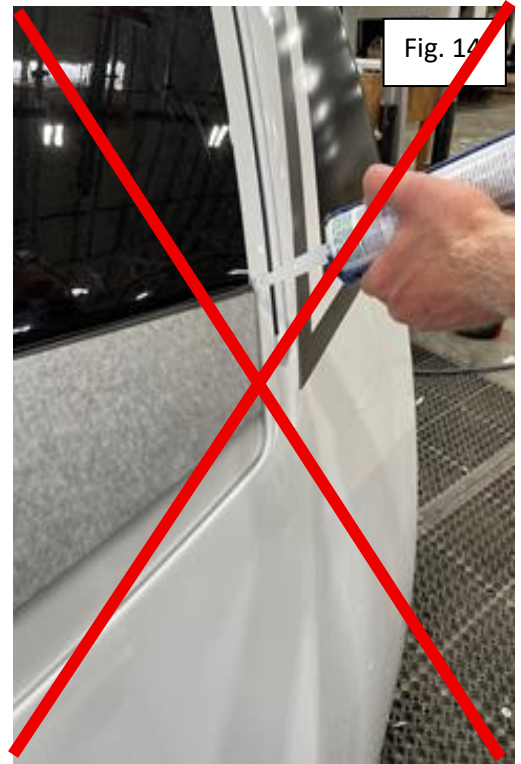
11. With the new bulb installed, sealing the perimeter of the badge will no longer be necessary. (Figure 14)
