CAN-AM ON-ROAD (3W) 2025-6 Canyon Rust on Saddle Bags Latches

Vehicle - Quality Bulletin

December 18, 2025
Bulletin 2025-6 | Version A
Campaign N° 2025-0006

Canyon Rust on Saddle Bags Latches

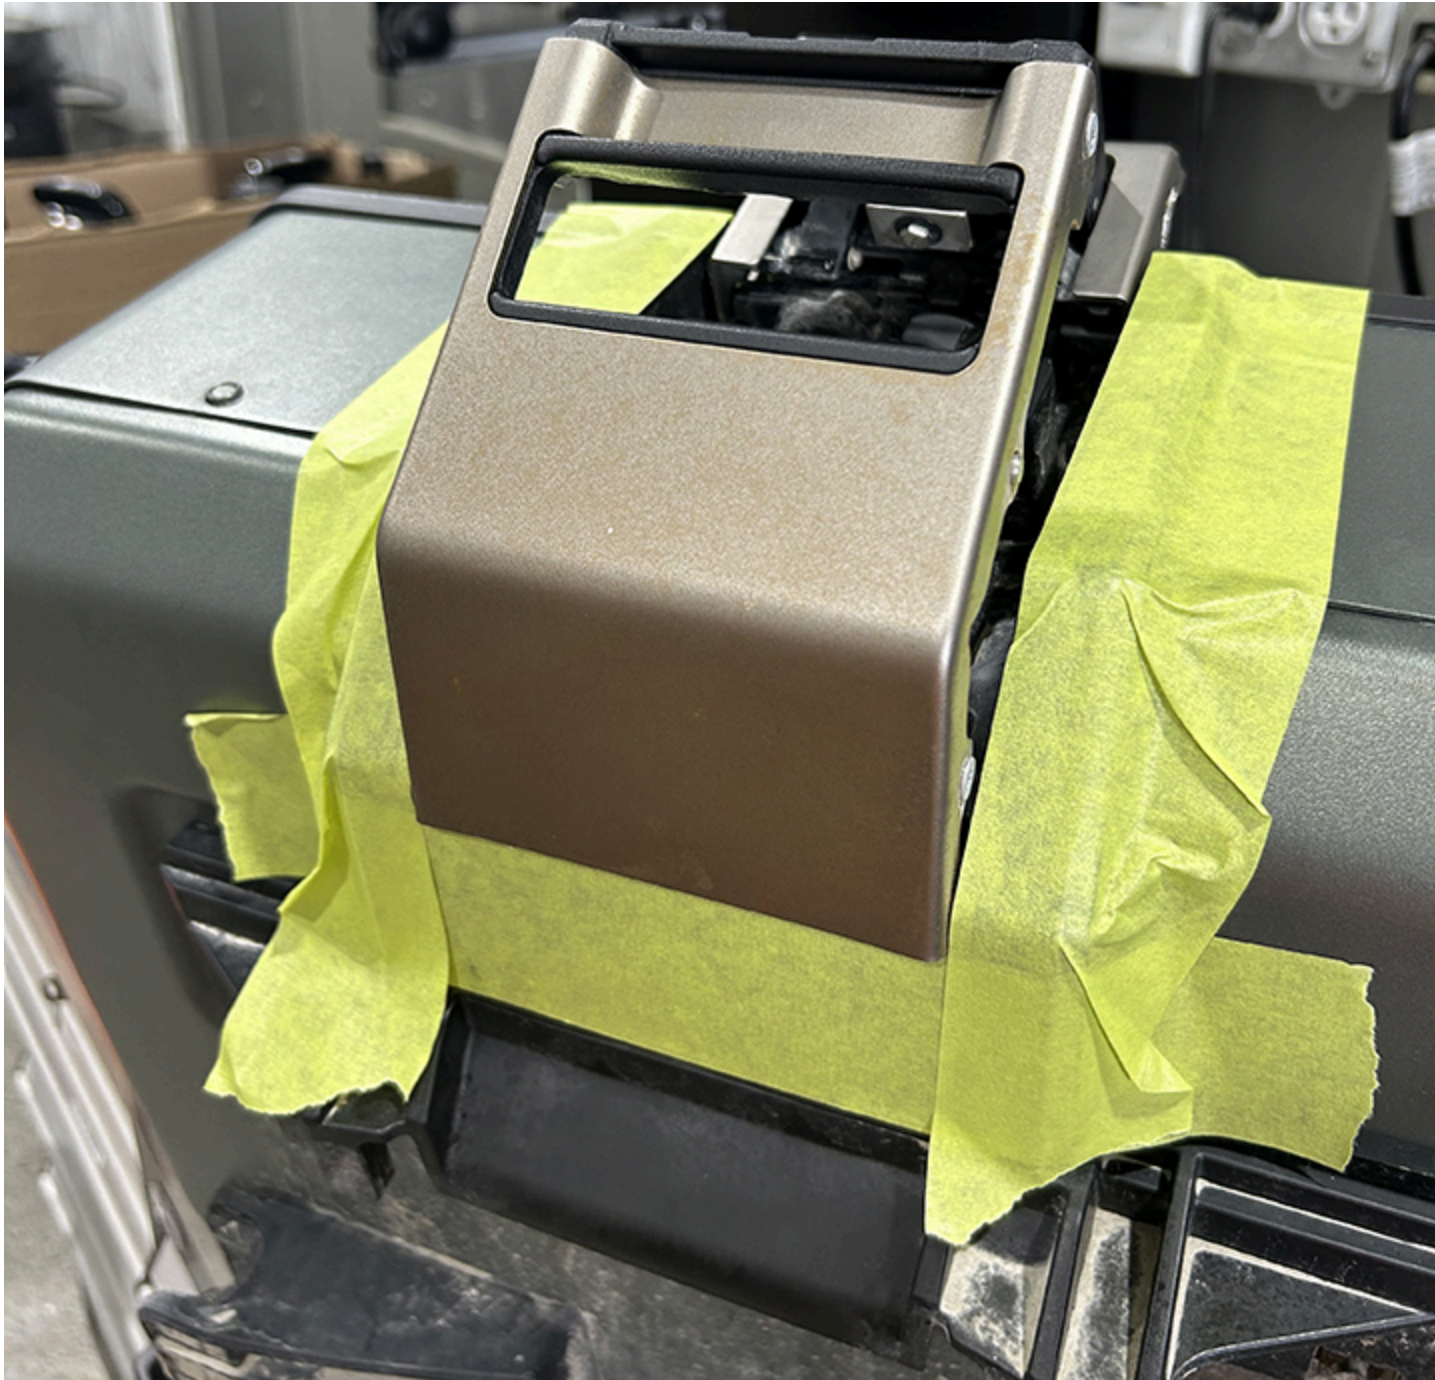
The affected areas are, side case handles, top case handles, top case hinges.

1. Remove the top case and two saddle bags from vehicle.
2. Clean thoroughly and dry out.
3. Open latch to have access to the sides of the handle affected areas.
4. Use masking tape to protect the plastics, bare or painted aluminum surfaces.

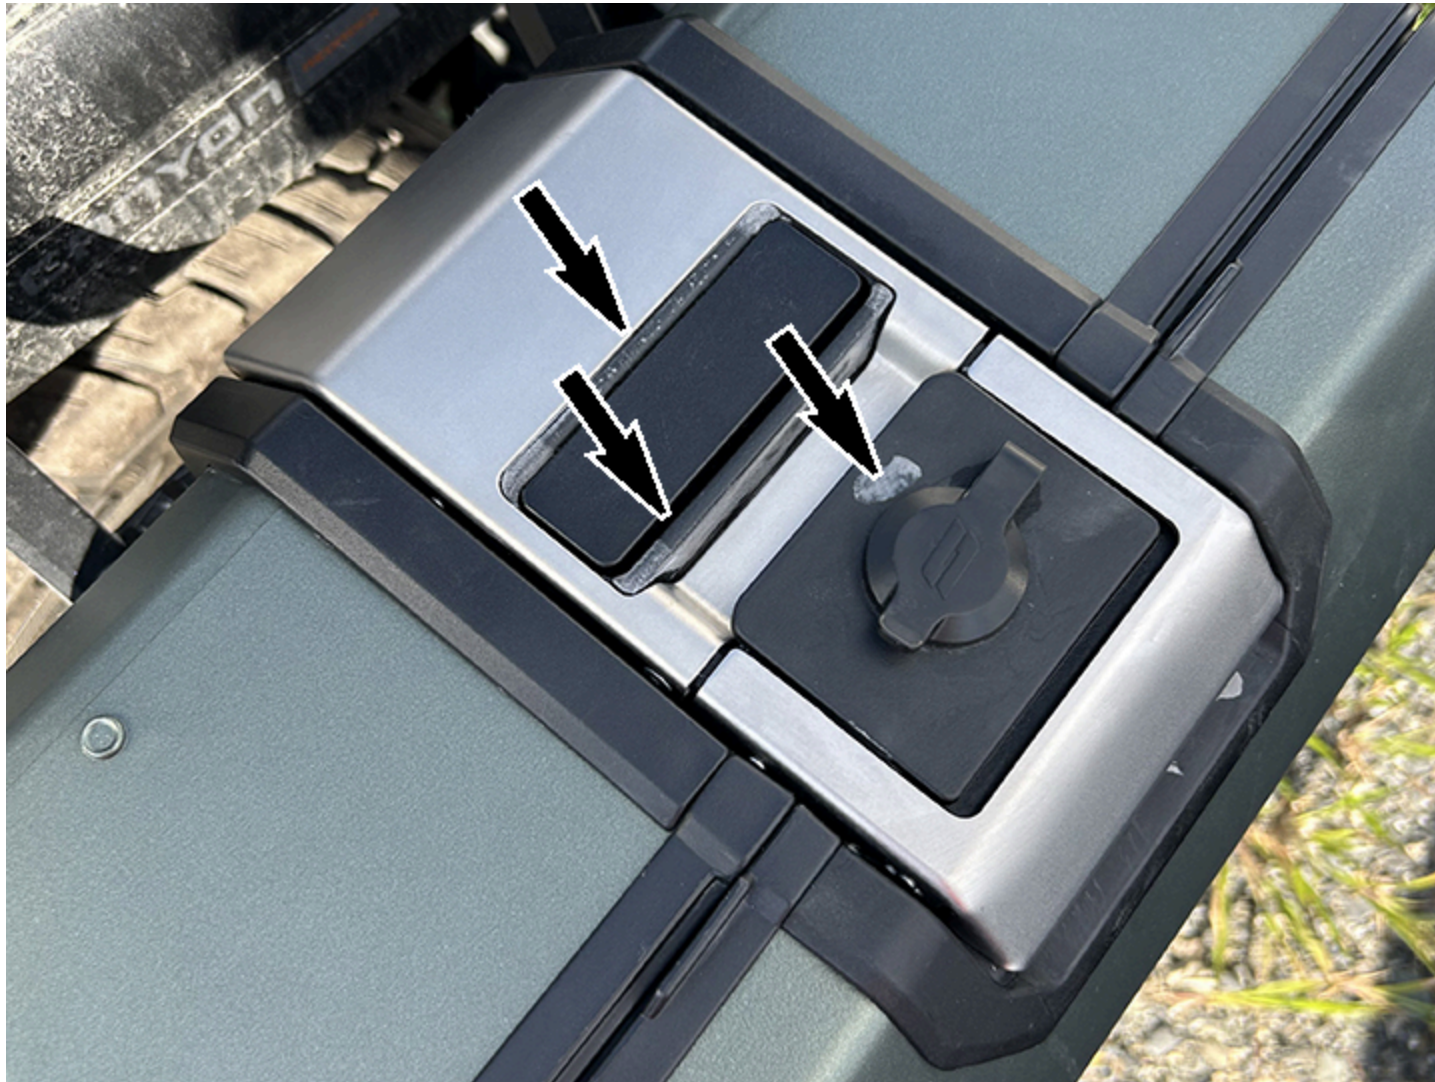
DAMAGED PLASTIC

- Avoid using a foam paint brush as it will have a tendency to drip too much product.
- If some of the product gets spilled on the plastic or Aluminum surfaces, rinse immediately to avoid damage (white sections).

6. Let the product work for 10 minutes *maximum*.
7. Then make sure to thoroughly rinse with plenty of water.
8. Remove masking tape and rinse again to avoid any Ferronet remaining.
9. Dry completely.
