Keystone RV Company

SERVICE ADVISORY # 25-476

Outback Power Lift Roof Vent

It has been determined that the Power Lift Roof Vent used on specific models may crack. The following procedure describes how to identify and replace the Power Lift Roof Vent.

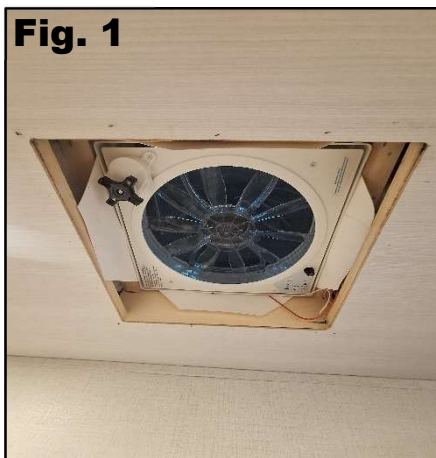
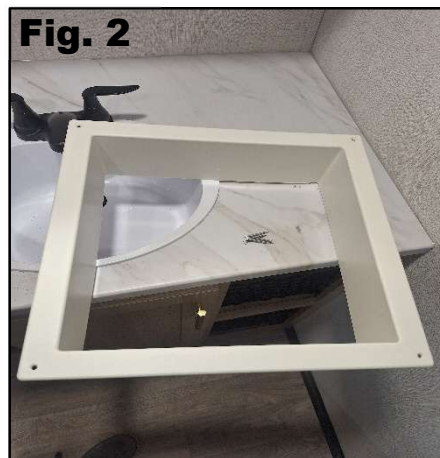
Locate the bathroom Power Lift Roof Vent from the interior of the trailer. Remove the screws securing the garnish ring to the roof vent opening, set them aside. See Fig 1 – Fig 2

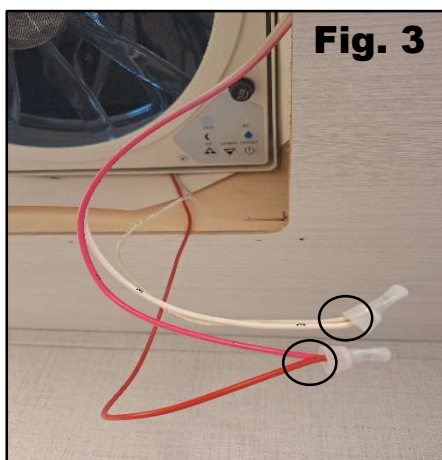
Use 12v wire strippers to disconnect the power supply to the Power Lift Roof Vent by cutting both sets of 12v wires below the bell caps. See Fig. 3

From the interior of the trailer, use 12v wire strippers, a sta-kon crimper, and bell caps to connect to the power supply wires from the roof vent to the 12v wire disconnected previously in step 4. Reconnect all 12v and 120v power to the trailer, test the newly installed roof vent fan as well as the replacement remote (KRV # 710123 - Fan - Remote & Holder - For 00-04501KX - MaxxFan Standard - 10 Speed) to verify it functions as intended.

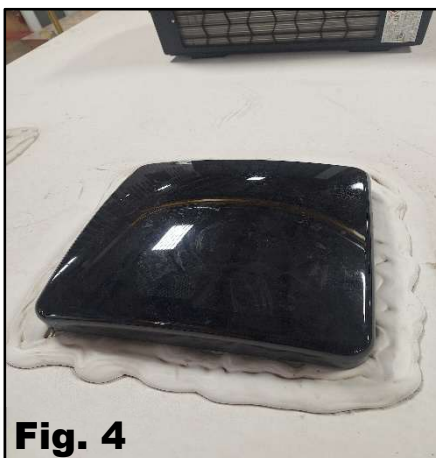
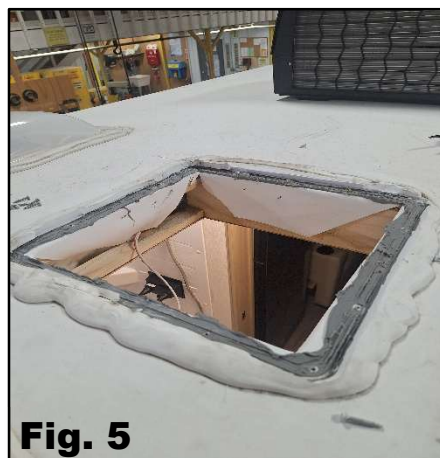
From the roof exterior, use plastic scraping tools to remove the roof sealant from the existing roof vent flange exposing the pan head screws. Use a screw gun to remove all the screws from the vent flange. Carefully lift the Power Lift Roof Vent from the roof opening. Remove any old roof sealant for a minimum of 2” entirely around the roof opening. See Fig. 4 – Fig. 5
