Technical Journal Title Propulsion Warning with IEM POCBC62		Ref. No. TJ 37521.1.0	
Issuer (Dept.) Technical Service		Issue Date 10/9/25	Status Date 10/14/25
Car Market United States and Canada	Partner 3 US 7510 Volvo Car USA	Function Group 3233	
Function Description Electric converter, high voltage		Page Page 1 of 4

If a customer experiences a “Propulsion System Service Required” message in the DIM, and the DTC IEM POCBC62 is stored, please follow the advice under “Service”.

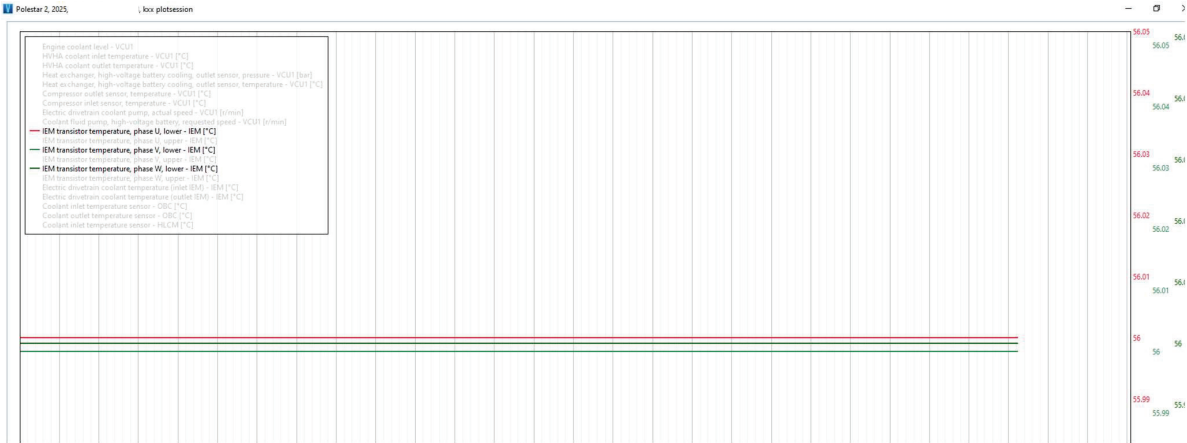
TJ 37521

To determine if this coolant valve is faulty, the IEM transistor temperature parameters for phases U, V, and W can be monitored and plotted with VIDA.

Tip: During driving, the transistor temperatures for the three phases should be similar. However, the temperatures in the transistors can differ when the vehicle is at a standstill.

- Page 1: A diagram of a fault-free car during normal driving.
- Page 2: A fault-free car during aggressive driving—still only slight increases and temperatures remain below 65°C.
- Page 3: A car where the coolant one-way valve is faulty. Notice the large temperature fluctuations that frequently occur while driving. Once the temperature reaches 80–100°C (176–212°F), the IEM will set a DTC for temperature and switch to freewheeling mode.
 - If a car has a single motor, the vehicle will come to a stop.
 - In a car has dual motors, only half of the power will be available.

If the vehicle behaves as shown on page 3, replace the hose with the one-way valve to avoid unnecessary replacement of the IEM.
