Technical Service Bulletin

GROUP	NUMBER
BODY	25-BD-013G
DATE	MODEL(S)
DECEMBER 2025	G70 (IK)

SUBJECT: WIDE SUNROOF CREAK/RATTLE NOISE ON UNEVEN ROAD CONDITIONS – REPAIR GUIDE

Description: Certain G70 (IK) vehicles may exhibit abnormal creak and/or rattling noise from the wide sunroof assembly while driving on uneven road conditions. This bulletin outlines the procedures to repair the noise.

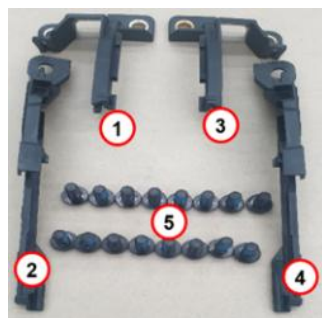
1. LH Front Outside Locator	1
			2. LH Front Inside Locator	1
			3. RH Front Outside Locator	1
			4. RH Front Inside Locator	1
			5. Hex Bolt M6x12 HEAD M5	16

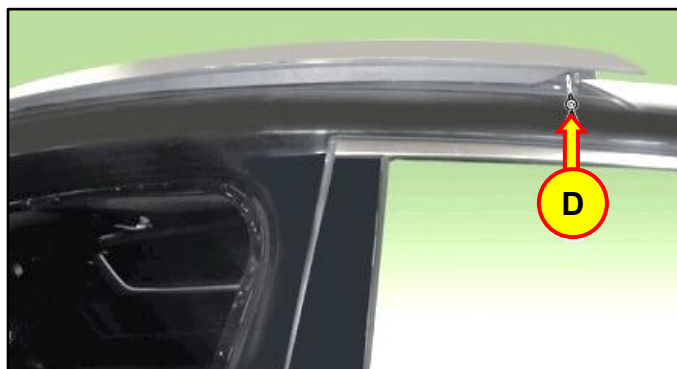
4. Remove the exterior sunroof glass bolt (D) on each side.

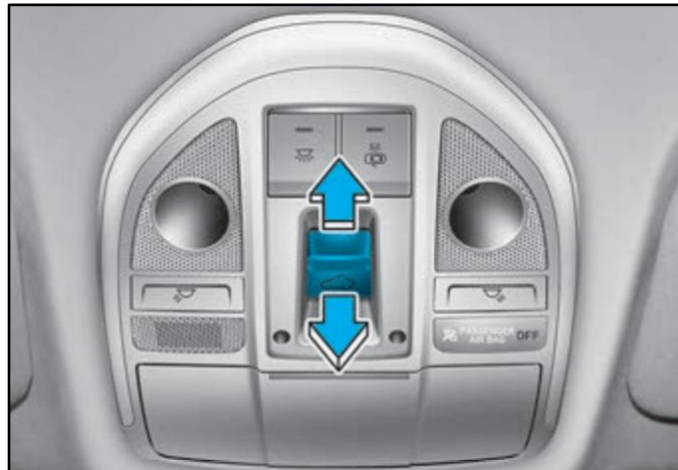
6. Move the sunroof mechanism rearwards approximately **2 inches** using the wide sunroof switch.

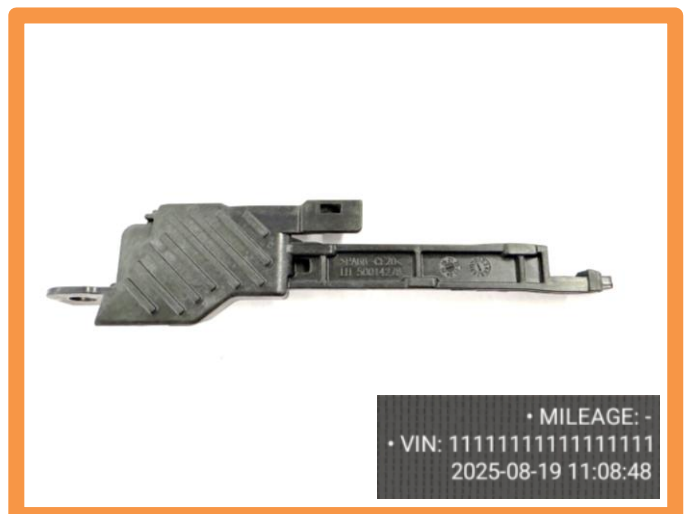
Using the STUI camera function, take a photo of the LH front inside locator removed from the vehicle.

Ensure the Digital Documentation photo in **step 14** is captured for the RH front inside locator removed from the vehicle.

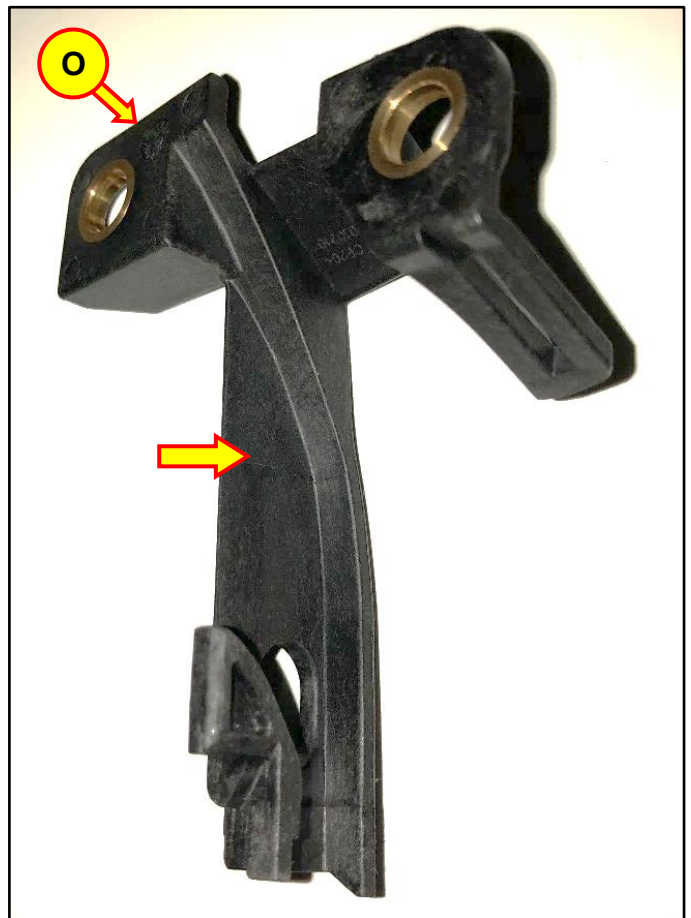
18. Apply silicone lubricant to the indicated groove on the new LH front outside locator (O).

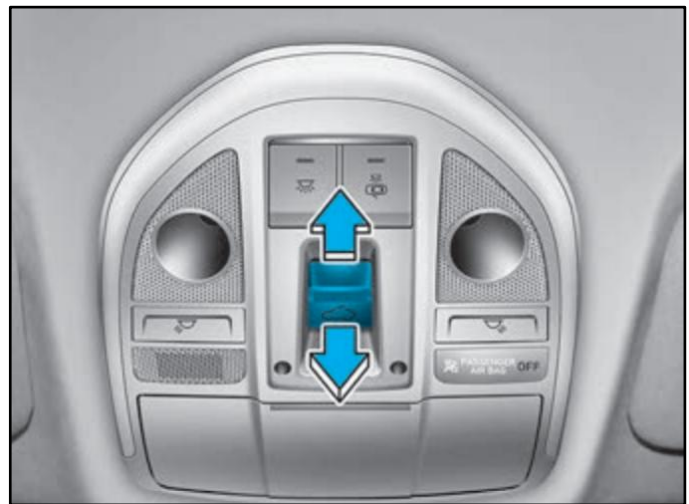
27. Put the sunroof mechanism in the tilt position by pressing the wide sunroof switch.

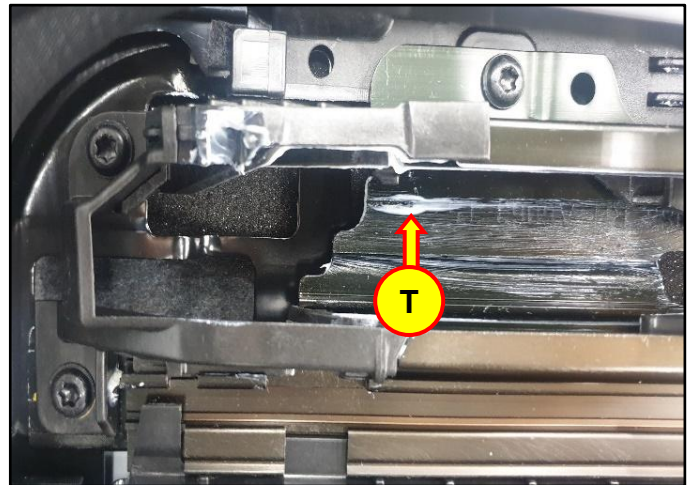
Apply more silicone lubricant to the area (T) on the top of the front locator.

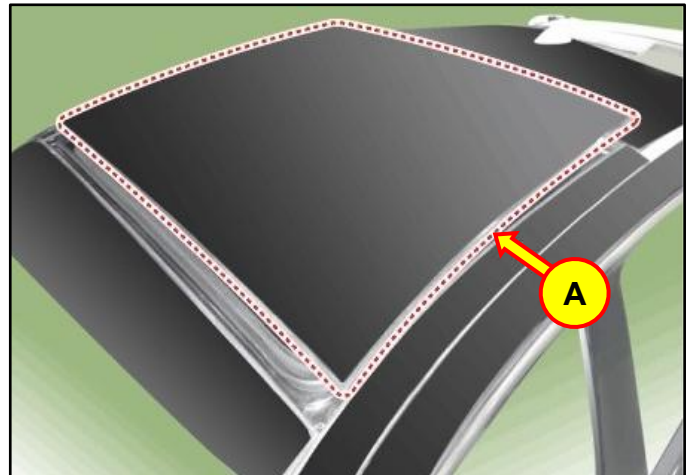
29. Reinstall the sunroof glass (A).
