24KWE: Kongsberg Automotive Right-Hand Shift Stalk

24KWE NHTSA: 24V190 / Transport Canada: 2024-161

Safety Recall

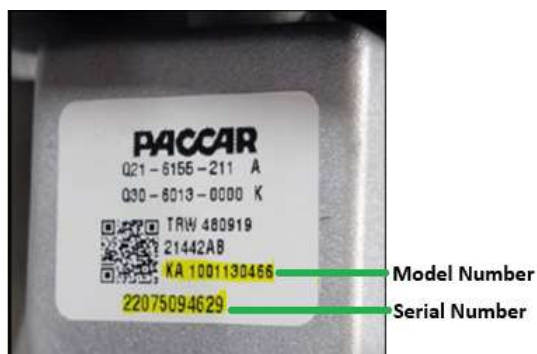
Right-hand shift stalk part/serial number label

- **0.4 hours** to inspect the right-hand shift stalk for the affected part number, R&R shift stalk with part number **Q21-6124-213**, attach connector photos, and dispose of the old shift stalk per bulletin procedures. Use Recommended Repair Code **24KWEG**.
- **You must enter all the following information from the as-installed right-hand shift stalk into the warranty claim:**
 - Serial number into the Causal Part Serial Number field
 - Model number into the Causal Part Model Number field
