**WPC6 - Replacing Driver's Airbag Unit (Workshop Campaign)**

Model Year: **As of 2015 up to 2017**

Model Line: **Macan (95B)**

Concerns: **Driver's airbag unit**

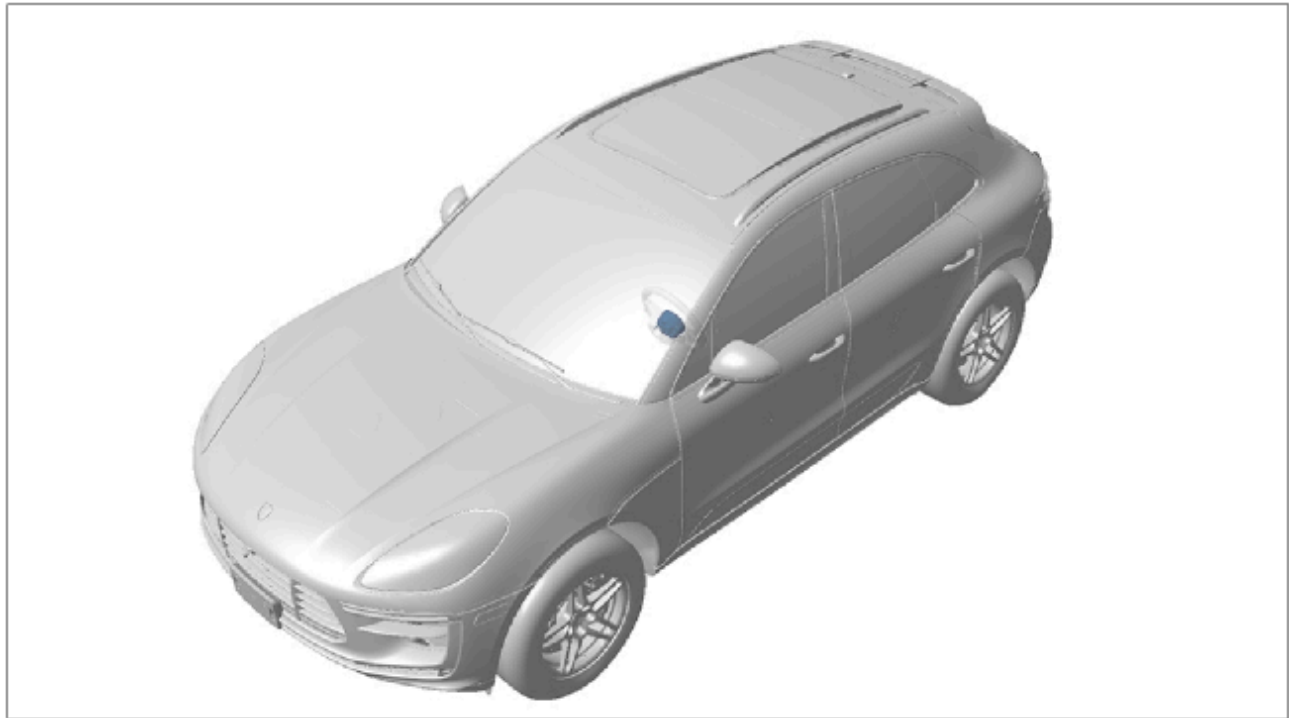
Position:

*Driver's airbag unit (replace)***Required parts**

- 1 Replace driver's airbag unit.

For instructions, see: ⇒ *Workshop Manual '695819 Removing and installing driver's airbag unit'*

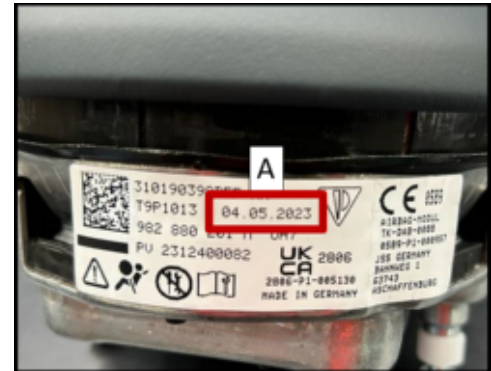
Production date (exemplary representation)

Before replacing the airbag unit, check the production date ⇒ *Production date (exemplary representation) -A-*.

If this **date is after 31.12.2017**, the affected airbag unit is not relevant for this action and can remain in the vehicle.

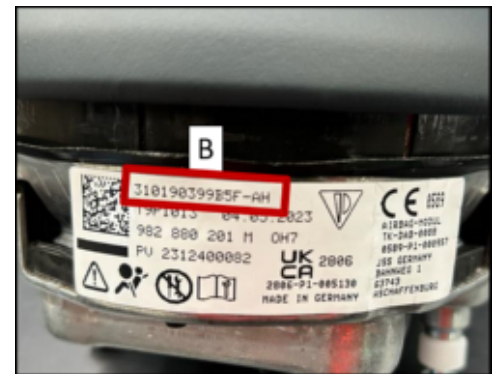
Airbag module number (sample illustration)

- Campaign number
- Vehicle identification number
- Vehicle type (Cayenne or Macan)
- Model year of the vehicle
- Vehicle mileage
- Airbag module number ⇒ *Airbag module number (sample illustration) -B-*

2 **ALL REMOVED AIRBAGS FOR WPC6 CAMPAIGN MUST BE RETURNED TO YOUR FACING PDC.**

Document the following data on a sheet of paper and attach it, for example with adhesive tape to the removed airbag unit before repacking it for return:
