WPC6 - Replacing Driver's Airbag Unit (Workshop Campaign)

Model Year: **As of 2015 up to 2017**

Model Line: **Cayenne (92A)**

Concerns: **Driver's airbag unit**

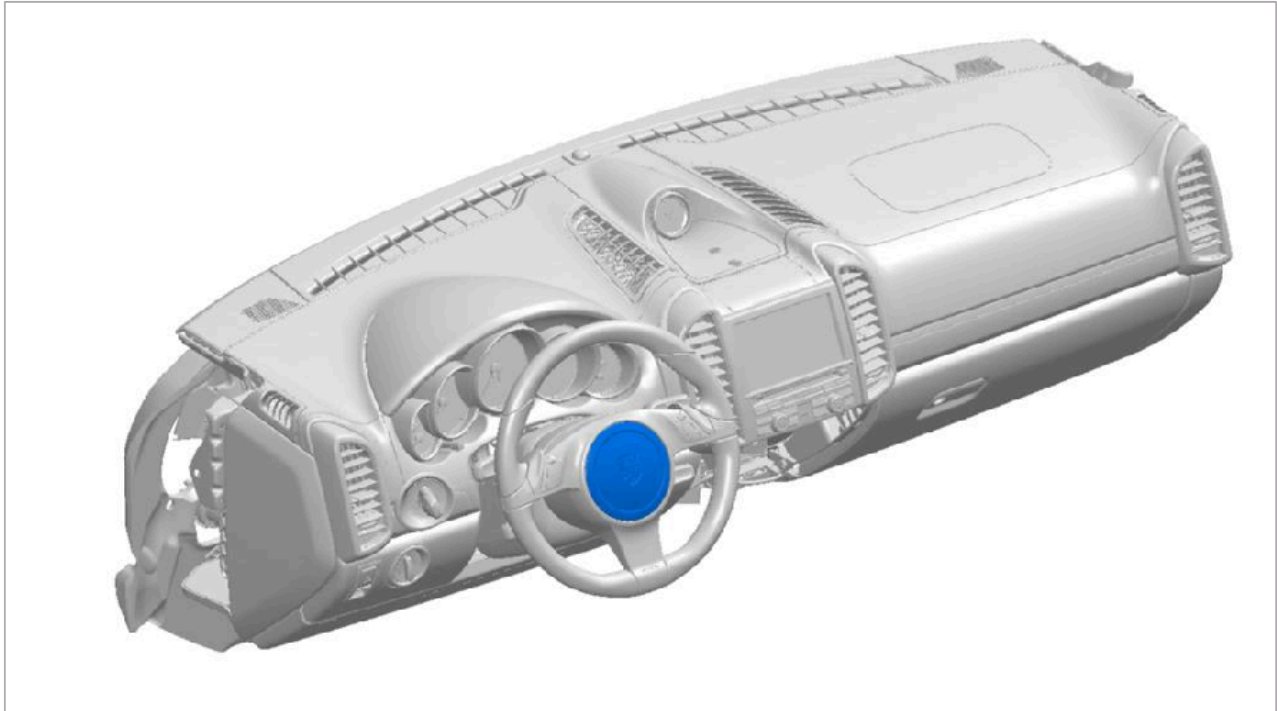
Position:

Driver's airbag unit (replace)

- 1 Replace driver's airbag unit.
For instructions, see: ⇒ *Workshop Manual '695819 Removing and installing driver's airbag unit'*

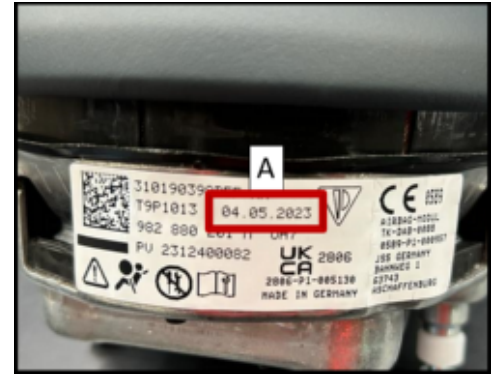
Production date (exemplary representation)

Before replacing the airbag unit, check the production date ⇒ *Production date (exemplary representation) -A-*.

If this **date is after 31.12.2017**, the affected airbag unit is not relevant for this action and can remain in the vehicle.
