Polestar emblem in front bumper, poor fit

REF NO: TJ 37113.2.0	ISSUING DEPARTMENT: Technical Service	CAR MARKET: United States and Canada	
PARTNER: 3 US 7515 Polestar		ISSUE DATE: 2025-12-02	STATUS DATE: 2025-12-11
FUNC GROUP: 8412	FUNC DESC: Emblem	Page 1 of 14

TJ Instruction VCC-530080-1

Title	Cover bumper front	Page	1 (11)
Action		Operation number:	86103-2 99922-2

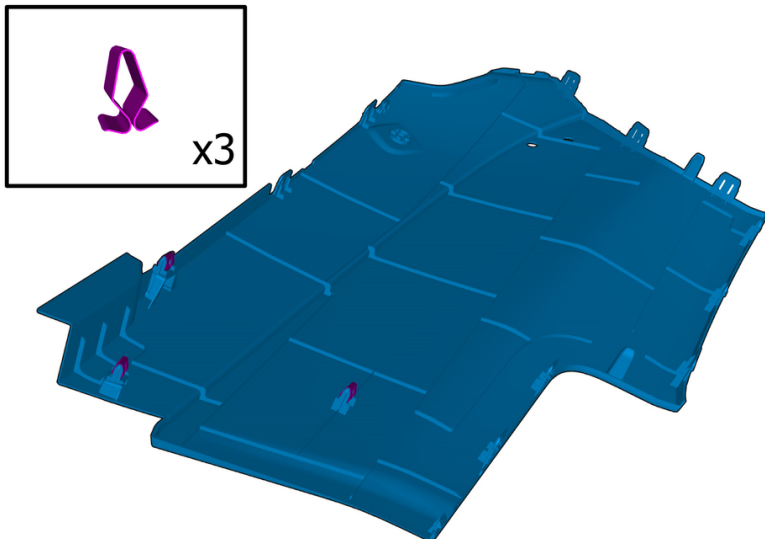
Note! The graphic shows the back of the component before removal.

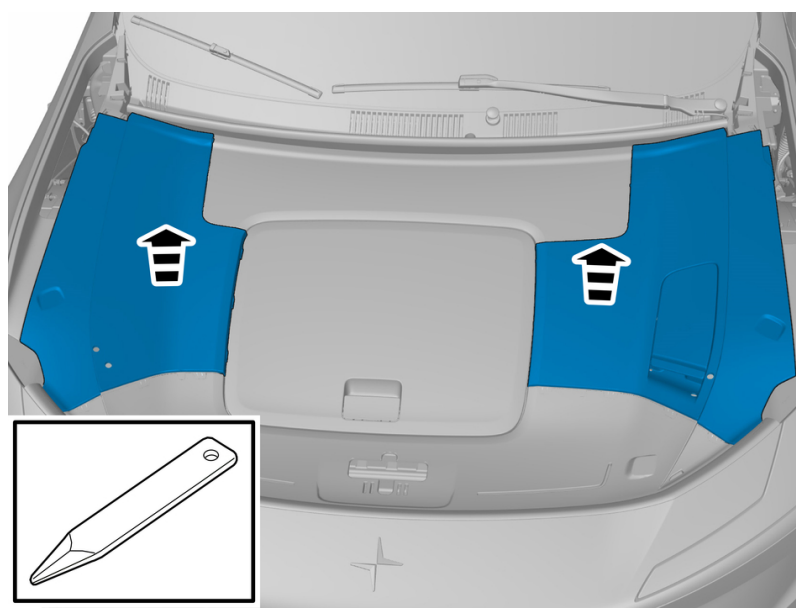
Remove the marked part.

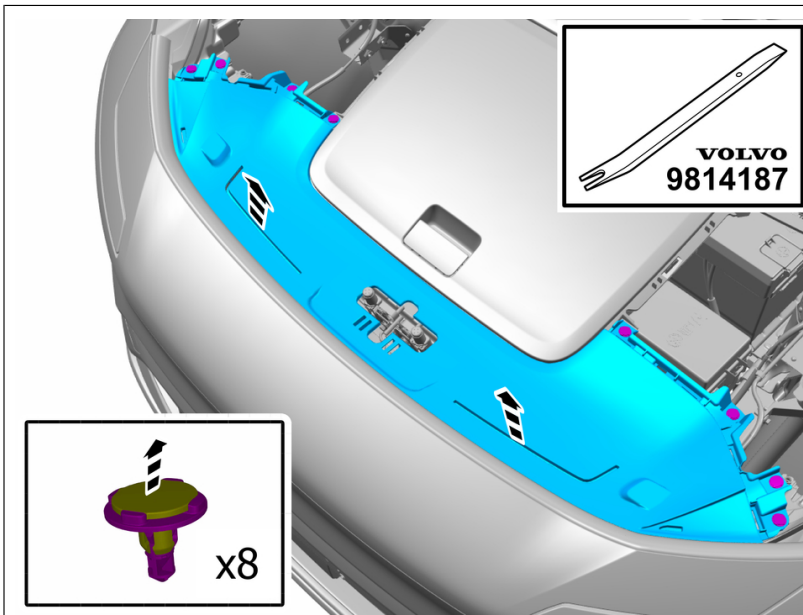
Loosen the clips.

Remove the marked part.

Special Tool: T9814187, Clip tool

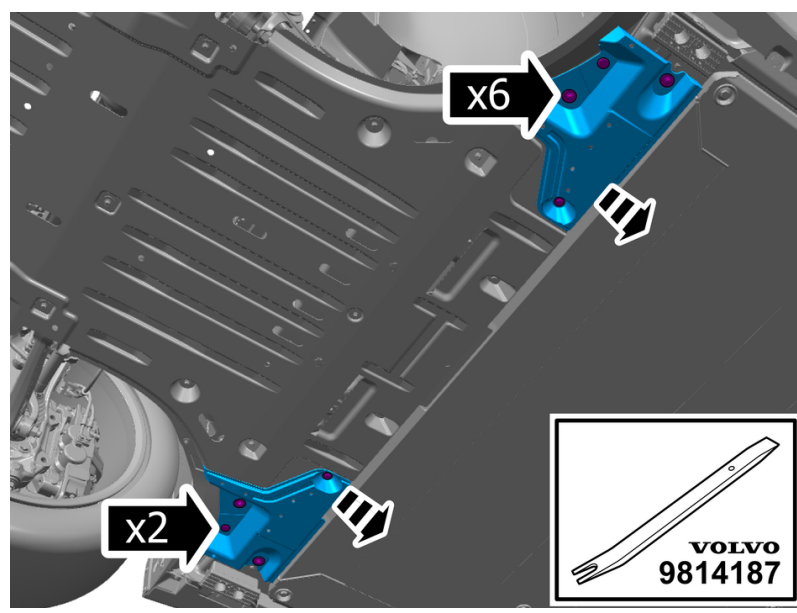
Loosen the clips.
 Special Tool: T9814187, Clip tool
 Remove the marked part.

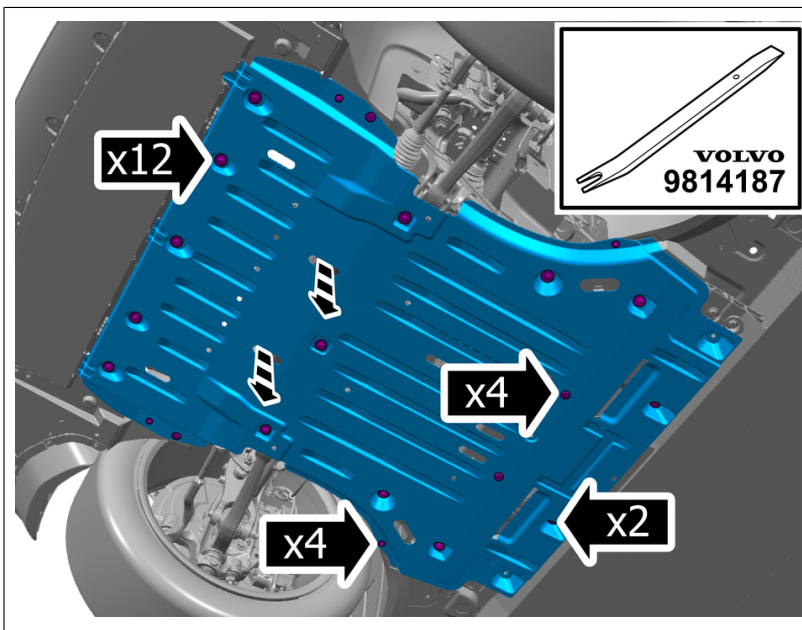
Remove the screws.
 Loosen the clips.
 Special Tool: T9814187, Clip tool
 Remove the marked part.

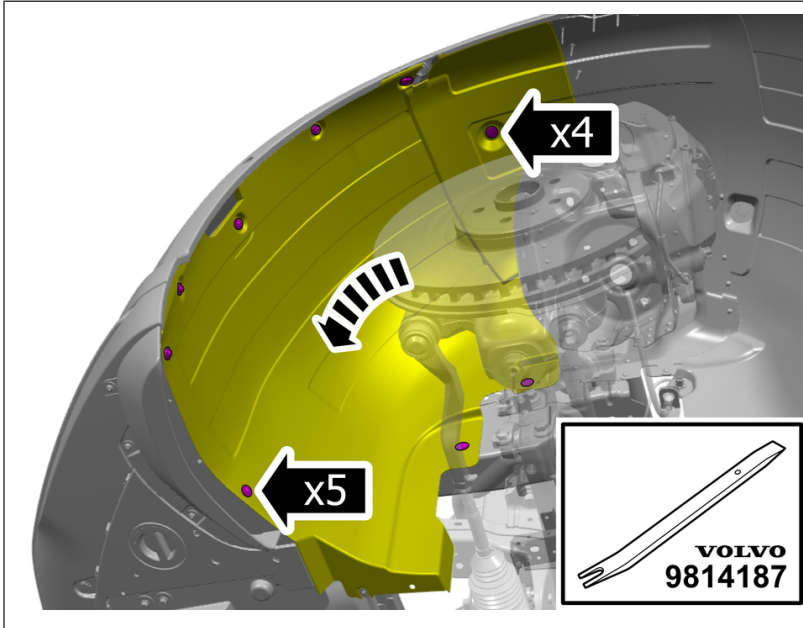
Remove the screws.
Loosen the clips.
Fold marked part aside.
On both sides.
Special Tool: T9814187, Clip tool

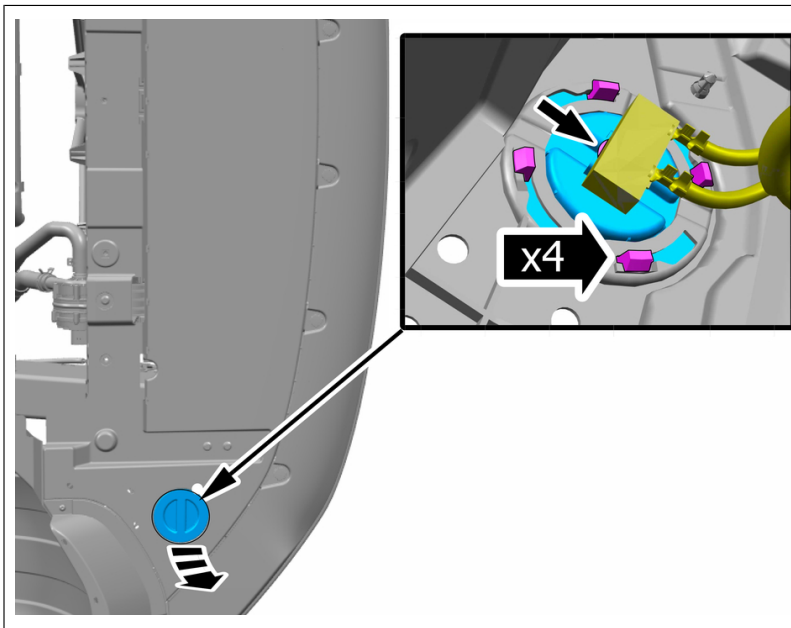
Release the catches.
Unhook the cable harness clips.
Remove the marked part.

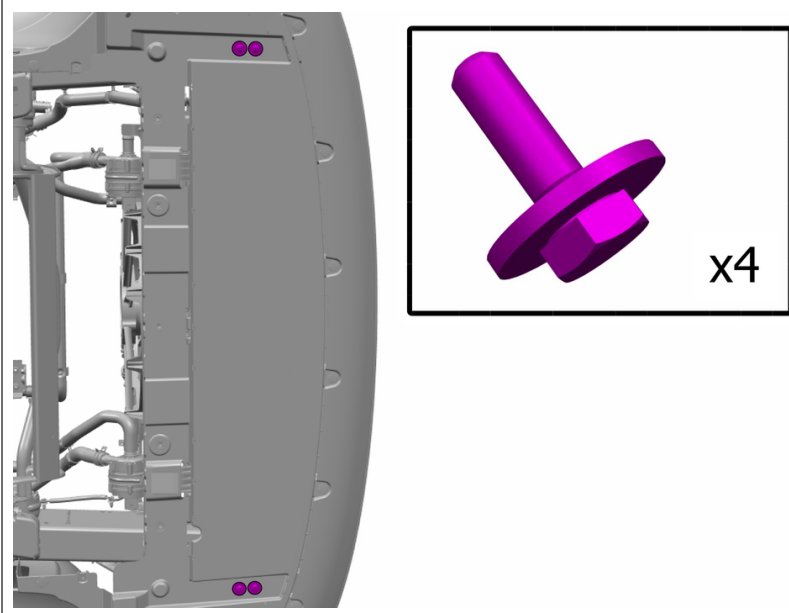
Remove the screws.

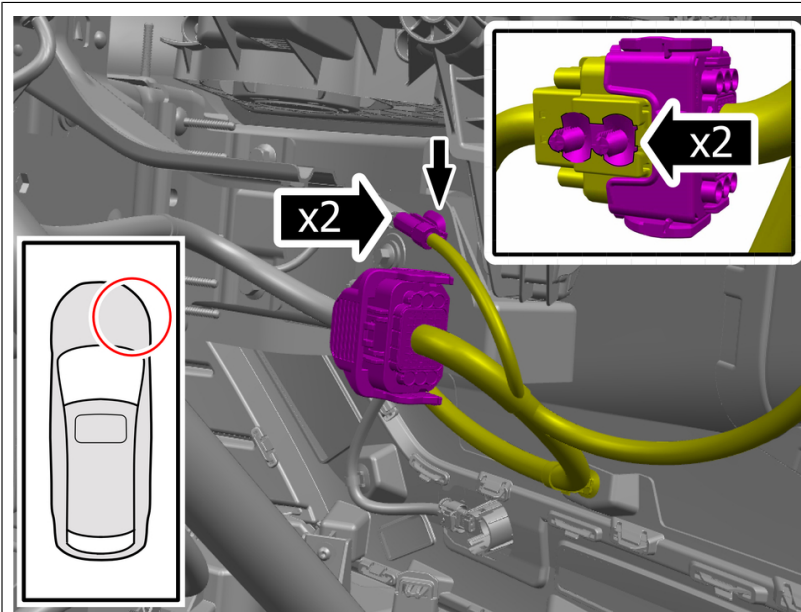
Release the catches.
Disconnect the connectors.
Fold the cable harness aside.

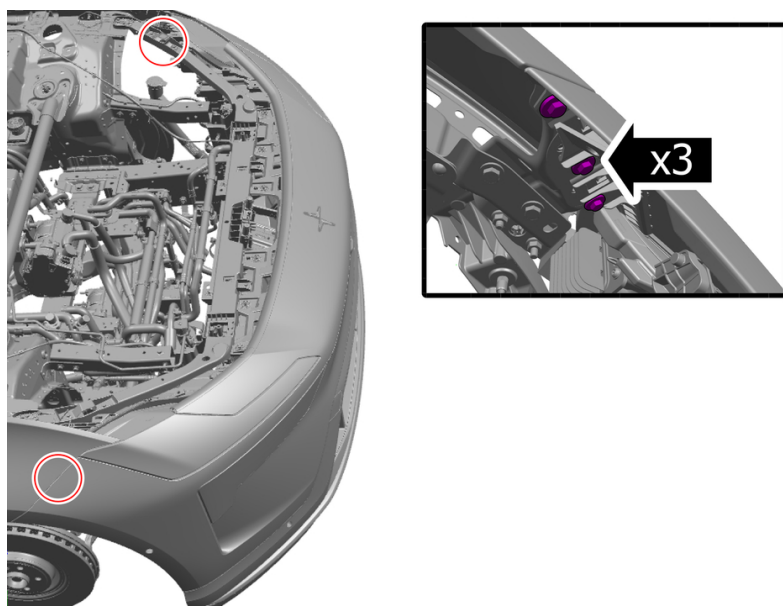
Remove the screws.
On both sides.

Torque:

M5 , 5 Nm

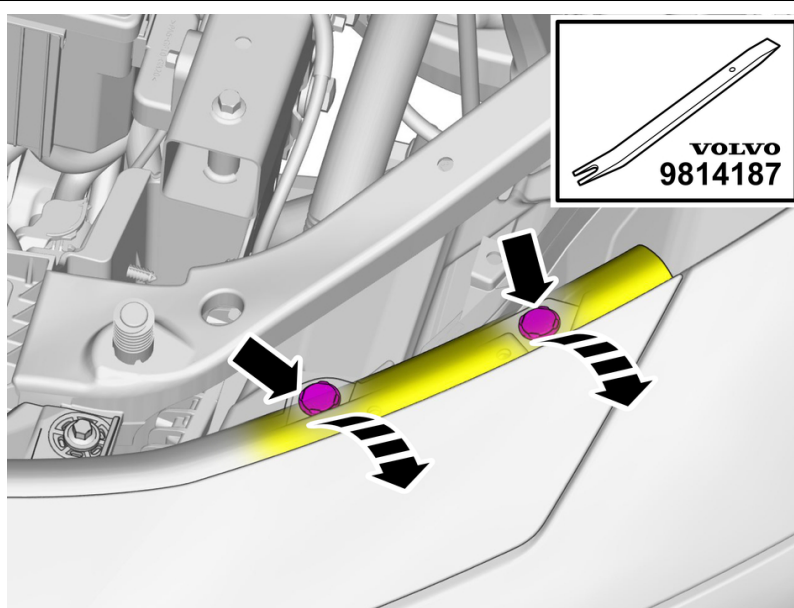
Fold marked part aside.
Remove the clip.
Repeat on the other side.

Special Tool: T9814187, Clip tool

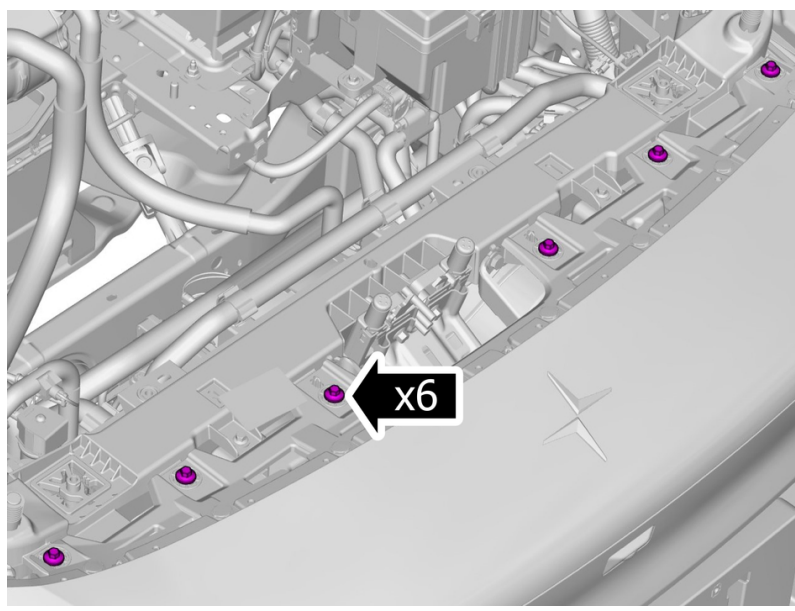
Remove the screws.

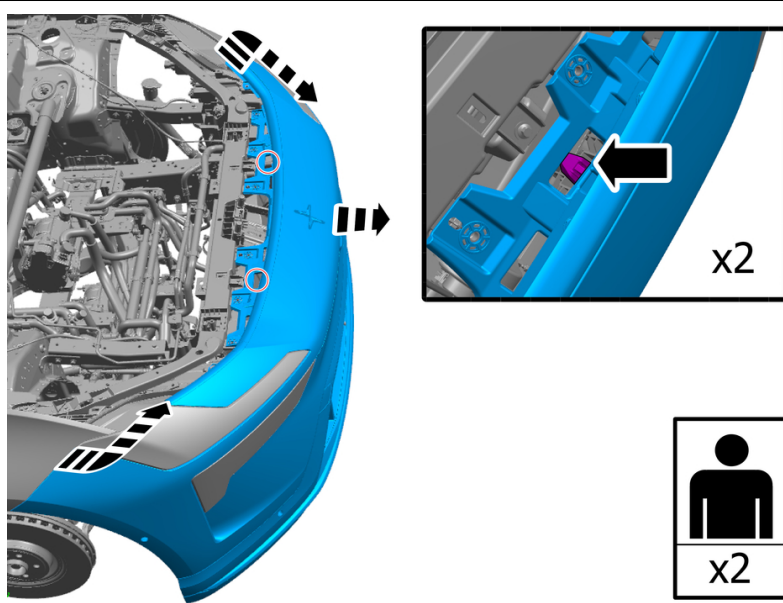
Caution! Make sure that the sharp edge does not damage the surrounding component.

Note! This step requires the aid of another technician.

Release the catches.
Remove the marked part.

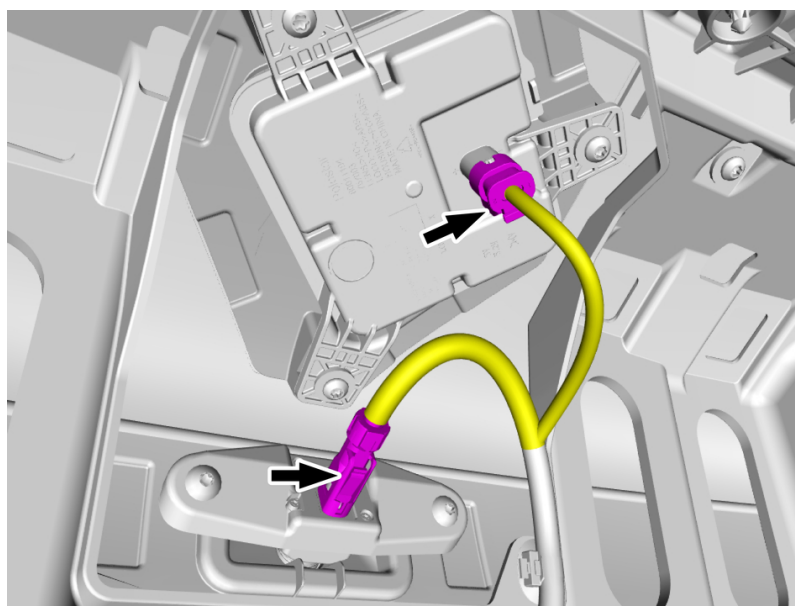
Disconnect the connectors.

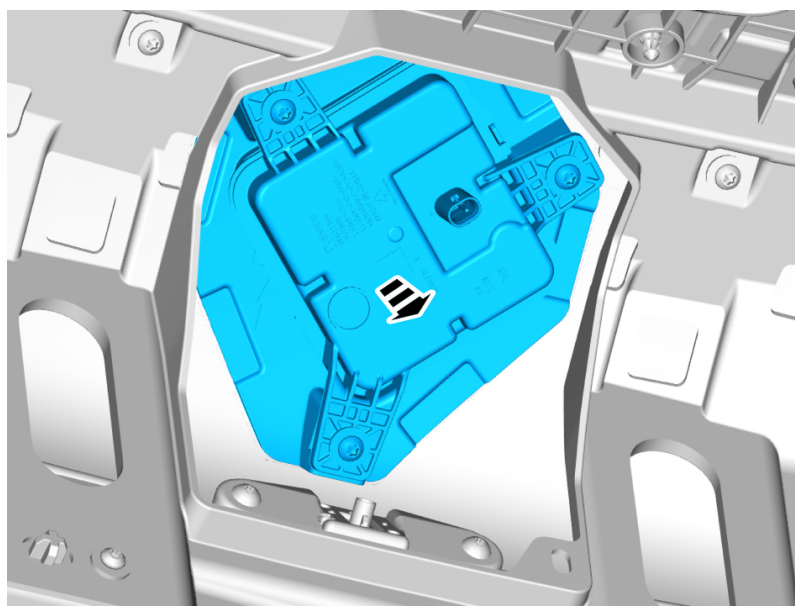
Remove the marked part.

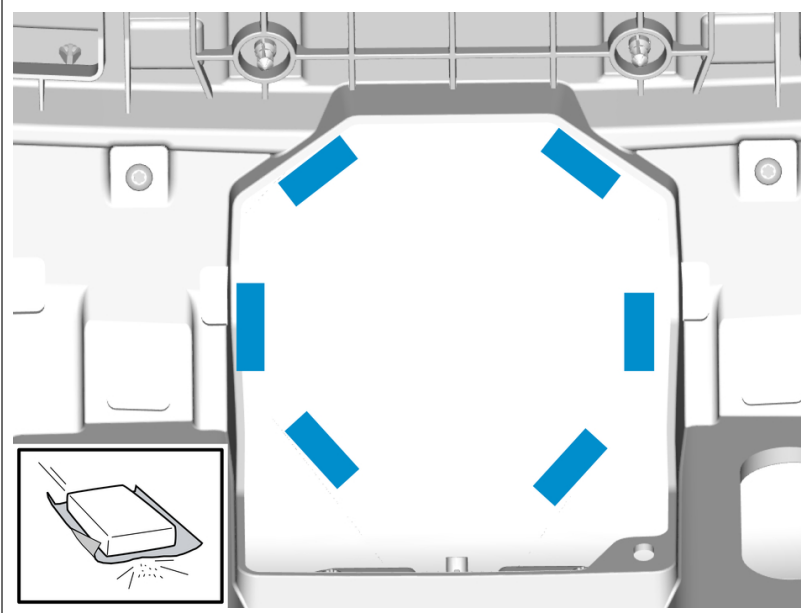
Grind off excess glue to the paint level.

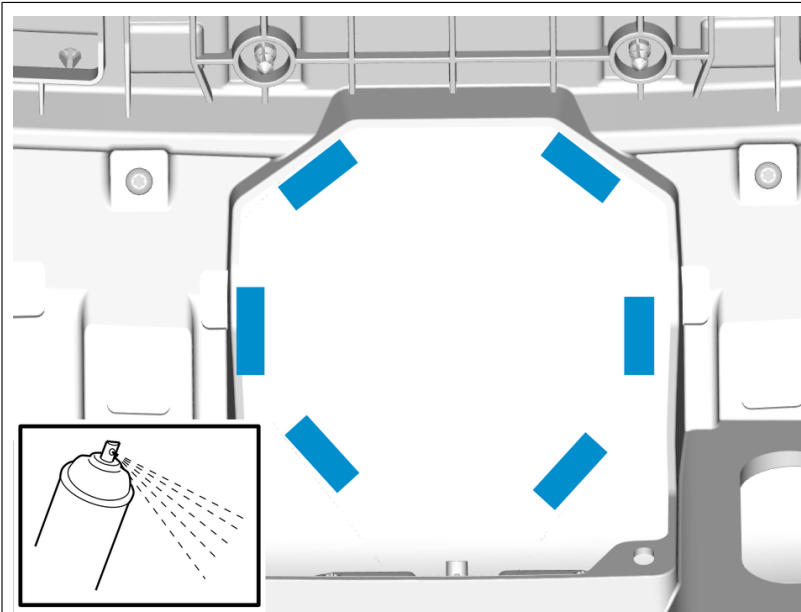
Apply a thin layer of primer.

Primer: Würth REPLAST plastic primer, part number 08935002.

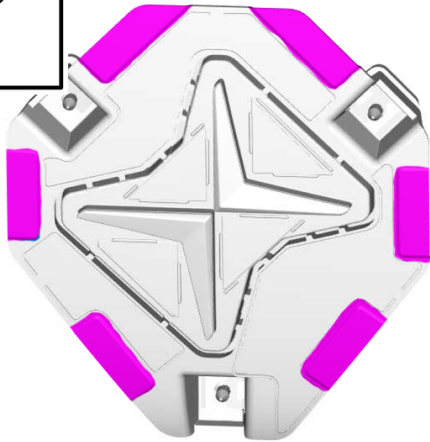
Caution! Apply the adhesive carefully as illustrated.

* Adhesive: Würth REPLAST Plastic adhesive 2C, fast curing 90 seconds, part number 0893500042.

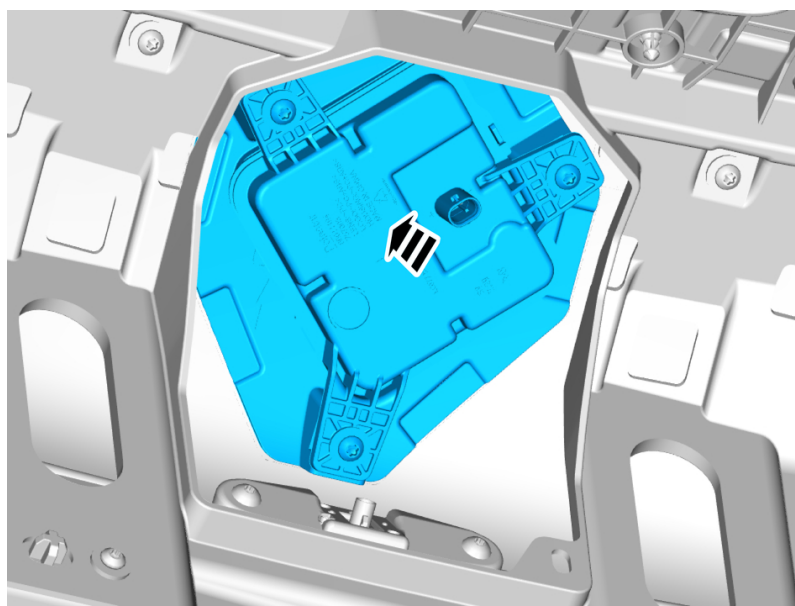
Caution! Make sure that equal pressure is applied to the full length of the component.
